**PRODUCT CAMPAIGN BULLETIN**

**APPLICABILITY:** 2023MY WRX  
 2024MY Crosstrek  
 2024MY Impreza  
 2023-2024MY Forester

**NUMBER:** WRP-23  
**DATE:** 12/19/23  
**NHTSA ID:** 23V-754

**SUBJECT:** Safety Recall – Driveshaft Failure

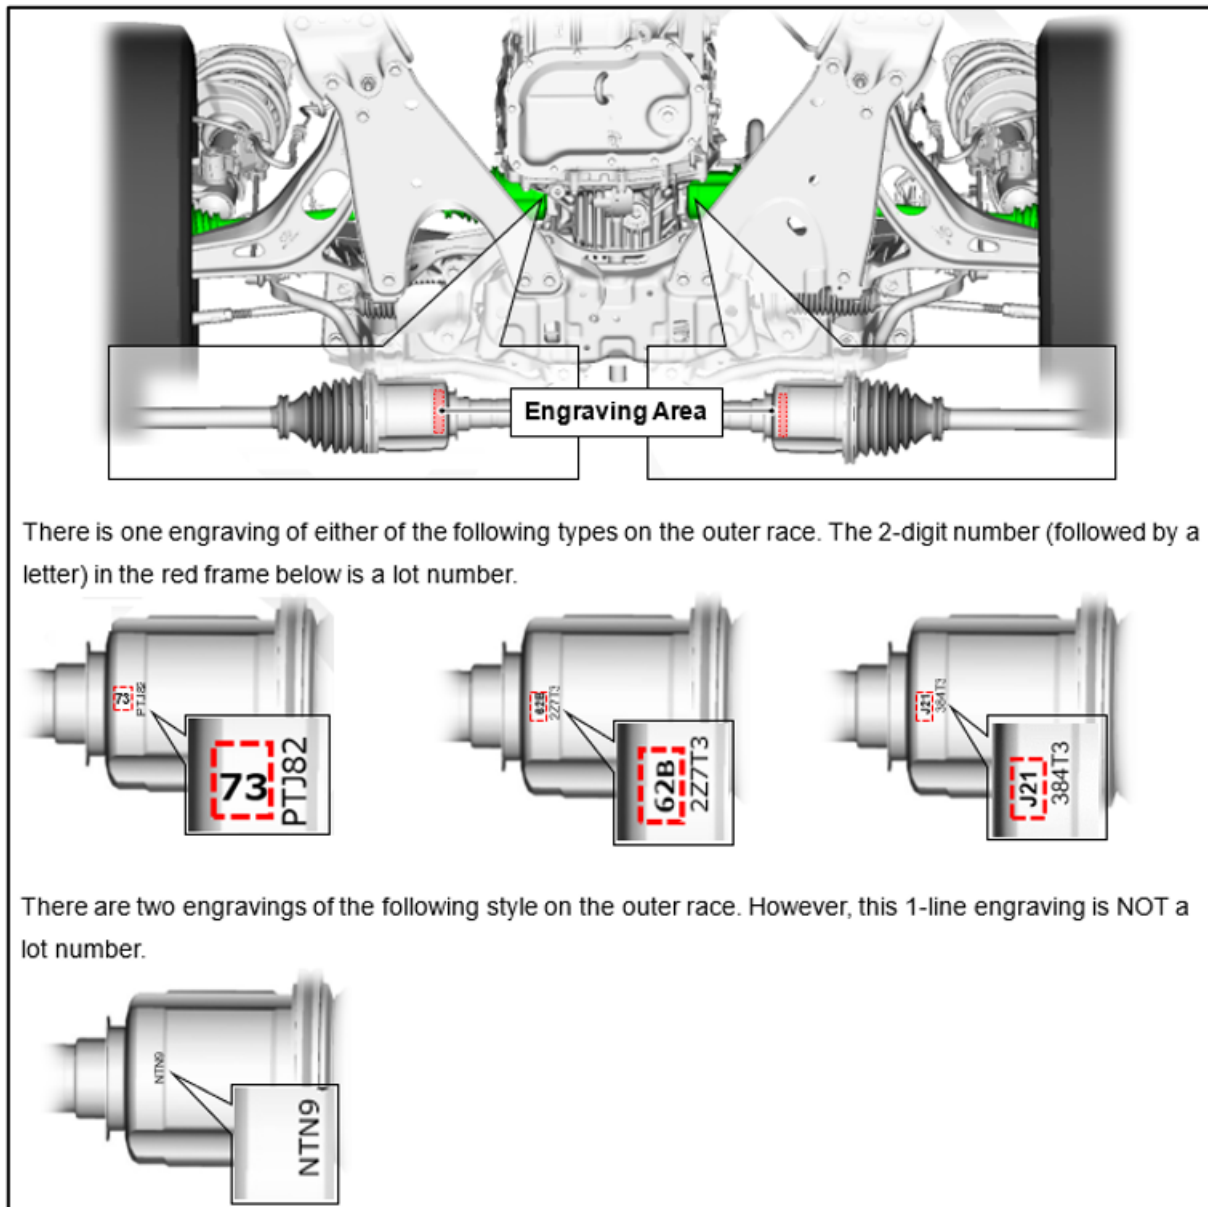
**STEP 2:** Rotate the left/right front wheel to find the 2-Line engraving located on both the left and right outer race portions of the inner drive shaft joints.

- There are three engravings on the drive shaft outer race. One is the lot number, and the others are NOT lot numbers. The lot number engraving is shown in the images below.
- SLOWLY rotate the wheel to find the lot number. Remove and dust and/or dirt using a clean cloth to make the numbers more visible. A flashlight will also aid in the reading.

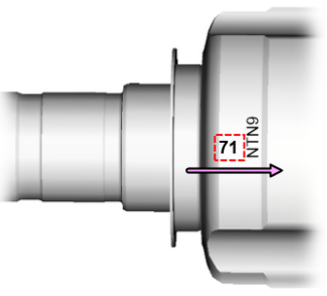
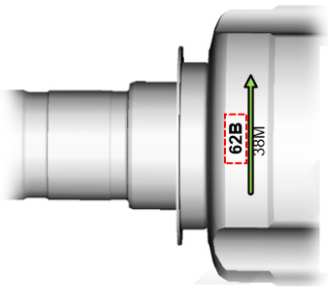
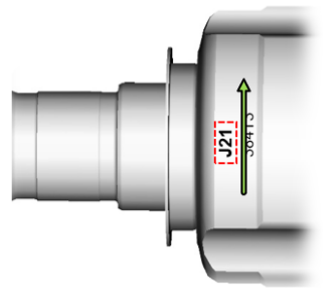
Engraving Type 1	Engraving Type 2	Engraving Type 3
2-digit number is engraved in the axis direction.	3 digit-character starting with a number is engraved in the circumferential direction.	3 digit-character starting with a letter is engraved in the circumferential direction.

<b>Results</b>		
Engraving style 1	Refer to the table below for further details.	
Engraving style 2 or 3	The drive shaft is a good part. Record and include the lot number to the repair order.

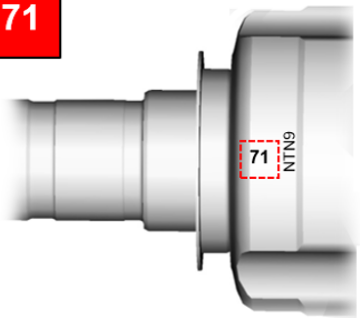
<b>71</b>

<b>Results</b>					
<b>71, 73 or 75</b>		The drive shaft is a defective part. Replace the affected front drive shaft with new parts.			
Other 2-digit numbers		The drive shaft is a good part. Record and attach the lot number to the repair order.

**YES:** Review the additional service procedure tips listed below. Replace the affected drive shaft as per the applicable Service Manual. Refer to STIS: Driveline/Axle > PROPELLERSHAFT / DRIVE SHAFT / AXLE > Front Drive Shaft
