## PRODUCT CAMPAIGN BULLETIN

**APPLICABILITY:** 2003-2004 Baja  
 2003-2008 Legacy and Outback  
 2004-2005 Impreza, WRX, STI

**SUBJECT:** Takata Front Passenger Air Bag  
 Inflator Replacement

**NUMBER:** WQR-53R

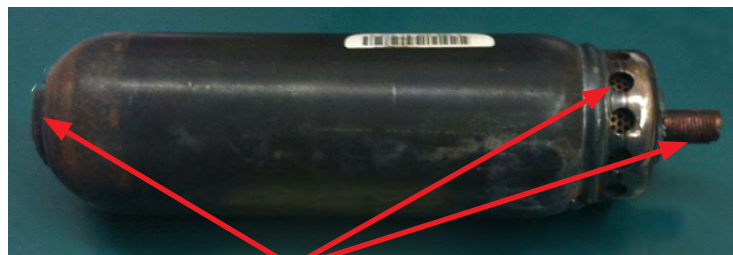
**The shape, holes, and copper-colored stud indicate this not a Genuine Subaru inflator.**

- Document the presence of the aftermarket or counterfeit device on the repair order and with photos. Report this information immediately on a Quality Monitoring Report (QMR).

- Once the QMR has been submitted, contact the Subaru Claims Helpline to discuss the details. They will advise you on how to proceed with treatment of the open campaign.

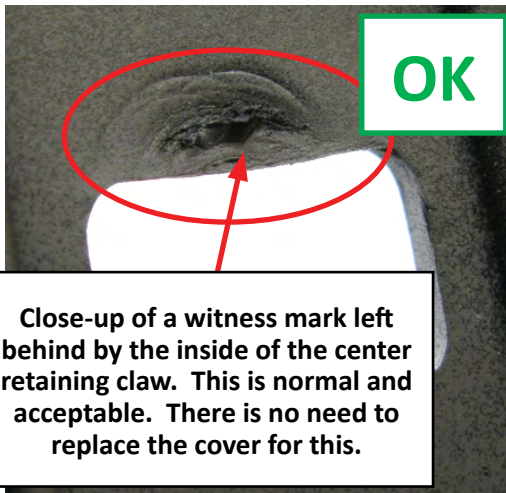
Close-up of a witness mark left  
behind by the inside of the center  
retaining claw. This is normal and  
acceptable. There is no need to  
replace the cover for this.

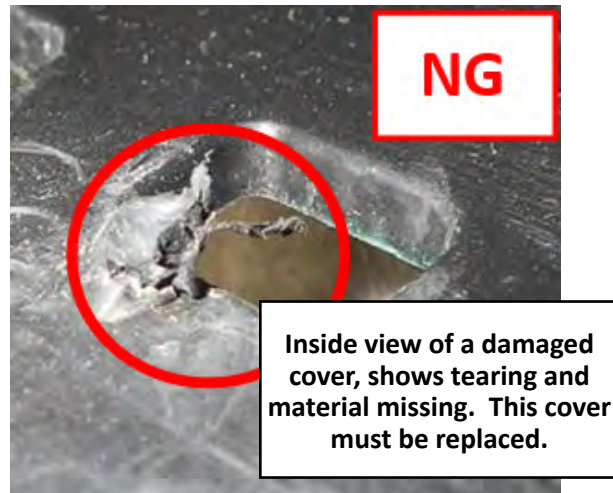
Inside view of a damaged  
cover, shows tearing and  
material missing. This cover  
must be replaced.
