**PRODUCT CAMPAIGN BULLETIN**

<p><b>APPLICABILITY:</b> 2003-14 MY Legacy          2003-14 MY Outback          2003-06 MY Baja          2009-13 MY Forester          2004-11 MY Impreza          2004-14 MY WRX and STI</p> <p><b>SUBJECT:</b> Takata Front Passenger Airbag Module /          Inflator “Like for Like” Recall</p>	<p><b>NUMBERS:</b> TKA-20R          TKB-20R          TKC-20R</p> <p><b>DATE:</b> 01/06/20</p> <p><b>REVISED:</b> 12/28/23</p> <p><b>NHTSA ID:</b> 20V001          20V002          20V003</p>
---	--

**DESCRIPTION OF THE SAFETY DEFECT AND SAFETY HAZARD**

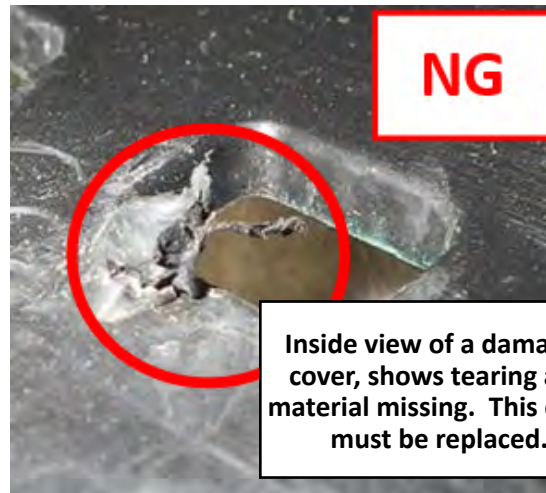
Inside view of a damaged cover, shows tearing and material missing. This cover must be replaced.
