Coolant Warning Light Lights Up: Supposed Coolant Loss on the Coolant Pump (167/23)

Vehicle Type: **Cayenne (9YA / 9YB) / Cayenne S (9YA / 9YB) / Cayenne E-Hybrid (9YA / 9YB)**

Concerns: **Coolant pump**

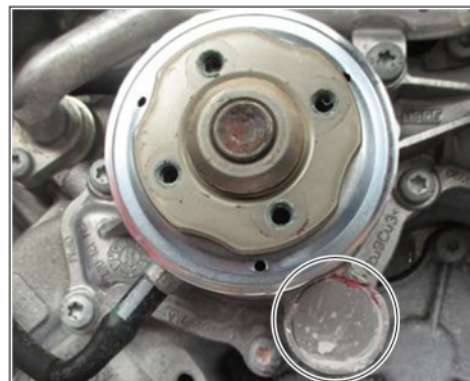
The visual inspection can show that small traces of coolant are detected at the weep hole of the coolant pump.
 Due to lubrication/cooling of the lip seal on the coolant pump, up to **3 ml coolant per 100 operating hours** can escape. Coolant outlet to this extent can be considered normal and does not constitute grounds for complaint. ⇒ *Traces of coolant on coolant pump*

Traces of coolant on coolant pump

Assessment		Action
(✓)	No further coolant leak can be detected at the affected location.	Continue observing, a part replacement is not required. End of remedial action.
(x)	New coolant leak can be detected at the affected location.	Replace component causing damage.
