Technical product information

Topic	Diagnosis guidelines relating to Headlamp operation/Daytime running lights (Inner lamp) and/or Turn signal (Outer lamp)
Market area	Australia E04 Bentley rest Asia and Australia (6E04),China 723 Volkswagen (Anhui) Automotive CO (6723),China 796 VW Import Comp. Ltd (Vico), Beijing (6796),Germany E02 Bentley rest Europe (6E02),Japan E03 Bentley Japan (6E03),Korea, (South) E08 Bentley South Korea (6E08),United Arab Emirates E06 Bentley Middle East and Africa (6E06),United Kingdom E01 Bentley UK (6E01),United States E05 Bentley USA and rest America (6E05)
Brand	Bentley
Transaction No.	2054599/9
Level	EH
Status	Approval
Release date

New Continental GT - New Continental GTC and New Flying Spur

Diagnosis guidelines relating to Headlamp operation/Daytime running lights (Inner lamp) and/or Turn signal (Outer lamp)

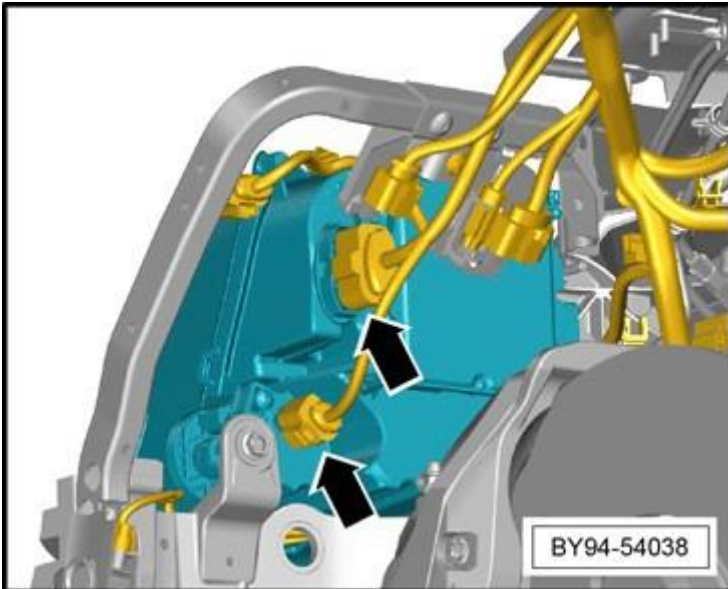
Hint: After disconnection look out for any abnormalities **For example:** Headlamp plugs which are loose/broken or is easily disconnected

- 1) Remove the applicable front wheel arch liner - Refer to Repair manual Rep.Gr 66
- 2) Referring to the examples shown in Figure 1 (New Continental GT/C and New Flying Spur) and Figure 2 (Bentayga)

- Disconnect the applicable headlamp plugs (right and/or left hand side)
