# Service Bulletin

**Subject:** Information on Vibration Analysis and Diagnostic

**Models:** 2014 Chevrolet Silverado 1500  
 2015-2018 Chevrolet Silverado 1500  
 2019 Chevrolet Silverado LD \*  
 2014 GMC Sierra 1500  
 2015-2018 GMC Sierra 1500  
 2019 GMC Sierra Limited \*  
 EXCLUDES HD Trucks

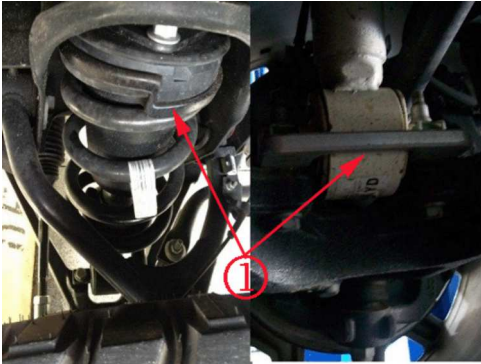
1. Inspect the truck for any aftermarket equipment installations. For example: non factory tires, wheels and/or lift kits or leveling kits – shims (1) installed as shown above. Aftermarket equipment does include running boards, bug deflectors, and window shades, etc. Remove any aftermarket that might cause vibration transmission paths.
2. Mark each tire valve stems location on the tire. This will be utilized to check for tire slippage on the rim.

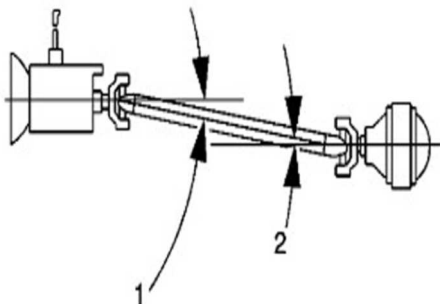
Measurement	Notes:
Yoke to Shaft		The first (forward most) U-joint action on a two piece driveshaft system is not canceled out by another U-joint. Because of this, the first U-joint working angle should be between 0.5 and 0.75 degrees.
Front Shaft to Center Support Bearing (if equip)		U-joint pairs cancel each other. Neither U-joint working angle should exceed 4 degrees, nor the allowable range of difference between cancelling U-joint working angles is 0.00 to 1.0 degrees.
Shaft to Diff Yoke
