TECHNICAL SERVICE BULLETIN

Lack Of Air Flow/HVAC Blower Motor Inoperative

23-2288

Ford 2021-2023 E-Series

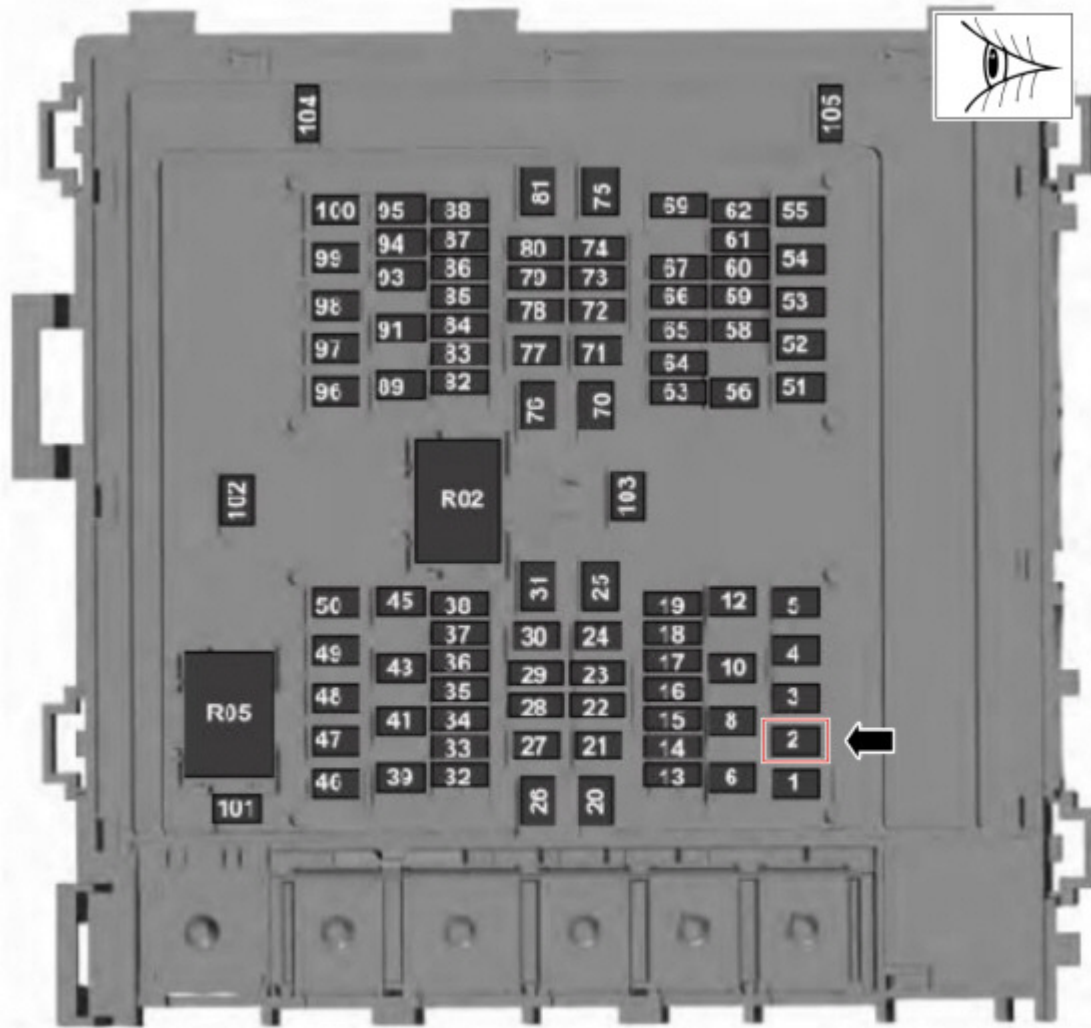
Figure 6

Issue: Some 2021-2023 E-Series vehicles may exhibit a lack of air flow due to an inoperative heating, ventilation, and air conditioning (HVAC) blower motor. This may be due to a damaged fuse F2 (50A) in the battery junction box (BJB). To correct the condition, replace the BJB, pigtail connector, and replace fuse F2 in the new BJB with the listed service replacement part.

6. Repair or replace connector C1035B. Refer to Wiring Diagram, Cell 005 for repair procedures.
7. Replace the BJB reversing the removal procedure.
8. Remove fuse F2 and replace with the listed service replacement part. (Figure 6)
