# PREVOST

## WARRANTY BULLETIN

### WB23-37

| SUBJECT: | <b>WIPER MOTOR HARNESS MODIFICATION</b> | | |

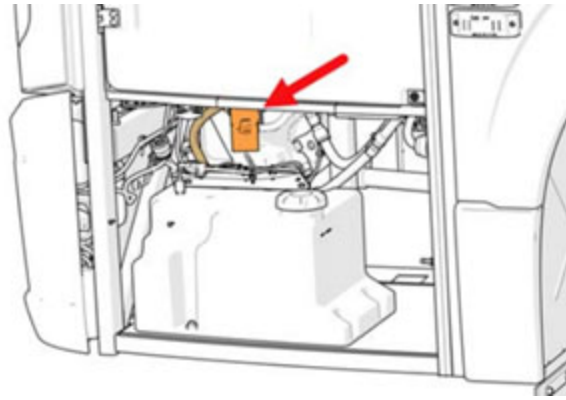
1. Pull the release lever located inside the front service compartment to unlock.

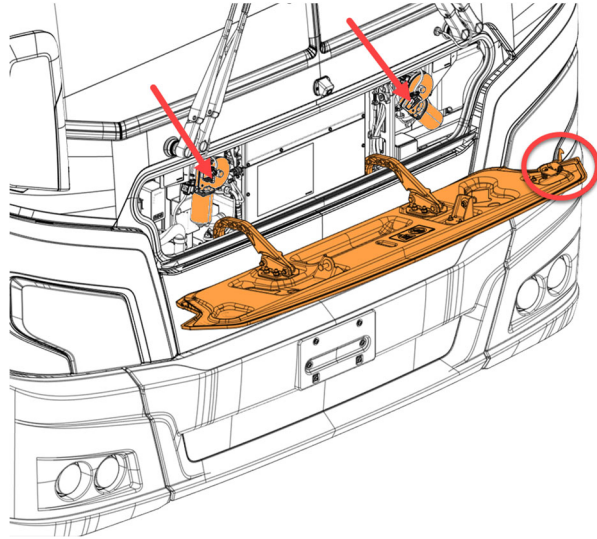
2. Pull the safety latch located on the upper right inner side of the hatch.
3. Locate the two wiper motors

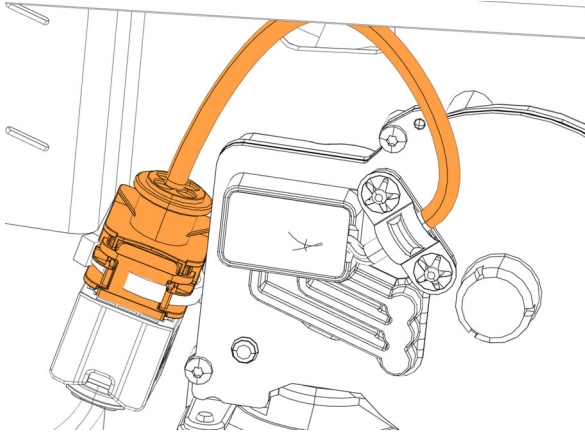
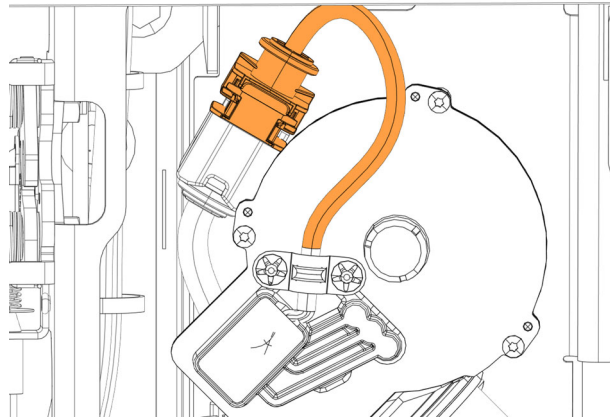
4. Locate the connector of the wiper motor.

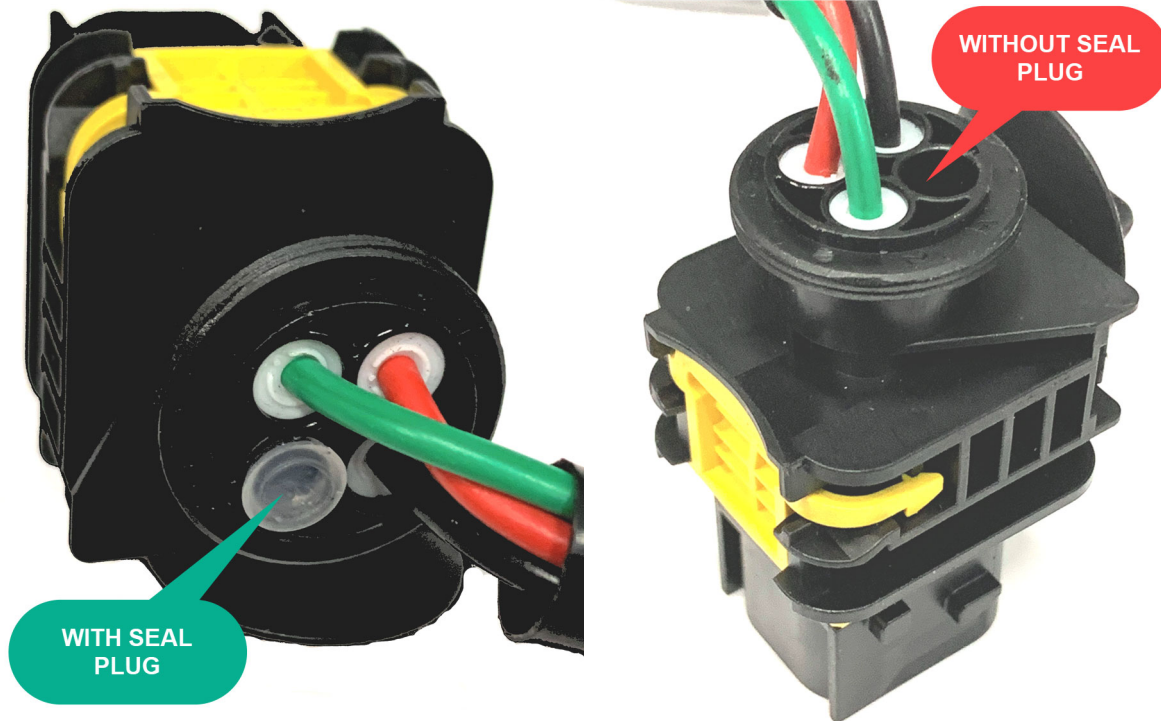
5. Verify if the connector has a plug into the empty cavity.
- If no, go to the next step.
  - If yes, the procedure is complete.

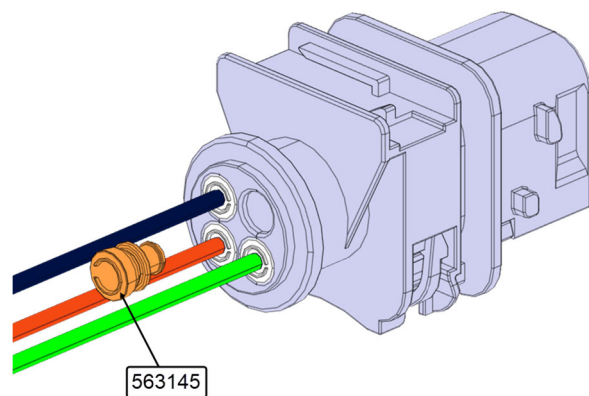
On the vehicles affected by this bulletin, the wiper motor harness needs a modification to avoid connector terminals corrosion.

6. Add cavity plug 563145 to connector empty terminal hole.
