HOOD CANNOT BE OPENED

Service Alert No.: SA-085/23

2024 CX-90

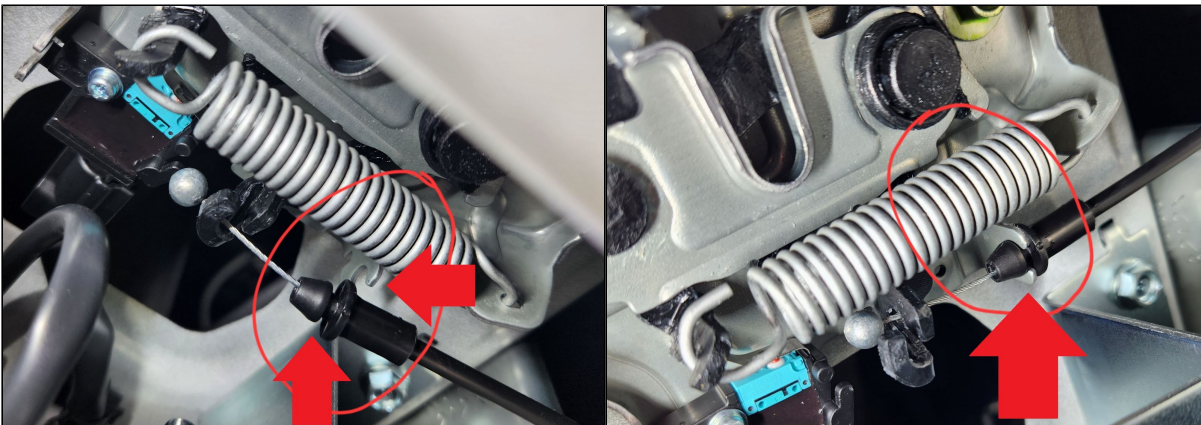
NON-DESTRUCTIVE WAY TO GET TO THE LATCH AND OPEN THE HOOD

Some customers may experience an issue where the hood cannot be opened using the release cable. To open the hood for diagnosis and repairs, follow the repair procedure below.

The procedure in MGSS directs you to remove the front bumper for hood cable and latch repairs, however, you need the hood open to do that. To open the hood, you do not need to remove the bumper, and the final repair may be as simple as properly attaching the cable to the latch. (See the photos below.)

1. Pull the inner fender panel.
2. Reach up to access the hole in the core support.
3. Manually operate the lever to open the latch.
4. Repair the vehicle as needed.
