<b>Subject:</b>  INDENTATION DENT ON REAR SEATS	<b>Service Alert No.:</b> SA-080/23
	<b>Last Issued :</b> 12/05/2023

2023-2024 CX-50 vehicles produced before Apr., 2024

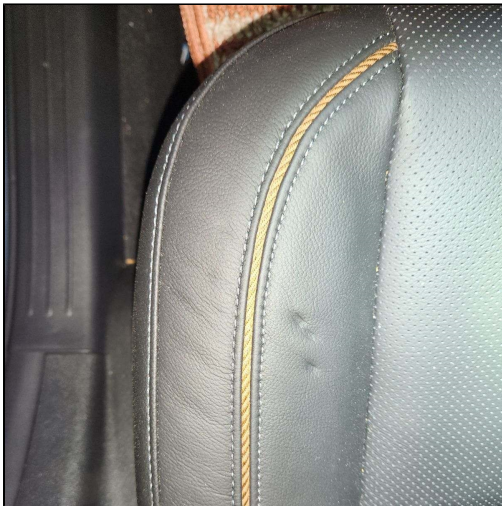
When folding down the rear seat back, there is a possibility that the seat belt buckle may cause a dent on the rear seats. This occurs because the buckle is stored too low on the belt, pressing it between the seat back and the seat bottom. The buckle stop button was moved 100mm upward to reduce the chance this will occur.

1. Replace both rear seat belts with the modified parts.
2. Do not replace the seat cushions, the dents will disappear as the vehicle cabin warms up in the sun.
