Subject: FRONT END OF REAR DOOR GLASS RUN-CHANNEL IS LOOSE	Bulletin No.: 09-044/23
	Last Issued : 12/07/2023

2024 CX-90 with VINS lower than JM3KK*****125140 (produced before July 27, 2023)

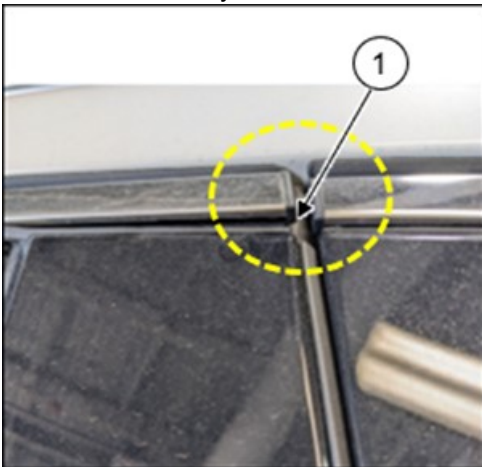
Some vehicles may exhibit the front end of the rear door glass run-channel (1) coming off from the rear door.

This is caused by the adhesive process of the sash molding primer coating and the double-sided tape not being properly performed with sufficient adhesive strength, resulting in the peeling off the double-sided tape on the the rear door glass run-channel. To eliminate this concern, the adhesive process of the sash molding primer coating and the double-sided tape has been modified to improve the adhesive strength.

Customers having this concern should have their vehicle repaired using the following repair procedure.

1. Verify the customer concern.
2. Replace both sides of the rear door glass run-channels with the modified ones according to the instructions in MGSS (REAR DOOR GLASS RUN-CHANNEL REMOVAL/INSTALLATION) and the following steps.
 - a. Perform repairs up to "Remove Driver's Side Glass" of the instructions in MGSS (REAR DOOR GLASS RUN-CHANNEL REMOVAL/INSTALLATION).
