FIELD SERVICE CAMPAIGN – 23111

19 December 2023

Lane Keep Assist Software Update

International® LT® and RH™ Series trucks

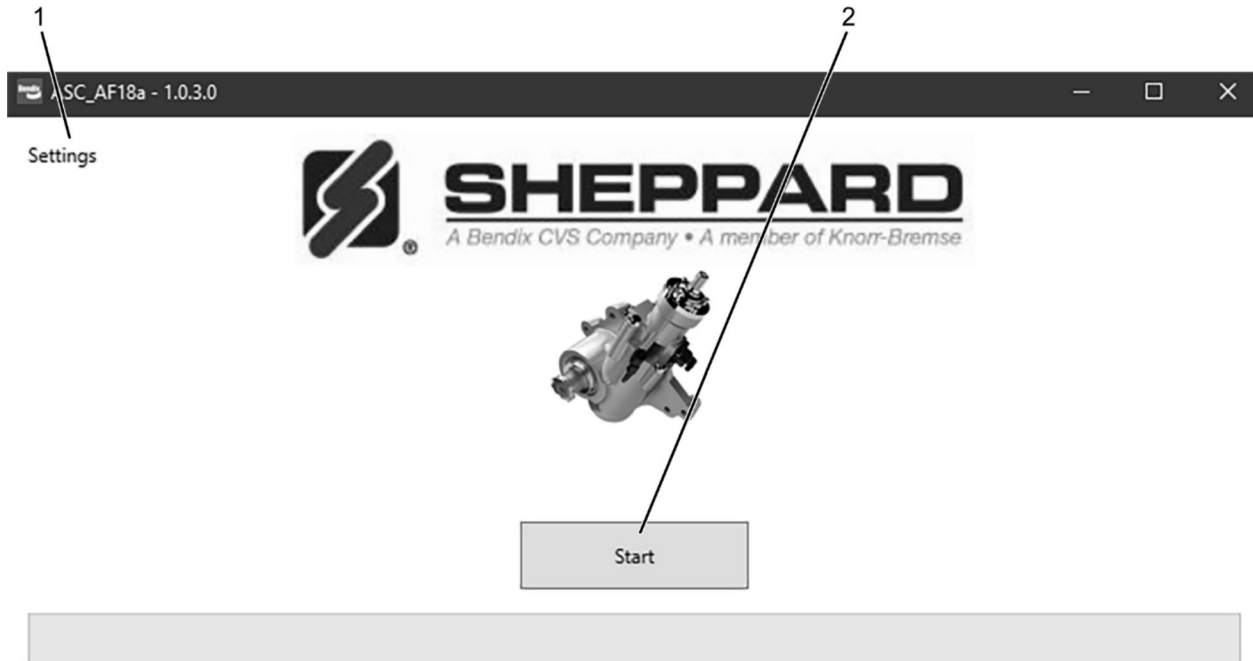
Figure 1. Bendix® Utility Software ACS_AF18a

1. Settings button
2. Start button

1. USB-Link settings
 2. Save button
9. Click the **Settings** button (Figure 1, Item 1) and then select the correct USB-link used to connect to the vehicle (Figure 2, Item 1).
 10. Click the **Save** button to save the correct setting (Figure 2, Item 2).

11. Click the **Start** button (Figure 1, Item 2).
12. Once the update status is complete (Figure 3, Item 1), the utility software displays a green bar at the bottom of the window.
13. Close utility software.
14. Launch Diamond Logic® Builder (DLB) software.

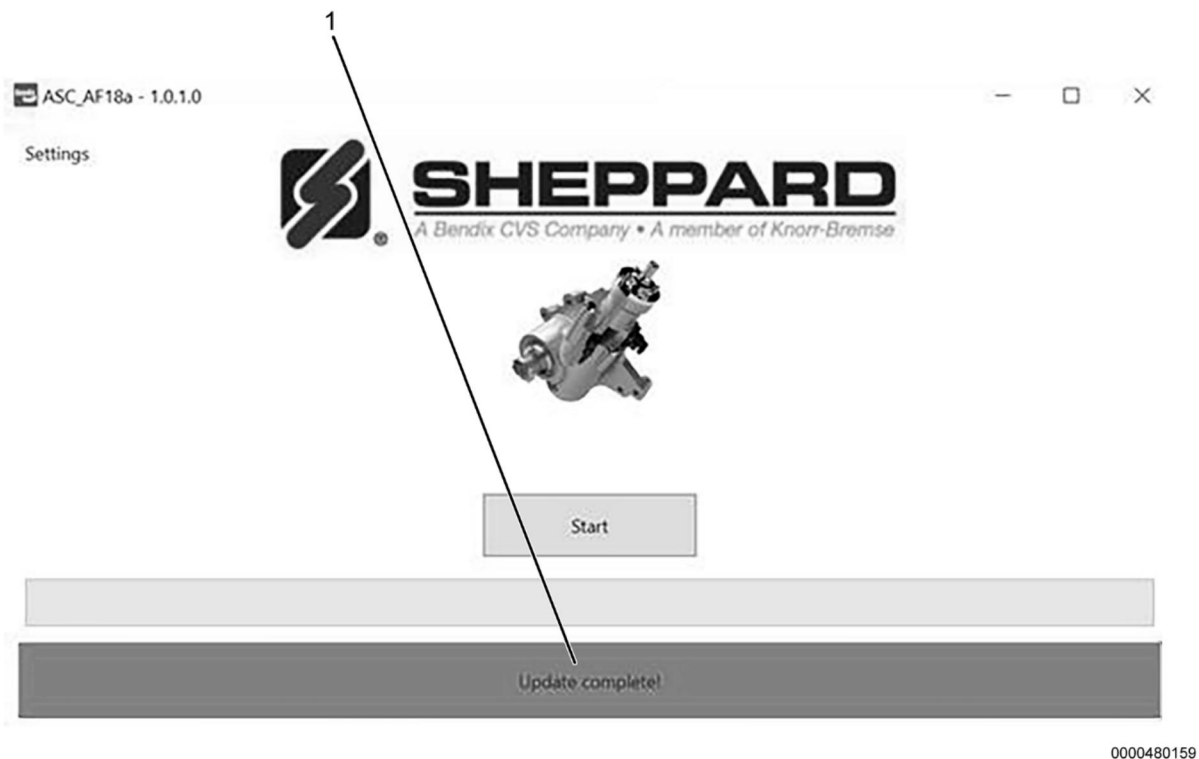
Figure 3. Bendix® Utility Software ASC_AF18a Completion

1. Update complete
