Countries:	CANADA, MEXICO, UNITED STATES	Document ID:	IK0800664
Availability:	ISIS, FleetSIS, NotSIR	Revision:	0
Major System:	Electrical	Created:	12/11/2023
Current Language:	English	Last Modified:	12/21/2023
Other Languages:	NONE	Author:	Anthony Tondola
Viewed:	105

Title: LT/RH Aftertreatment PDM F2 Fuse Falling Out or Cracking**Applies To:** LT/RH

DESCRIPTION

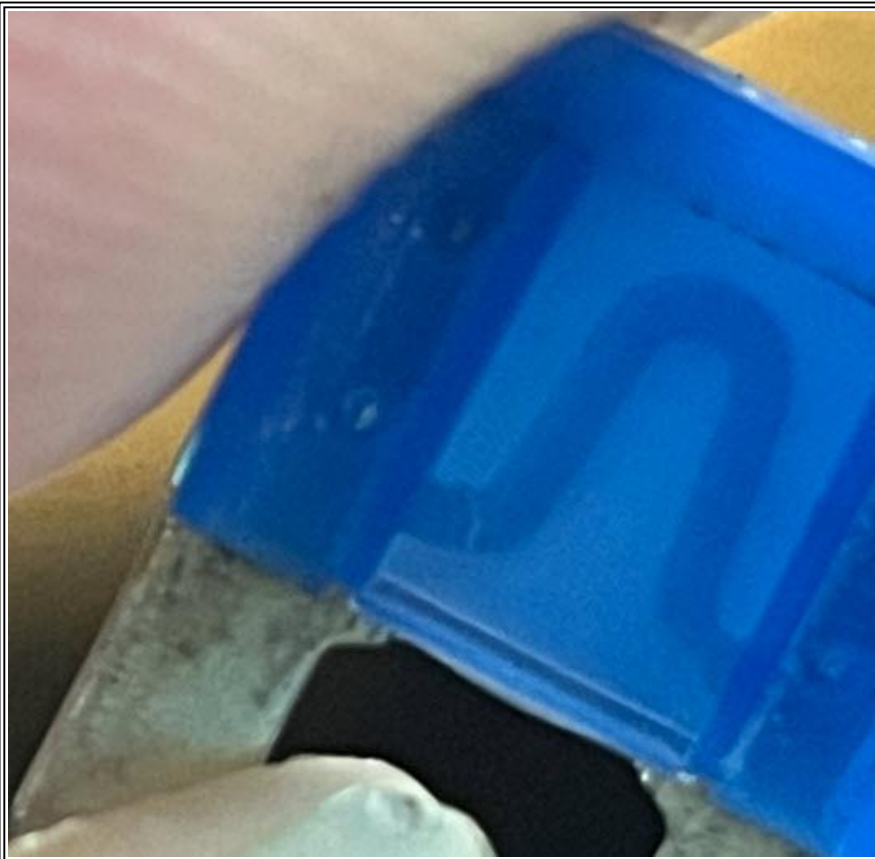
- The aftertreatment PDM F2 fuse can crack internally due to fatigue (Figure 1)
- Fatigue can be caused by excess aftertreatment PDM harness movement directly behind the PDM.
 - This excess movement is caused by the PDM harness being secured incorrectly, which does not allow for harness movement with cab suspension travel.
 - Cab movement causes the harness to twist the PDM terminals, which eventually leads to the fuse cracking internally.

Figure 1: Fuse Cracked without the Typical Signs of a Circuit Fault

1. Cut any tie straps that secure the aftertreatment PDM harness within 10 inches of the back of the PDM. (Figure 2)
2. Install a new tie strap around the main trunk of the harness, while ensuring there is 8-10 inches of unsecured harness from the back of the PDM. (Figure 3)
 - The section of unsecured harness allows for cab suspension travel, without stressing the the AFT PDM fuses and terminals

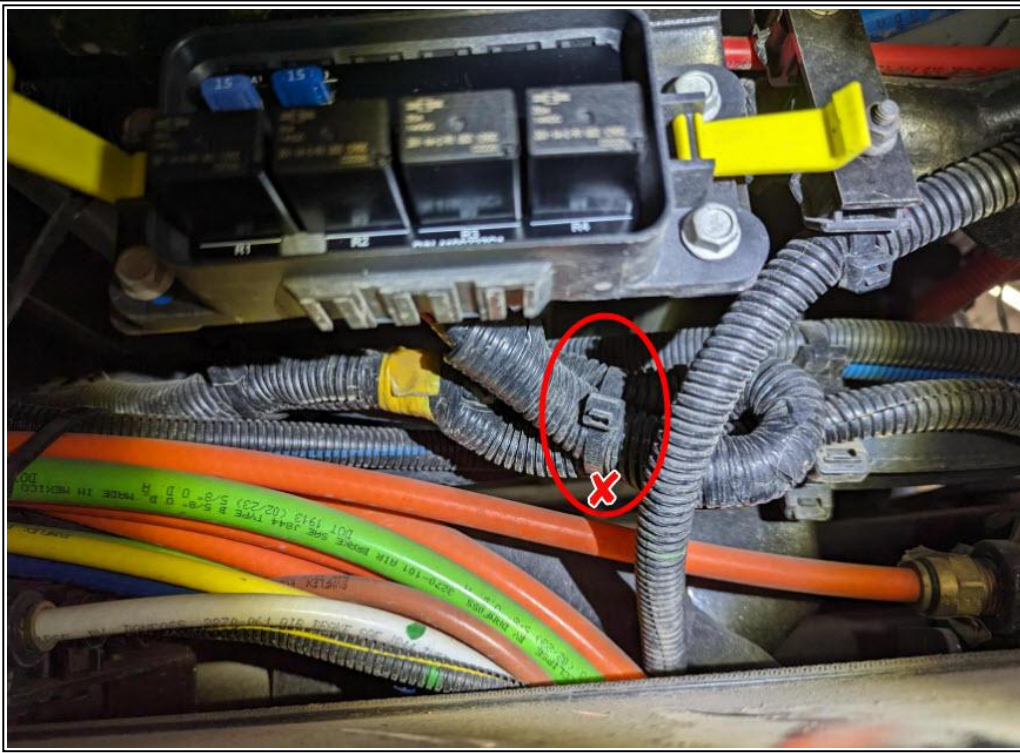
Figure 2: Improper securement of aftertreatment PDM harness

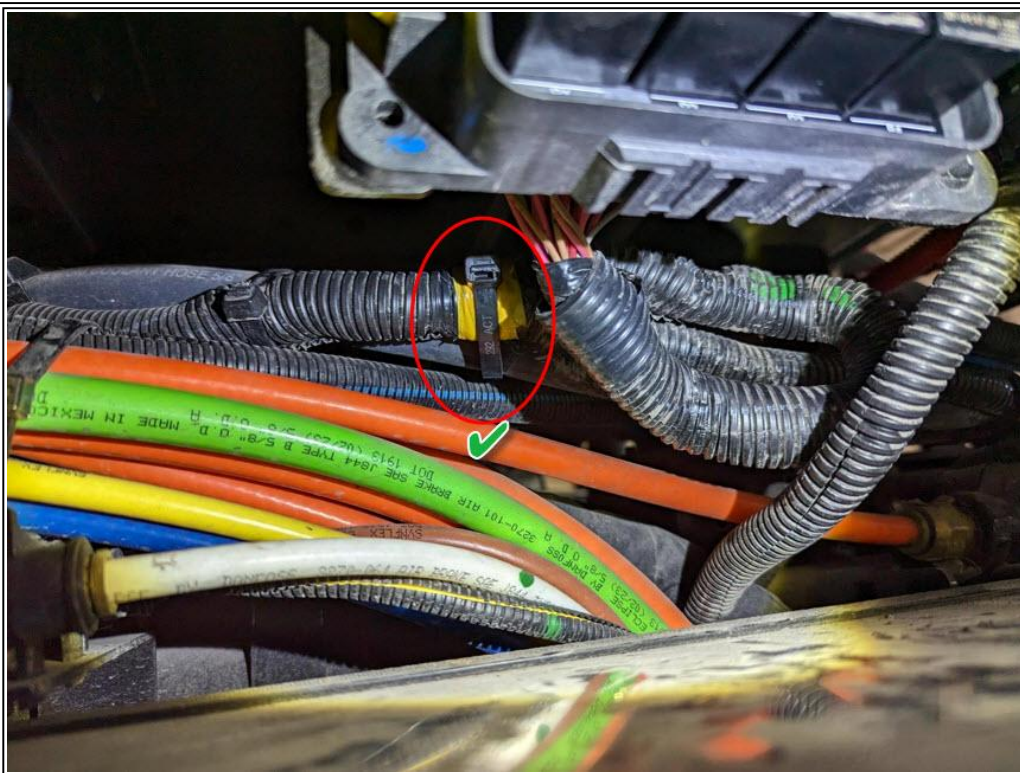
Figure 3: New Harness Securement Location

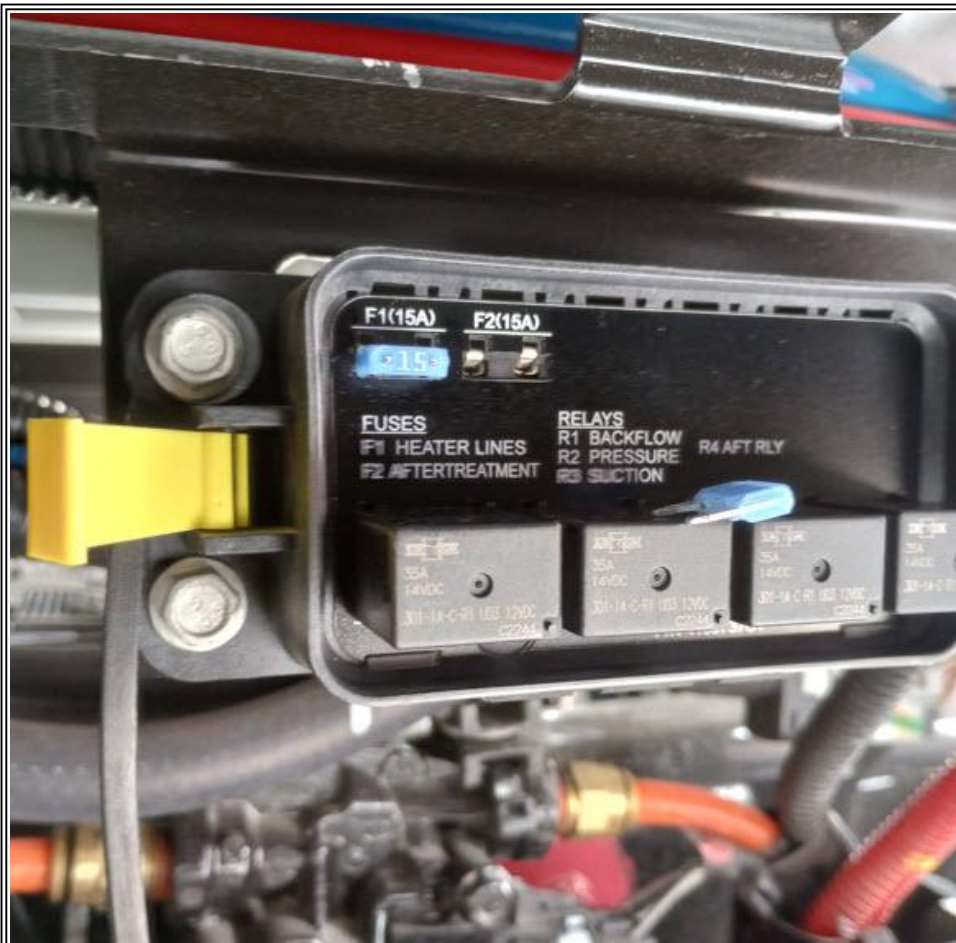
- The fuse falling out is most commonly caused by excess vibrations. (Figure 4)

Figure 4: F2 Aftertreatment Fuse Loose in PDM Cover

- 1.) Verify proper harness routing per repair steps for "Fuse Cracking without a circuit fault."
- 2.) Check for any engine performance issues that would cause excess 3rd order engine vibrations
 - 3rd order engine vibrations cause a "tuning fork" effect through the PDM support bracket, which can shake the fuses out of their terminals
- 3.) Make a foam block that fits inside the PDM cover that will prevent the fuse from falling out. (Figure 5)
 - This foam block needs to apply slight downward pressure on the fuses only, avoiding the relays.

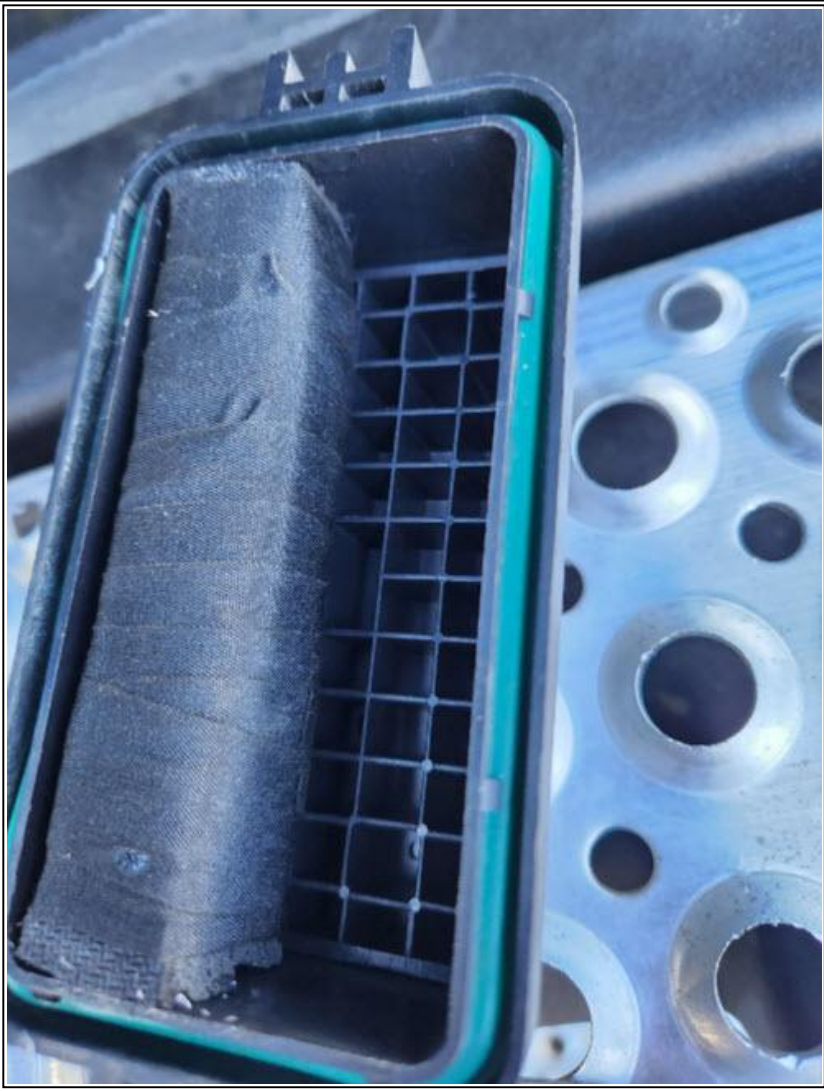
Figure 5: Foam Block Installed in PDM Cover
