Technical Service Bulletin

Subject: CREAK OR SQUEAK NOISE FROM FRONT OF VEHICLE WHEN TRAVELING OVER A BUMP WHILE TURNING AT LOW-SPEED	Bulletin No.: 02-002/23
	Last Issued : 12/07/2023

2024 CX-90

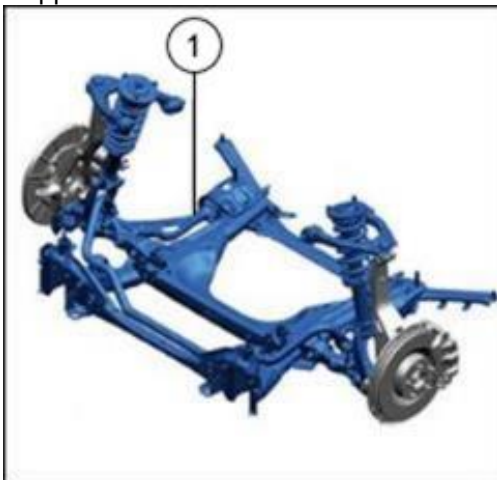
Some vehicles may exhibit a creaking or squeaking noise from the front of the vehicle when traveling over a bump while turning at low-speed. This is caused by a stick-slip phenomenon occurring between the rubber bushing and the stopper on the rear of the front lower arm (1). A mass production change is under study.

Customers having this concern should have their vehicle repaired using the following repair procedure.

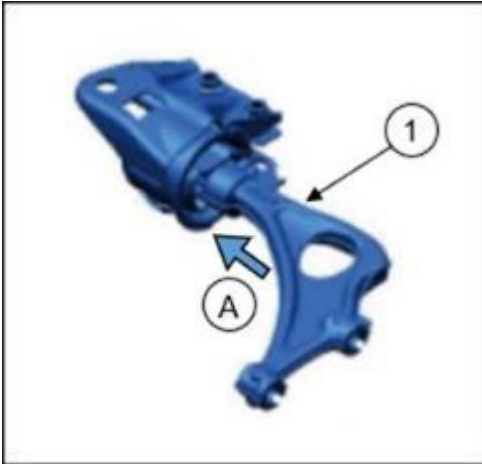
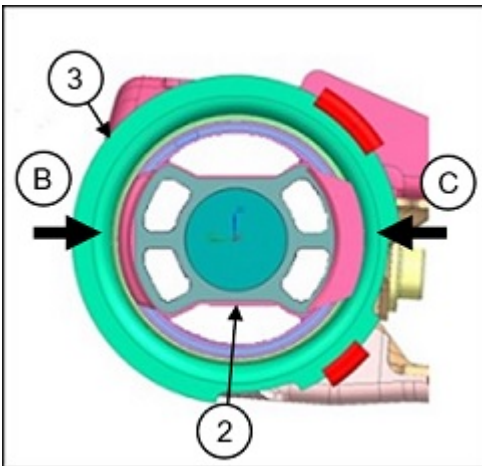
View of A

(2) Rubber Bushing
(3) Stopper

4. Apply the grease aiming at the yellow highlighted area (4) in View of B and C of the contact surface between the rubber bush (3) and the stopper (4) on both left/right sides of the front lower arm (rear) (1), **completely filling each of the 4 cavities with approximately 0.75 oz of grease.**
