TECHNICAL SERVICE BULLETIN

Squeak Or Rattle Noise From The Center Display Screen

23-2395

Lincoln 2023 Corsair

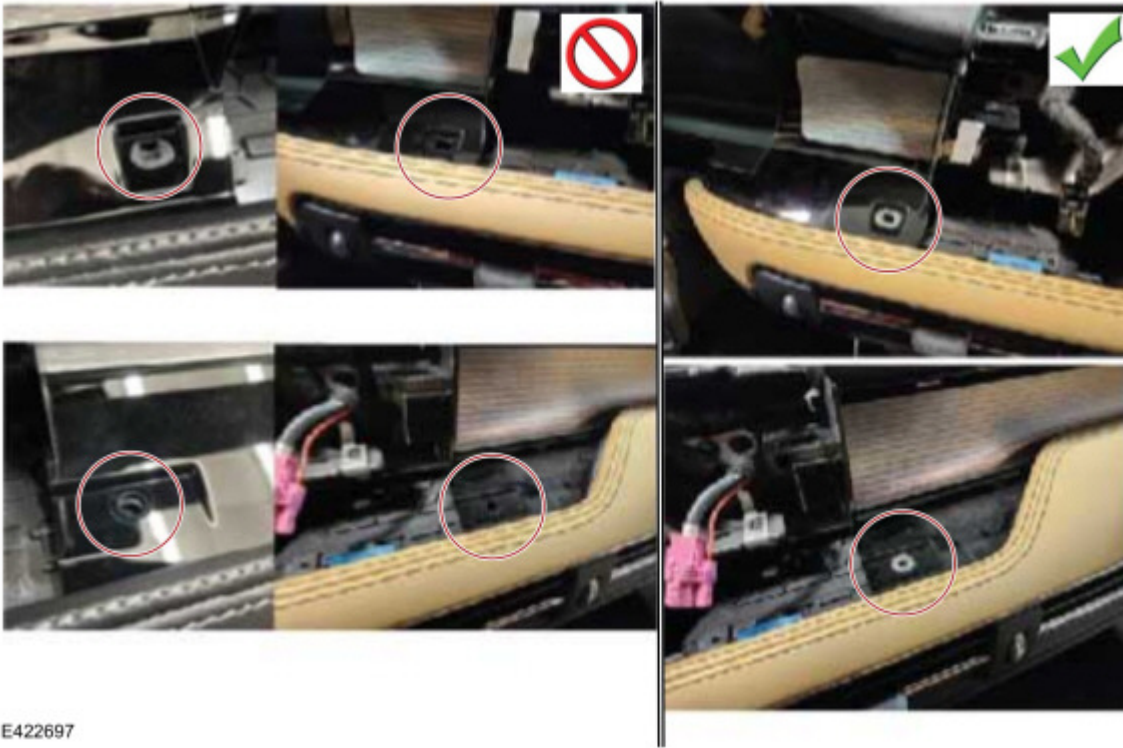
Figure 1

2. Inspect the grommets in the instrument panel that the center display screen dowels insert into. Are one or both of the grommets in the instrument panel damaged or missing? (Figure 1).

- (1). Yes - if one grommet is damaged or missing, remove both or the remaining grommet. Proceed to Step 3.
- (2). No - proceed to Step 4.
