TECHNICAL SERVICE BULLETIN

MT88 Manual Transmission - No 3rd Gear And/Or Grinding Noise Going Into 3rd And/Or 4th Gear

23-2409

Ford 2021-2023 Bronco	Transmission: MT88 Manual Transmission
--------------------------	--

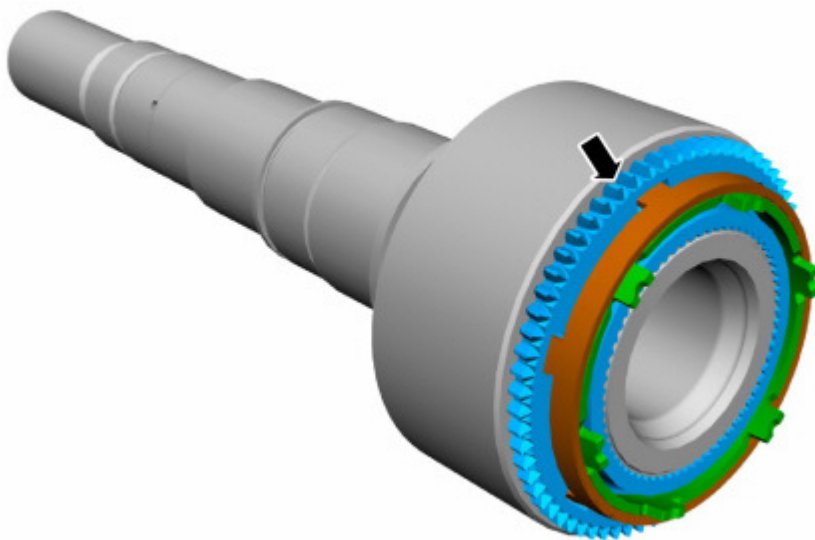
Figure 1

Issue: Some 2021-2023 Bronco vehicles may exhibit no 3rd gear engagement and/or a grinding noise going into 3rd and/or 4th gear. This may be due to the transmission shifting system and clutch interaction such as a lack of full clutch disengagement during shifts and/or placing weight upon the gear shift lever while driving. To correct the condition, follow the Service Procedure to replace the 3rd and/or 4th gears and/or synchronizers as needed.

1. Remove the transmission from the vehicle. Refer to Workshop Manual (WSM), Section 308-03.
2. Disassemble the transmission. Refer to WSM, Section 308-03 > Disassembly > Transmission, Steps 1-34.
3. Remove the output shaft from the transmission case to gain access to the 3rd and 4th gears and synchronizer assemblies. Refer to WSM, Section 308-03 > Disassembly and Assembly of Subassemblies > Input Shaft, Steps 1-5.
4. Replace the following components and any associated damaged parts. Refer to WSM, Section 308-03.
 - 3rd gear.
 - Synchronizer assemblies for 3rd and 4th gears.
 - 4th gear synchronizer ring. (Figure 1)

- Inspect and replace any other damaged parts as needed.

NOTE: 3rd gear is part of the input shaft. The 4th gear assembly is part of the output shaft assembly and does not require replacement, unless damage is found. In this transmission 4th gear uses a synchronizer ring to align the synchronizer assembly with the gear during shifts.
