# McLaren Artura Engine Oil Leak Diagnosis Guide - Front of Engine

**Location:** Powertrain

**Topic:** McLaren Artura Engine Oil Leak Diagnosis Guide - Front of Engine

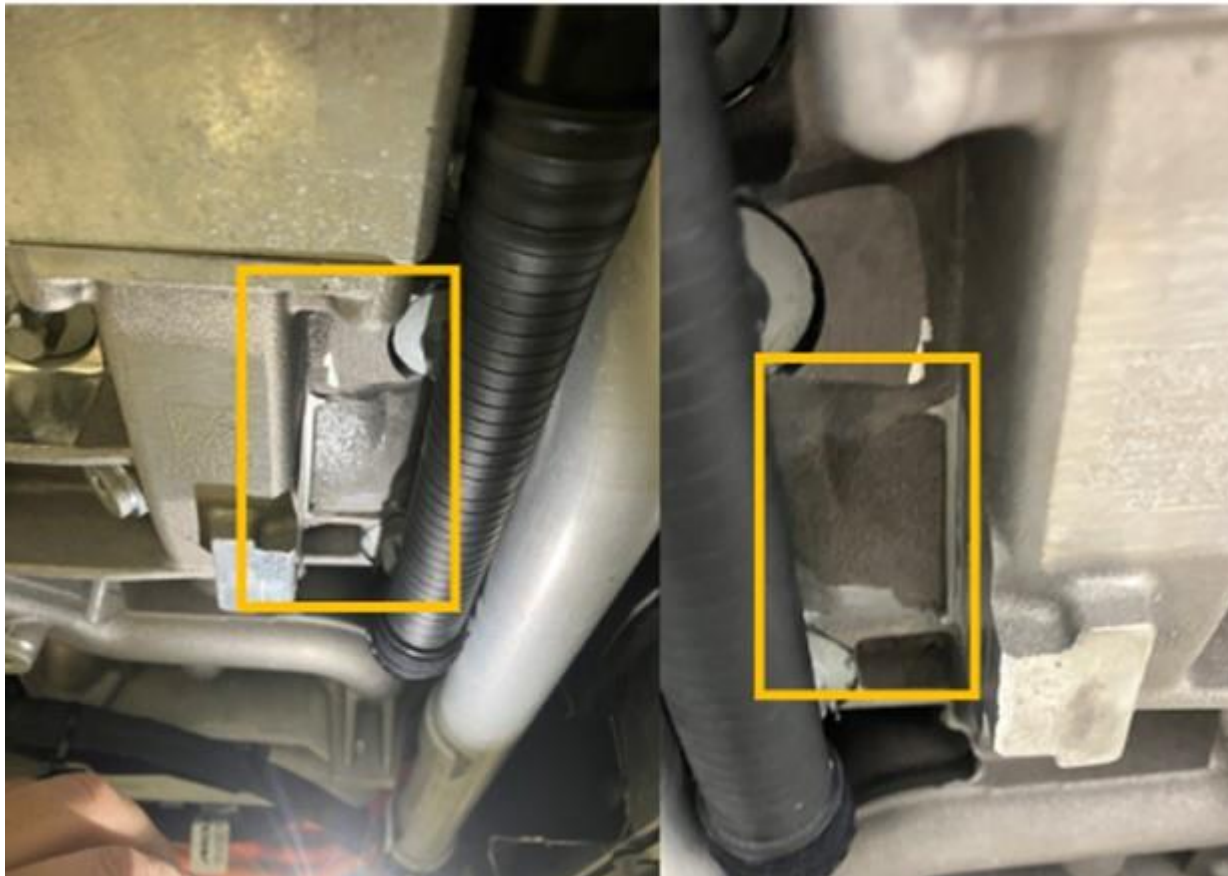
### Case A

Oil stain or evidence of oil present that appears shiny and reflects under torchlight similar to the example above.

**Case A** follow the procedure below:

1. Raise vehicle on ramp as per SIS instructions
2. Remove engine underfloor
3. Capture images prior to any cleaning, clearly showing the leaking area. Label images: "Pre-Cleaning"
4. Take picture of engine number and label image "Engine Number"
5. Clean area thoroughly using degreaser/solvent

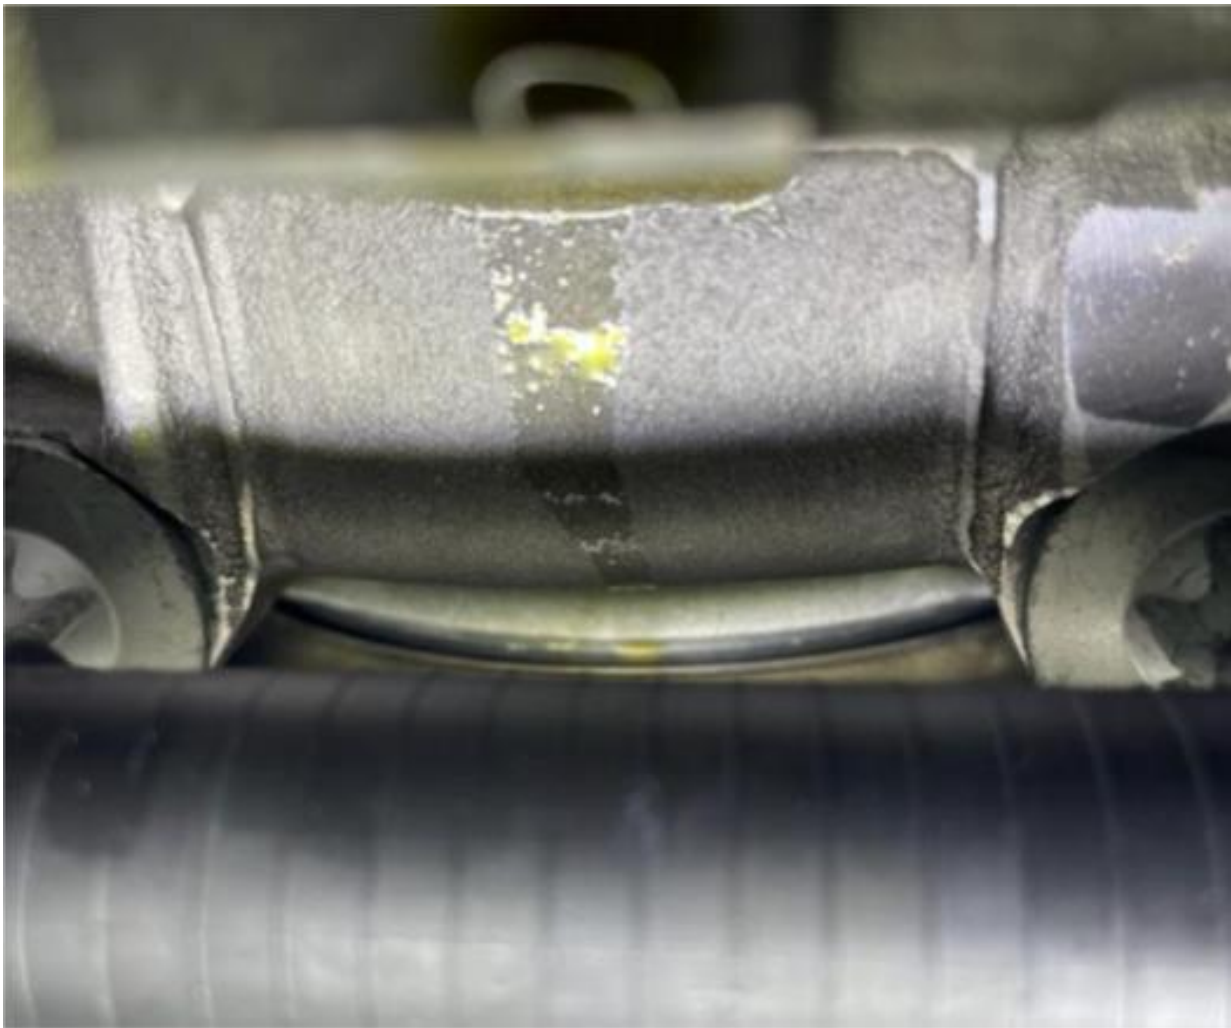
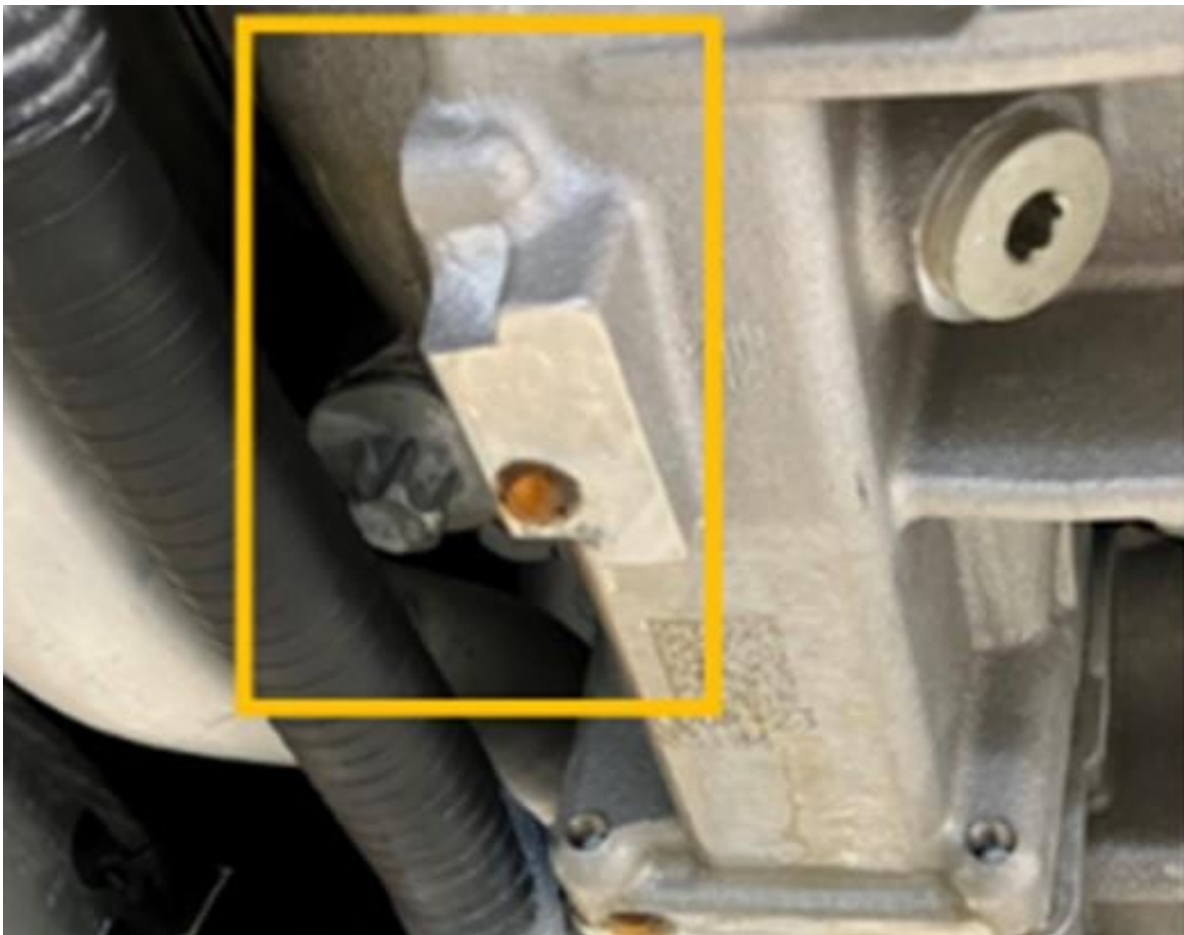
Oil forming drips with more than one drip detached similar to the examples above.

**Case B** follow the procedure below:

1. Raise vehicle on ramp as per SIS instructions
2. Remove engine underfloor
3. Capture images prior to any cleaning, clearly showing the leaking area. Label images: "Pre-Cleaning"
4. Take picture of engine number and label image "Engine Number"
5. Clean area thoroughly using degreaser/solvent
6. Add engine oil dye to the engine - Please refer to latest update of KA-01458 ([https://retailerportal.mclaren.com/en-US/kbar\\_clellist/article/KA-01458](https://retailerportal.mclaren.com/en-US/kbar_clellist/article/KA-01458)) for correct dye and torch to use

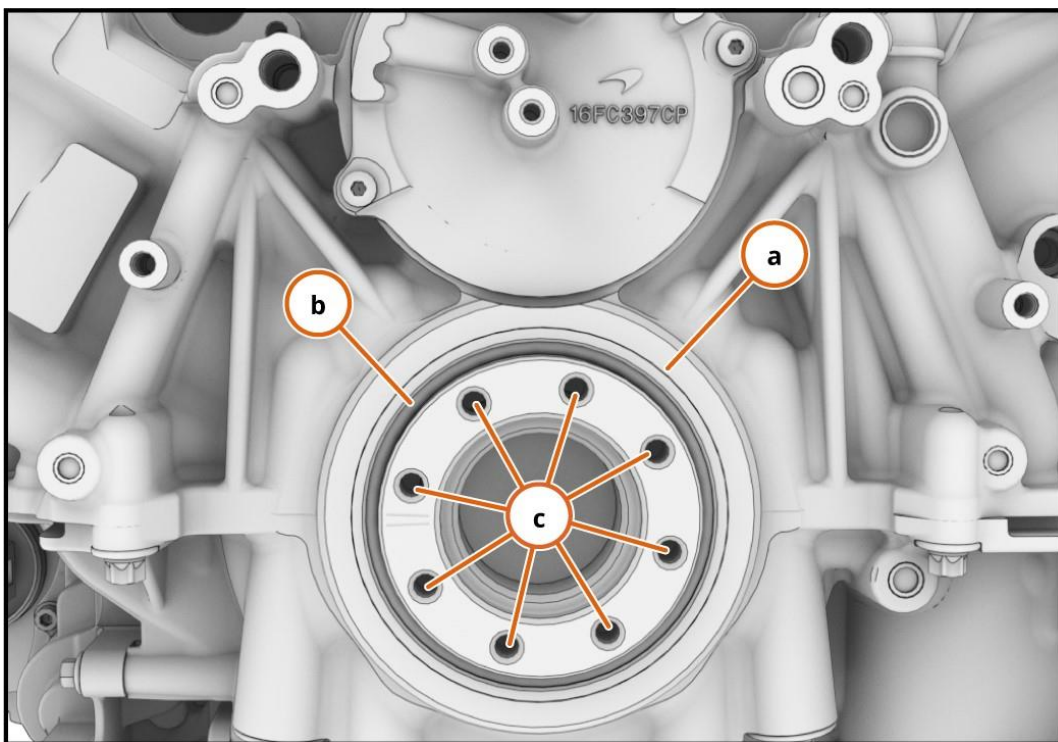
15. Identify leaking area of the front of the engine

- TVD threaded bolt holes (crankshaft flange) and TVD Bolts
- Front crank seal OD
- Front crank seal ID

**Repair: If the engine is only leaking from the TVD bolts skip steps 17 to 19 (front crank seal removal)**

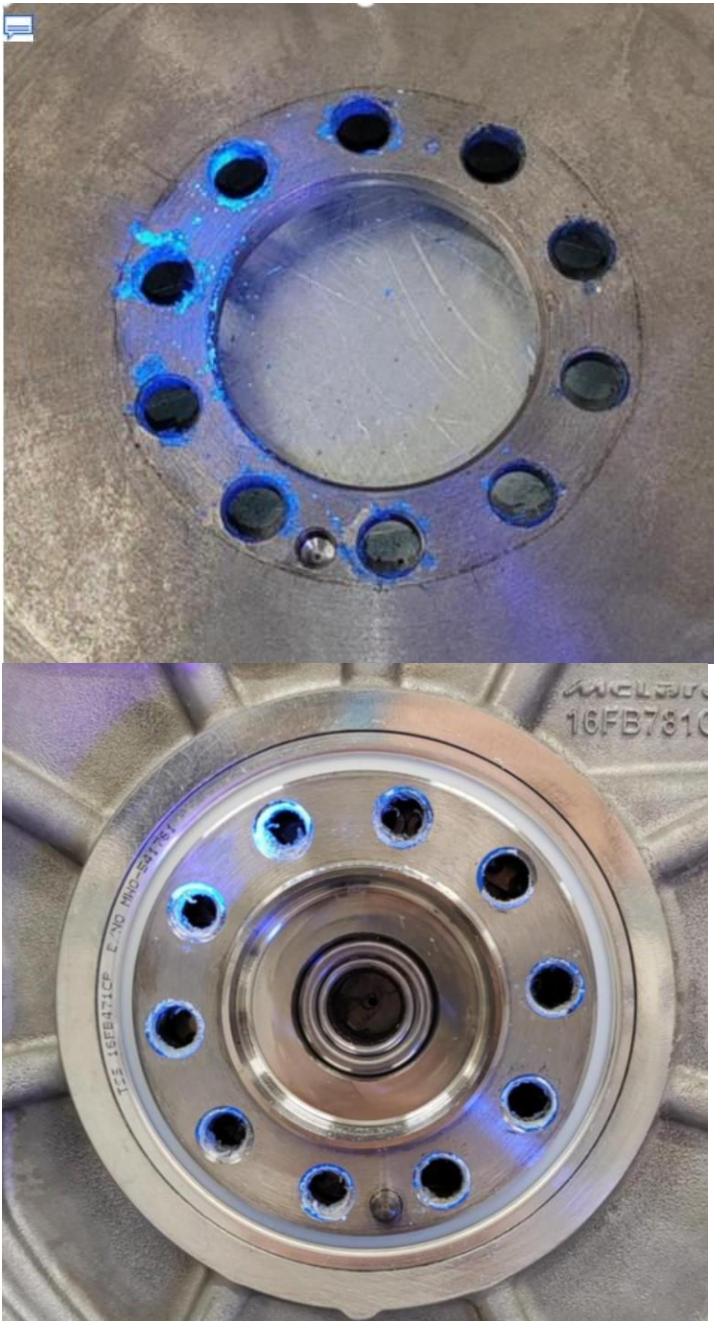
**Care Point: to avoid engine contamination, prior to attempting front crank seal removal clean the first 2-3 bolt hole threads (crankshaft flange) from residual threadlocker (from the original bolt fitment) and outer surface of crankshaft flange (threadlocker and oil) without pushing any debris into the engine (through holes), clean with standard automotive degreaser/solvent ensuring a thorough clean of the leak area. Do not leave the area like this:**
