Technical Service Bulletin

Mazda North American Operations Irvine, CA 92618-2922

Subject:		
WIRELESS CHARGER (Qi) CONCERNS	Bulletin No.: 09-023/23	
	Last Issued : 12/18/2023

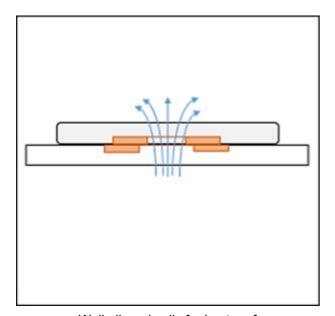
Well aligned coils for best performance

The center of both coils should be well aligned for the best performance. Poor alignment between both coils results in poor charging performance. Therefore, place the mobile device so that the center of the coil of the charger and the mobile device are aligned.

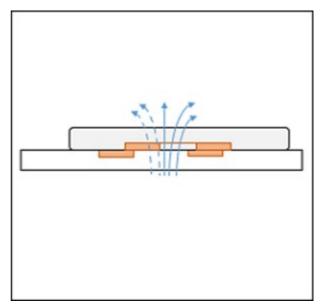
Poor alignment causes reduced power reception

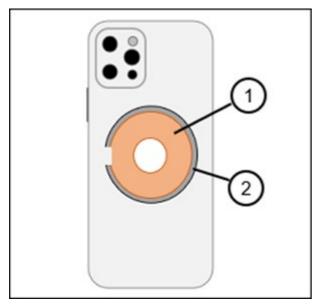
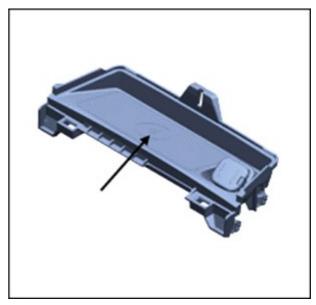
The coil (1) and magnets (2) are located at the center of iPh The coil is located at the center of the Qi symbol of the char one

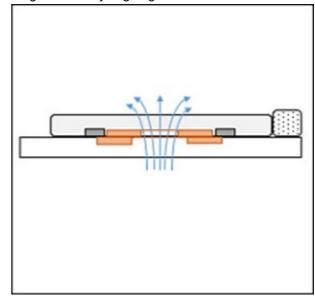
Interference by the coil and magnets spoil the charging perf Assist alignment with a rubber block for better power transf ormance er

Even for the MagSafe compatible mobile device, place it on the charger manually aligning the center of the coils.
