STAR ONLINE PUBLICATION

Case Number: S1923000044 Rev.F

Symptom/Vehicle Issue: Dust Intrusion Or Air Leak Into Cab

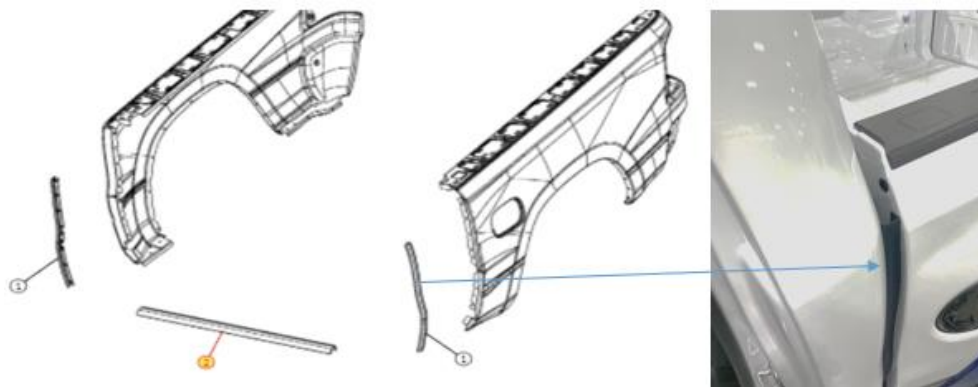
Fig 1
Cab to bed seal item #2

Discussion: Owner may complain of fine dust entering the cab even with windows rolled up. Verify the cab body exhausters are functioning and do not have deformed rubber flaps. Verify the rear cab to bed horizontal seal is in place (Fig 1). If missing the air flow under the truck may promote dust intrusion and cab wind noise. A possible air leak in the driver or passenger C Pillar and along the rear cab floor (Fig 2 and 3) may cause dust intrusion.

Note- Passenger side shown. Drivers side similar and should also be inspected.

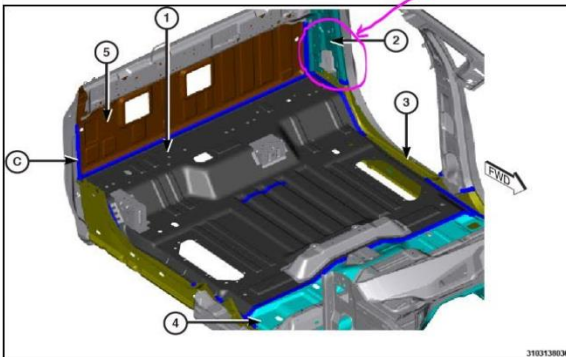
Fig 2

MISSING FOAM SEALER

FOAM SEALER PRESENT

The area shown in fig 2 is a pocket in the C Pillar. There is a foam blocker installed in the pocket. The blocker edges are meant to seal against the pillar. If there is a poor seal an air leak will result that could pull dust in to the interior if the vehicle is driven in dusty road conditions. If the blocker or cab sealer has gaps— careful application of (non-flammable) butyl rope (preferred) such as (Mopar: 04076274AB) rtv or seam sealer can be used.

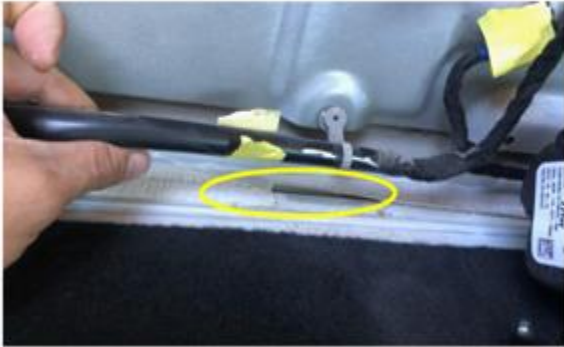
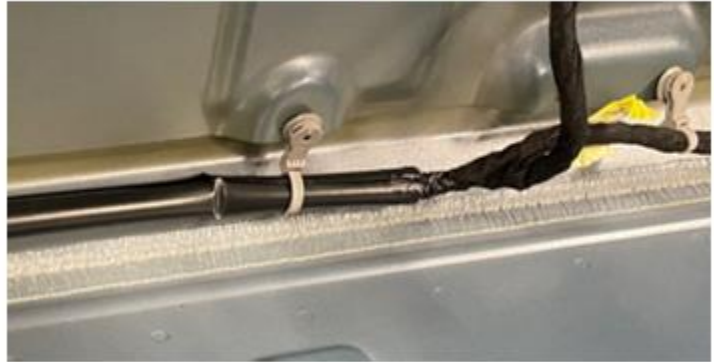
MISSING FOAM SEALER

FOAM SEALER PRESENT

Rear cab floor to bulkhead sealer. Sealer gap shown circled.

The area shown in Fig 3 is a seam at the rear cab wall. If there is a poor seal an air leak will result that could pull dust in to the interior if the vehicle is driven in dusty road conditions. If the sealer line has gaps– careful application of (non-flammable) rtv or seam sealer can be used.

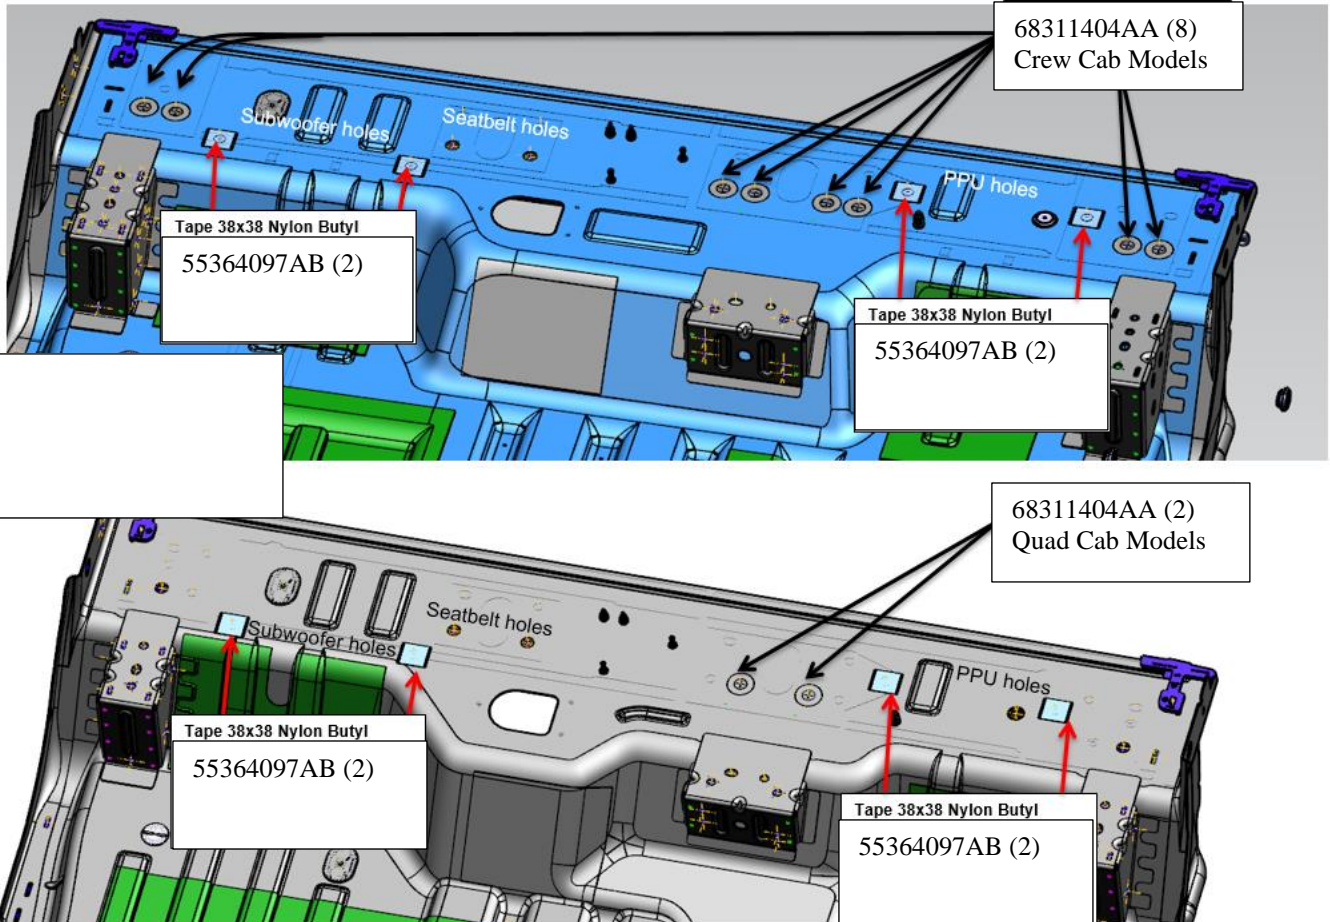
Fig 4.
Presence of tape over holes.

The areas shown in Fig 4,5,6,7 have areas where the blackout sticker may be missing. The number holes are dependent on the seat configuration. After the rear seat is removed, cover any of the open holes with the punch thru tape or nylon butyl noted above in Figure 4. If unsealed, an air leak will result that could pull dust in to the interior if the vehicle is driven in dusty road conditions.

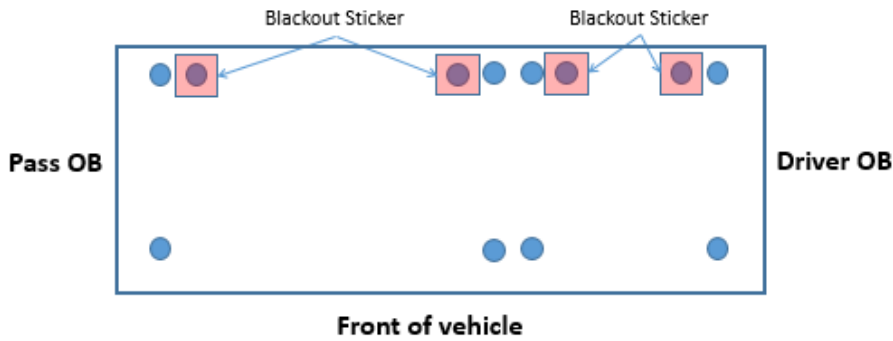
Fig 5

Crew 60/40 Standard

Blackout sticker 4 locations

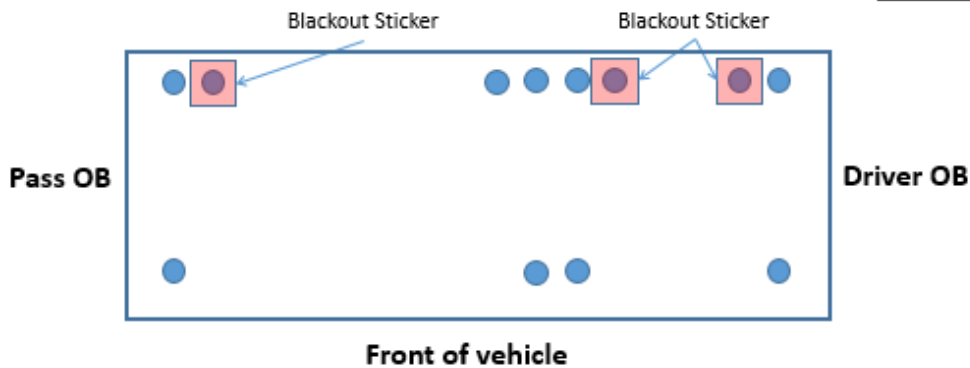
Fig 6

Crew Bench

Blackout sticker 4 locations

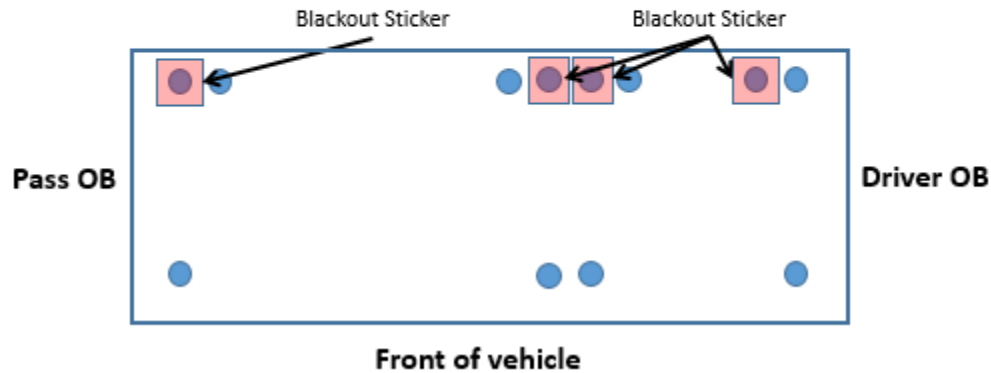
Fig 7

Crew 60/40 Recliner

Blackout sticker 4 locations

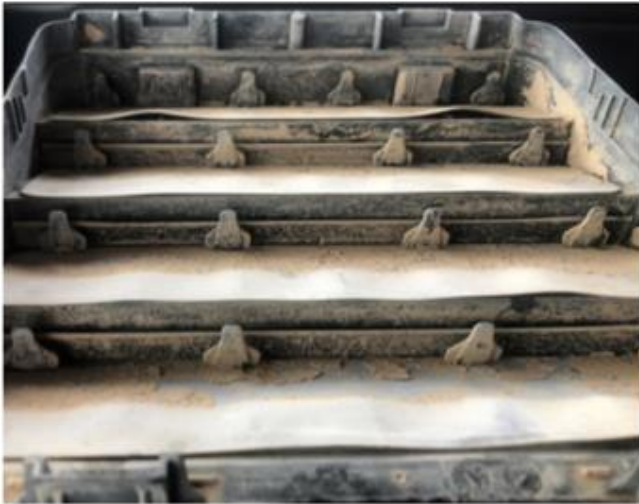
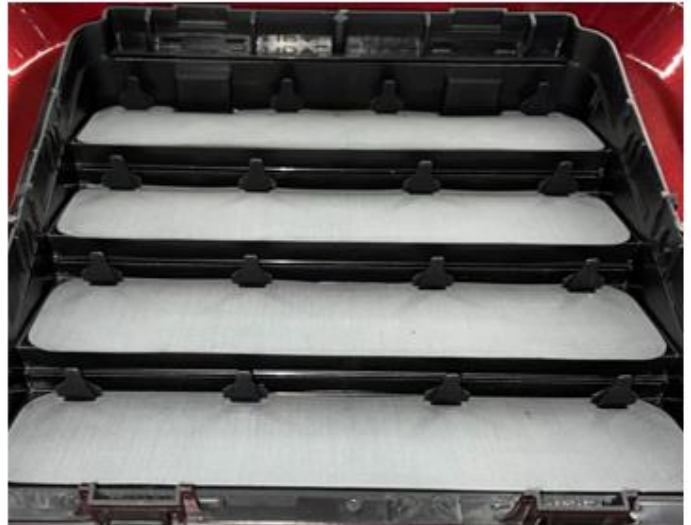
BAD WAVY EXHAUSTER LIPS

GOOD – STRAIGHT LIPS

Rear Exhauster flaps should be straight, not wavy

The areas shown in Fig 8 have areas where Rear Exhauster lips may be wavy and causing a poor seal (lets dust and air INTO vehicle). The lips should be straight as shown in the picture on the right.
