STAR ONLINE PUBLICATION

Case Number: S2323000072

Release Date: September 2023

Symptom/Vehicle Issue: Soft Top Windows Do Not Sit Flush To The Top.

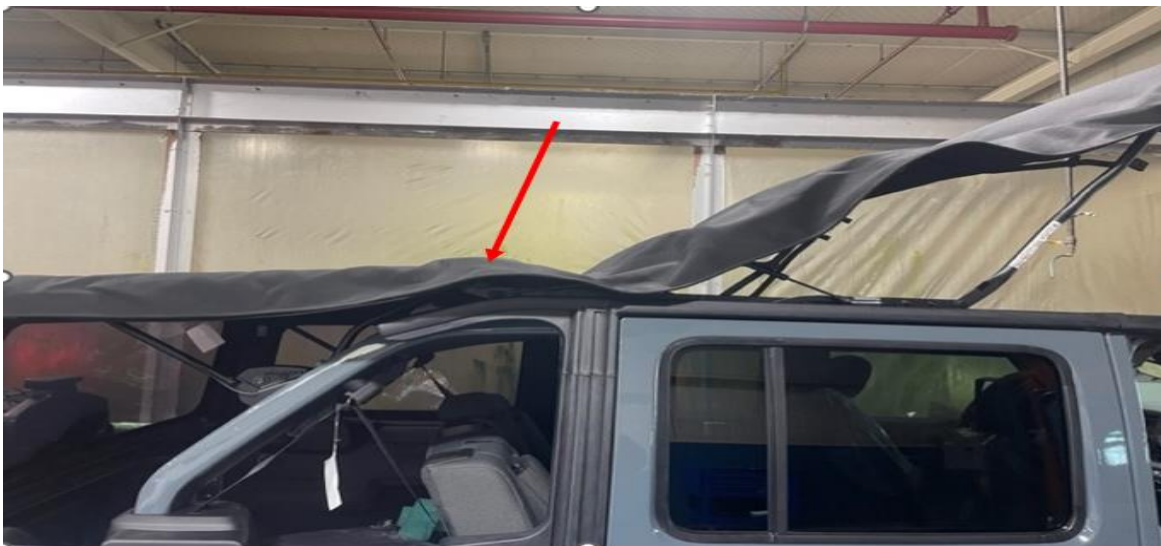
Fig 1.

Discussion: Verify proper fitment of the top fabric to the rear bow. This will require relaxing the top roof fabric by raising the sun rider front portion of the top (Fig 1).

Top Fabric Relaxed Allowing Access To The Bow (arrow).

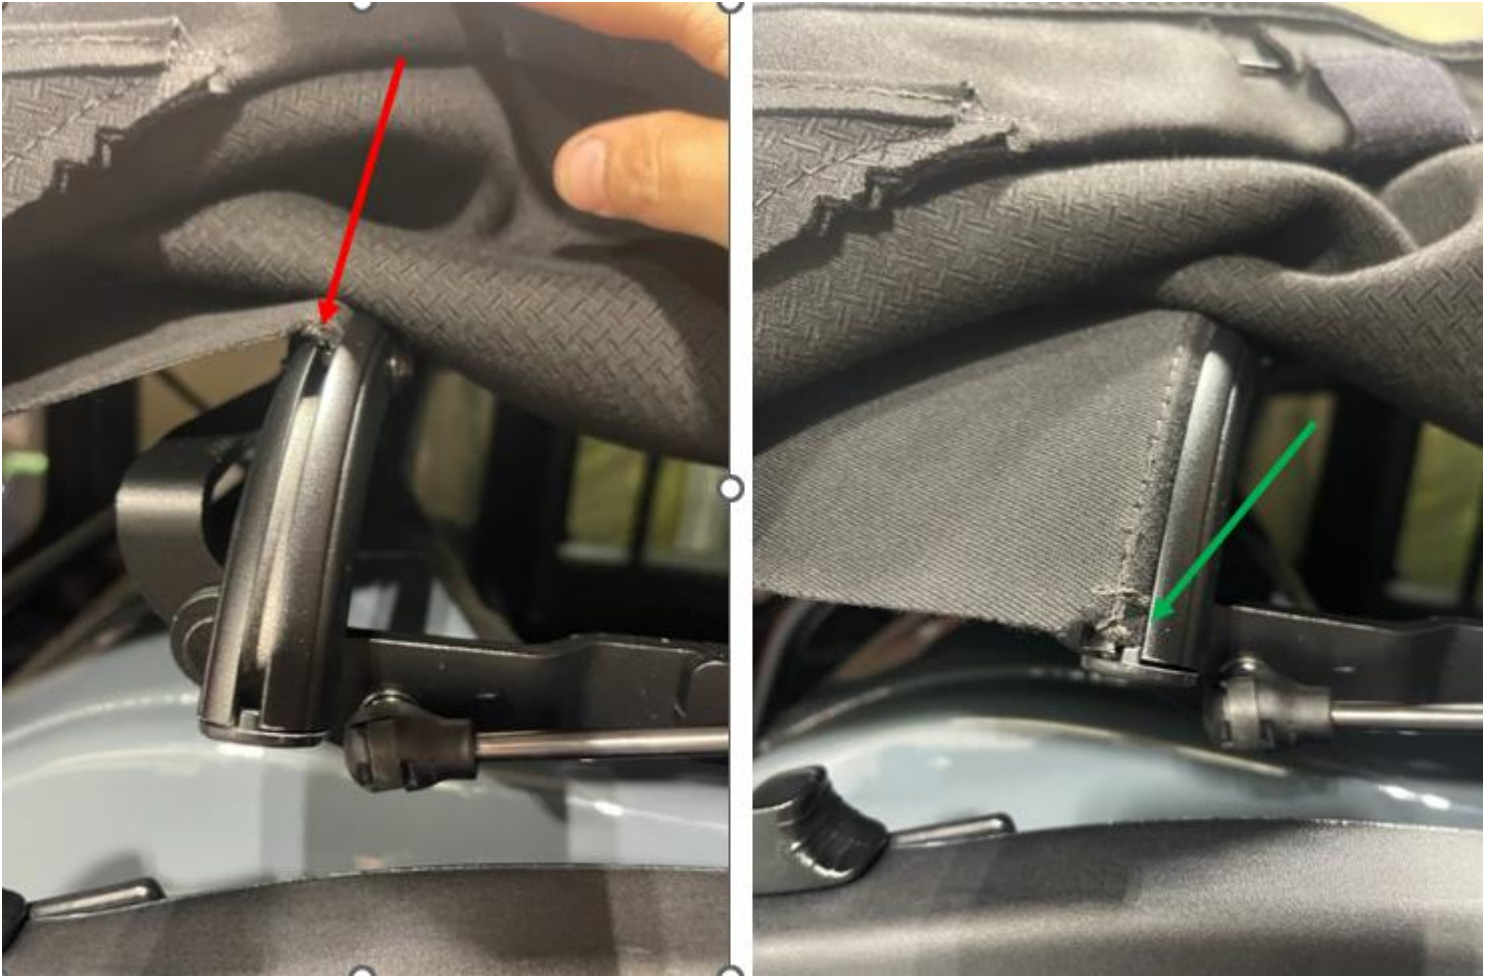
Fig 2

Refer to Fig 2: Left image shows the top fabric spline not in correct position. Right image shows the spline pulled down on the bow in proper location.

Top Fabric Spline Location. Right image shows spline pulled down into correct installed position.

Once the spline fit is corrected, close the sunrider top and install the quarter window to ensure fitment is proper.
