## STAR ONLINE PUBLICATION

**Case Number: S2308000036 Rev. E**

**Symptom/Vehicle Issue:** Cluster Displays an Electric Power Steering (EPS) Fault Warning Lamp or Service Power Steering Message

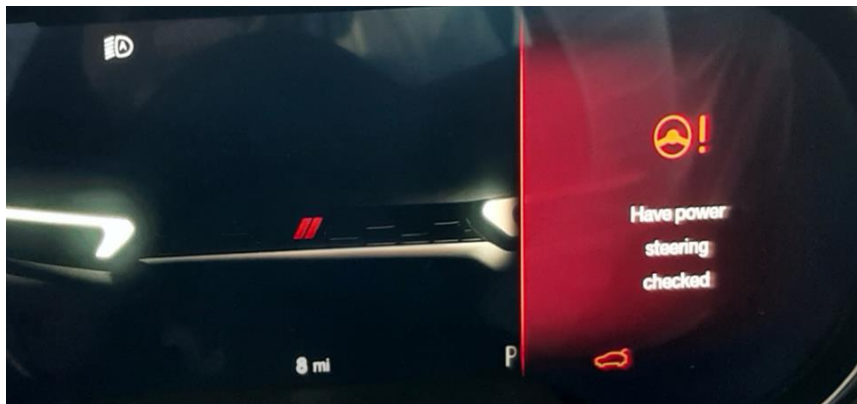
**Technician Observation:** After an EPS replacement and or EPS control module service the EPS cluster warning lamp remains on. The cluster may display “**Have Power Steering Checked**” message with a steering wheel icon displayed on the instrument cluster.

**Discussion:** Perform the **Lock-to-Lock** steering angle calibration. This procedure is for steering rack center position learning.

**Perform Calibration:** – Start the vehicle and adjust the tires so they are in the straightforward position. Calibration is performed by turning the steering wheel lock to lock with a slight applied steering torque while in the full steering wheel locked positions and holding the full locked position for a minimum of 5 seconds.

Start the vehicle, with the steering wheel centered tires in the straight-ahead position, turn the steering wheel to a full lock position to the right or left. Hold the steering wheel for a minimum of 5 seconds with slight torque applied (min torque 6Nm) while at the stop position. Then rotate the steering wheel to the full lock position in the opposite direction, again holding the steering wheel against the stop for a minimum of 5 seconds (min torque of 6Nm). Return the steering wheel/tires to the centered straight-ahead position, turn the vehicle off and wait for all the lights to turn off, then turn the key back on to complete, see Pg 2 for some of the potential fault codes setting for this concern.
