STAR ONLINE PUBLICATION

Case Number: S2223000058 Rev.A

Symptom/Vehicle Issue: Water Leak At Upper D-pillar Or Liftgate Area

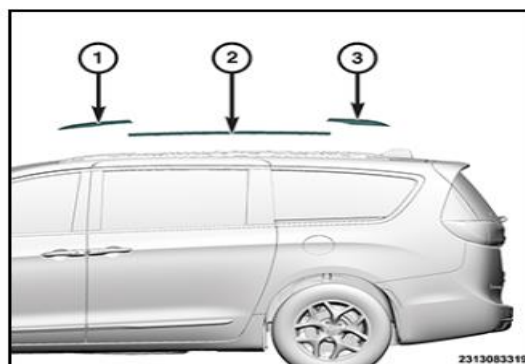
Customer Complaint/Technician Observation: Drips of water from either of the upper D-posts or pillars at the rear of the vehicle. Headliner may have wetness. Water observed at load floor.

Rear luggage rack rail cover item #3

Discussion: Remove roof rack cover at D-post and inspect for pin holes at roof seam (water path). Refer to Service Library 23 - Body / Exterior / RACK, Luggage / Removal and Installation REMOVAL AND INSTALLATION. To release the end cap use a fiber trim stick such as C-4755 or similar. If any pin holes or voids are found in the sealer use clear seam sealer such as Kent Products High-Tech clear seam sealer p10200 or equivalent. Follow the products application and cure directions. Install the rail cap. Verify leak is no longer present by performing a water leak test.
