STAR ONLINE PUBLICATION

Case Number: \$2323000077

Symptom/Vehicle Issue: Rattle Squeak Noise From Sunroof Area

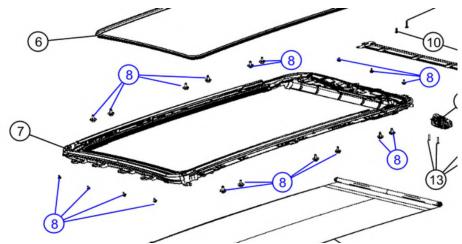
Diagnosis: Noises heard could originate from the sunroof mounting screws. Along with performing a visual inspection of the roof components also inspect the sunroof perimeter fastening screws for torque. Refer to Service Library 23 - Body / Sunroof, Single Pane / Dual Pane for information and torque specifications.

Attachment screw locations for sunroof. Dual pane shown, single pane similar.

Repair Procedure: Remove and inspect the sunroof frame attaching screws for missing Loctite patch. Install new screws if found.

Parts Required: Screw 06513746AA with Loctite patch
