## Technical Service Bulletin (TSB)

### Radio Over The Air Update From S26.17 and T25.48 to T25.51 Software Version

| REFERENCE: | TSB: 08-212-23<br>GROUP 08 -<br>Electrical | Date: | September 1, 2023 | REVISION: | — |

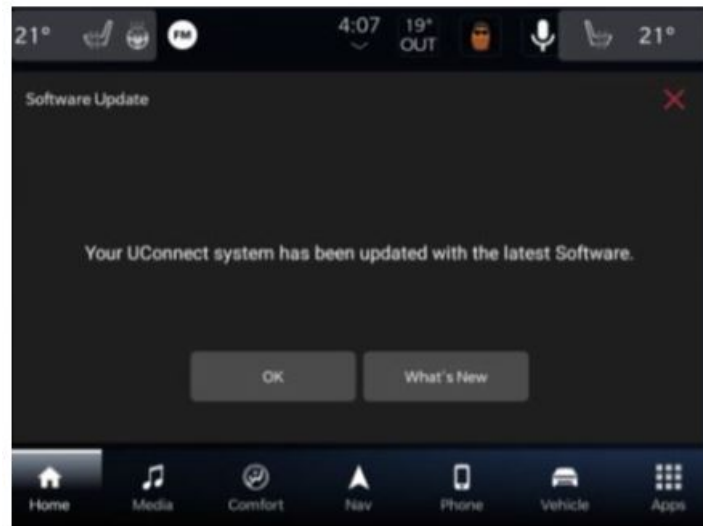
**Fig. 2**  
**Software Update Confirmation Screen**

3. Upon completion of update, the radio will display a confirmation message (Fig. 2) .
