REFERENCE:	TSB: 23-095-23 GROUP: 23 - Body	Date:	September 12, 2023	REVISION:	-
VEHICLES AFFECTED:	2023 (WS) Grand Wagoneer/Wagoneer This bulletin applies to vehicles built on and after January 01, 2023 (MDH 0101XX) and on and before February 10, 2023 (MDH 0210XX) equipped with Head Up Display (Sales Code LBK), Active Driving Assist System (Sales Code SJJ) and/or Full Speed Fwd Collision Warn Plus (Sales Code LSU).			MARKET APPLICABILITY: <input type="checkbox"/> NA <input type="checkbox"/> CH <input type="checkbox"/> EE <input type="checkbox"/> IAP <input type="checkbox"/> SA <input checked="" type="checkbox"/> MEA	
CUSTOMER SYMPTOM:	A snowflake pattern (delamination) appearing on the windshield Fig. 1 .				
CAUSE:	Windshield delamination.

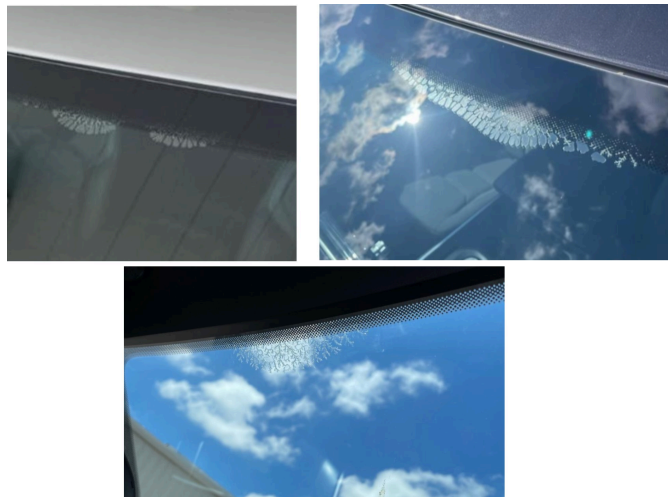
Fig. 1
Examples Of Snowflaking/Delamination

The defect will begin on the outside edge of the glass move inboard over time as the defect spreads.

1. Inspect the windshield glass for any snowflaking/delamination [Fig. 1](#).

2. Was any snowflaking/delamination in the windshield glass [Fig. 1](#)?

1. Replace the windshield. Refer to the detailed service procedures available in DealerCONNECT> Service Library under: Service Info>23 - Body / Stationary Glass / Windshield / Removal and Installation.
