REFERENCE:	TSB: 23-098-23 GROUP: 23 - Body	Date:	September 13, 2023	REVISION:	-
VEHICLES AFFECTED:	2019 - 2021 (DT) RAM 1500 Pickup This bulletin applies to vehicles built on and before September 30, 2020 (MDH 0930XX) equipped with a Rear Power Sliding Window (Sales Code GFE) or Rear Sliding Window (Sales Code GFD).			MARKET APPLICABILITY: <input checked="" type="checkbox"/> NA <input type="checkbox"/> MEA <input type="checkbox"/> SA <input type="checkbox"/> IAP <input type="checkbox"/> EE <input type="checkbox"/> CH	
CUSTOMER SYMPTOM:	The customer may experience one or more of the following: <ul style="list-style-type: none"> A cracked backlite frame Fig. 1 resulting in an interior water leak (crack is visible to the customer). Water leak from at top of the backlite. 				
CAUSE:	Manufacturing issue.

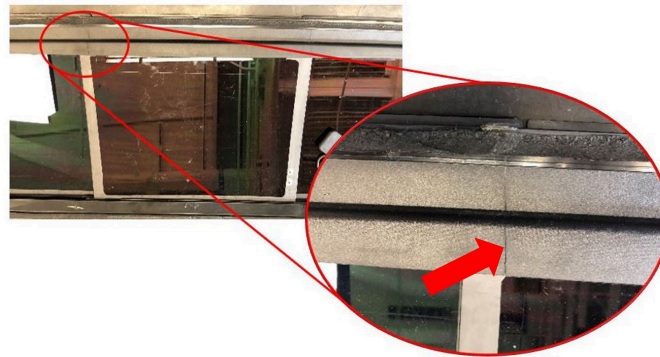
Fig. 1
Cracked Backlite Frame (Left Side Shown, Crack Can Also Be On The Right Side)

NOTE: Before performing this Repair Procedure, quickly visually inspect the backlite frame for a crack [Fig. 1](#) at the top corners of the sliding backlite window.

This bulletin involves replacing the backlite.

1. Replace the backlite. Refer to the detailed service procedures listed in DealerConnect>Service Library under: 23 - Body / Stationary Glass / Backlite / Removal and Installation.
