Technical Service Bulletin (TSB)
Lower Radiator Hose Not Properly Seated

REFERENCE:	TSB: 09-015-23 REV. A GROUP: 09 - Engine	Date:	September 22, 2023	REVISION:	09-015-23
VEHICLES AFFECTED:	2023 (JT) Jeep Gladiator This bulletin applies to the following vehicles built on or after **June 07, 2023 (MDH 0607XX) on or before June 15, 2023 (MDH 0615XX)** equipped with a 3.6L V6 VVT Engine Upgrade 1 (Sales Code ERC).			MARKET APPLICABILITY: <input checked="" type="checkbox"/> NA <input type="checkbox"/> MEA <input type="checkbox"/> SA <input type="checkbox"/> IAP <input type="checkbox"/> EE <input type="checkbox"/> CH	
CUSTOMER SYMPTOM:	Customers may experience the following: <ul style="list-style-type: none"> Coolant leak underneath the vehicle. 				
CAUSE:	Lower radiator hose is not seated properly.

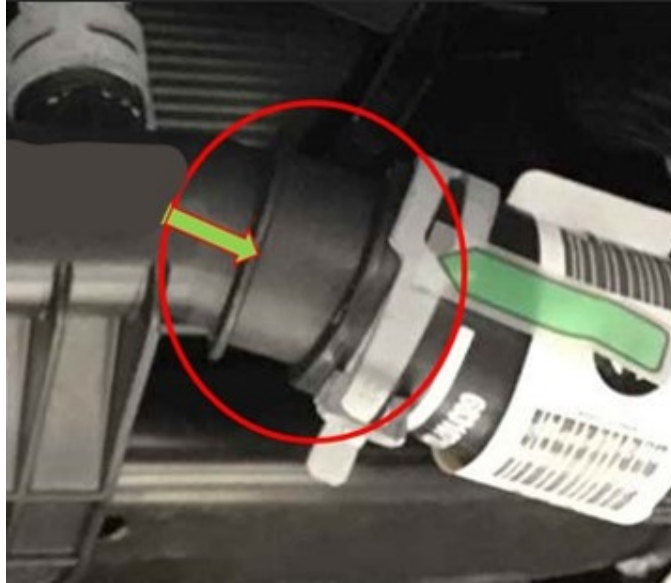
1. Raise and support vehicle. Refer to the detailed service procedures available in DealerCONNECT> Service Library under: Service Info>04 - Vehicle Quick Reference / Hoisting / Standard Procedure.
2. Inspect the lower radiator hose to make sure it's fully seated against the plastic stop [Fig. 1](#). The radiator hose should be fully seated against the plastic stop [Fig. 1](#) on the engine.

Fig. 1
Lower Radiator Hose Not Fully Seated Against Plastic Stop

1. Compress the radiator hose clamp and push the lower hose to the fully seated position against the plastic stop [Fig. 1](#).
2. Release the radiator hose clamp at the lower radiator hose.
3. Lower the vehicle.
4. Check and top off the coolant.
5. Run the engine and check for leaks.
