STELLANTIS PARTS & SERVICES		Technical Service Bulletin (TSB) Dual-Pane Sunroof Leaking			
REFERENCE:	TSB: 23-102-23 GROUP: 23 - Body	Date:	September 28, 2023	REVISION:	_
VEHICLES AFFECTED:	This bulletin applies to vehicles built on or before February 06, 2023 MDH 0206XX) equipped with a Dual-Pane Panoramic Sunroof (Sales Code GWJ).		MARKET AF	PPLICABILITY: CH IAP MEA	
CUSTOMER SYMPTOM:	Dual-pane sunroof is leaking Fig. 1.				
CAUSE:	Wind deflector assembly.

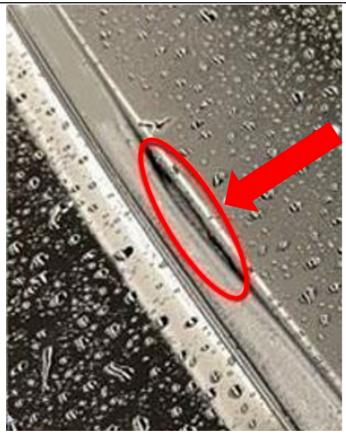
Fig. 1
Wind Deflector Getting Trapped In Sunroof Panel Causing Leak

This bulletin involves replacing the dual-pane wind deflector assembly with an updated design.

Replace the dual-pane wind deflector. Refer to the detailed service procedures available in DealerCONNECT/Service Library under: Service Info>23 - Body / Sunroof, Dual Pane / Deflector, Wind / Removal and Installation.
