Technical product information

Topic	Headlamp control unit replacement and/or turn signal control unit replacement
Market area	Australia E04 Bentley rest Asia and Australia (6E04),China 796 VW Import Comp. Ltd (Vico), Beijing (6796),Germany E02 Bentley rest Europe (6E02),Japan E03 Bentley Japan (6E03),Korea, (South) E08 Bentley South Korea (6E08),United Arab Emirates E06 Bentley Middle East and Africa (6E06),United Kingdom E01 Bentley UK (6E01),United States E05 Bentley USA and rest America (6E05)
Brand	Bentley
Transaction No.	2071934/1
Level	EH
Status	Approval
Release date

New Continental GT and New Continental GTC

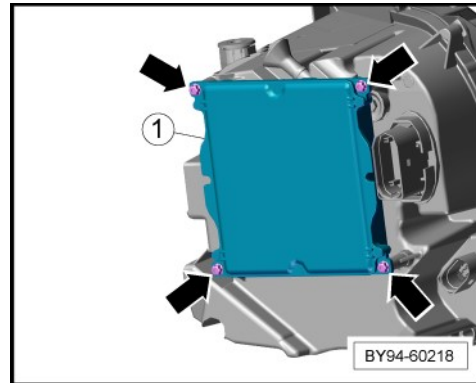
The headlamp control unit -1- is accessible from under the front wheel arch apertures.

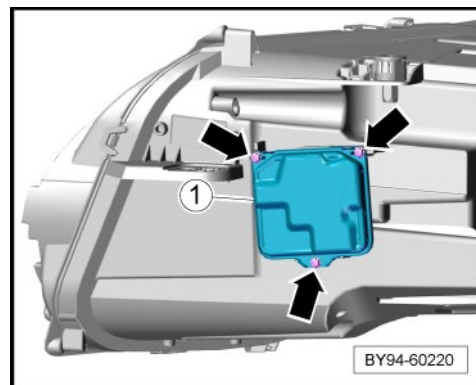
The turn signal control unit -1-, requires the headlamp assembly to be removed in order to gain access to the control unit.
