TSB #:	TSB20112301	Release Date:	12/15/2023
Main Group:	20 - Chassis		
Subject:	Tire Sealant Canister Service Action		
Vehicle: 32	FM29 OCEAN	Production Range:	Up to 10/25/2023
Model Year(s):	2023	Region(s):	Global
Mobile Service:	YES

SERVICE ACTION: Inspect – Remove – Replace Tire Sealant Canister

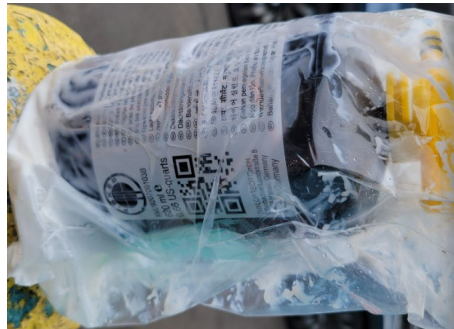
Figure 1 - Container with Leakage

Tire sealant material may leak from the Tire Sealant Canister.

- In some cases, the sealant may leak out of the protective bag and into the Styrofoam partition compartment located below the rear cargo area.
- Customer will not be able to use the tire sealant system, in the event a flat tire with a minor "sealable" link is encountered.

Internal the container will present a volume difference due to temperature change, generating a vacuum which sucks the anti-leak cap from this fixed position.

All canisters will be replaced with a newly revised yellow cap with modified internal sealing cap and additional plugs to prevent leakage.

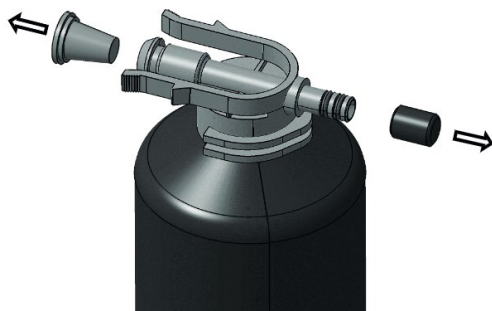
Figure 2 - External plug locations

- Additional plugs (black and yellow) on external yellow sealant cap (Fig. 2 & 3).
- Revised internal sealing cap.
- Revised part number on container (FM292070001038BDEV - Fig. 4) or green dot on the outside of the bag for early replacement canisters.
- User instruction

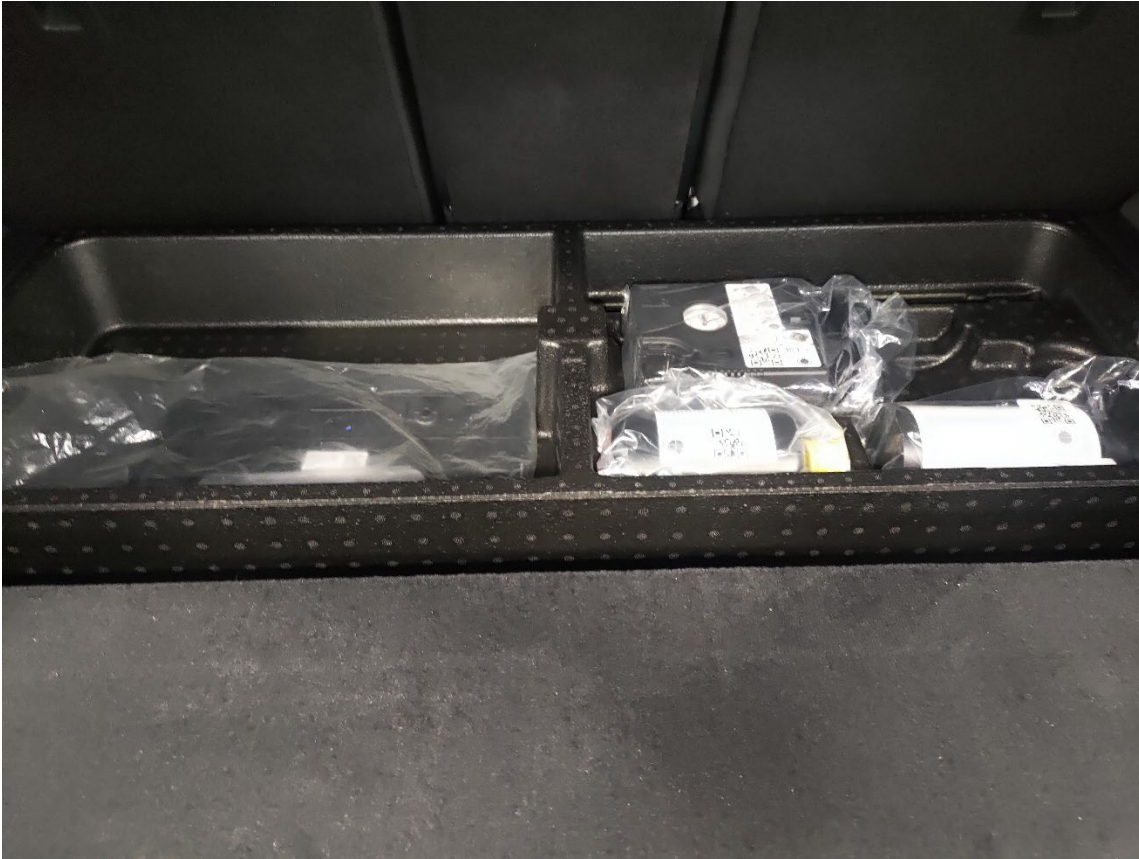
- Example of a clean partition box.

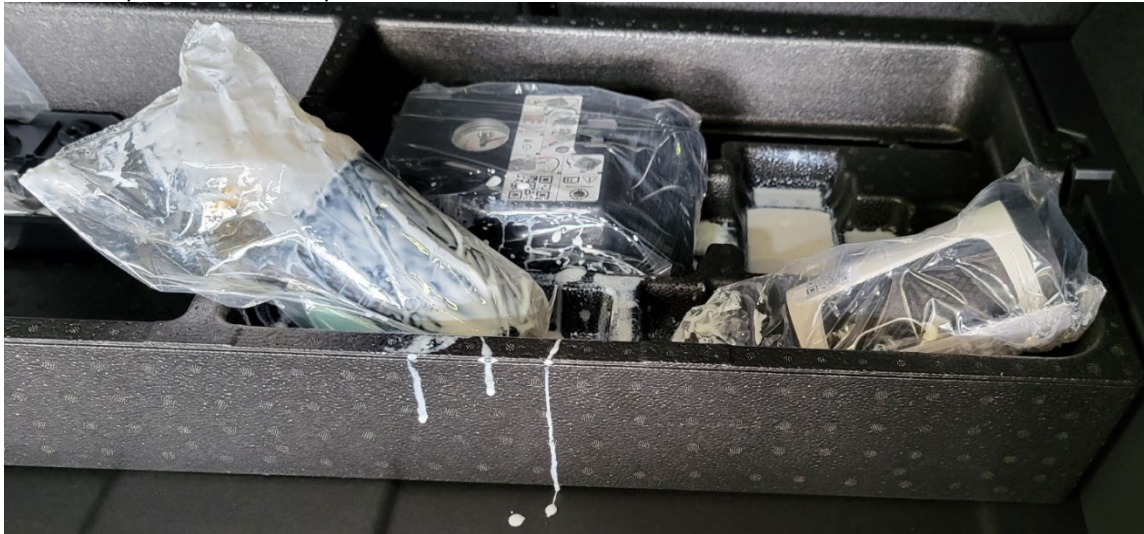
- Example of a leaked partition box.

The Partition box material has the property to absorb the liquid if exposed for a prolonged amount of time, leading to a possibility of spreading the liquid sealant into other areas of the storage area requiring additional clean-up

5. Remove everything from inside the partition box.

NOTE: If the amount of sealant that has leaked out of the canister and plastic bag is significant or has been absorbed into the partition tray or has congealed then:

- Take a picture of the issue and attach it to the Work Order.
- Ignore the cleaning process of step 6,7 & 8 and replace with a new partition box; a picture will be needed to justify the replacement.

6. If the amount of sealant that has leaked out of the canister and plastic bag is minimal: use an absorbent material or pad to assist in the cleanup of the liquid sealant and dispose of the saturated material or pad in compliance with local regulation.
7. Use a vacuum, if any absorbent material such as sand or silica gel was used to absorb the sealant, to clean up the material.
8. With a dry cloth and mild cleaning agent, clean the rest of the partition box, especially in the areas where the leaked fluid has dried or was not removable in the prior step.
9. Replace the tire sealant bottle and reinstall all components that were removed.
