# Service Bulletin

Bulletin No.: 19-NA-181

**Subject:** Multiple Electrical Concerns, Intermittent Multiple Instrument Panel Cluster (IPC) Warning Lamps Illuminated, Intermittent Multiple Message on Drivers Information Center (DIC) and Malfunction Indicator Lamp (MIL) Illuminated - DTC P057D, P057E, P0658, P0700, P073D, P07E4, P16F4, P175F, P1778, P1789, P2760, U0073, U0101 and/or U0121

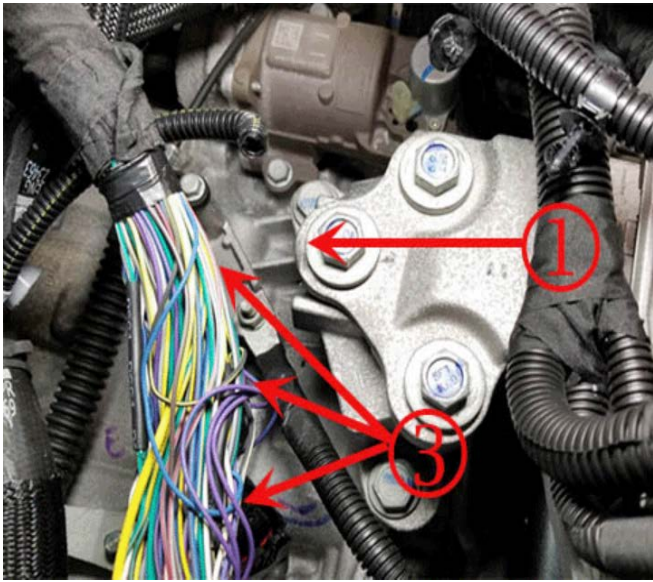
5023193

1. For **M3H/M3U**, inspect engine harness for proper routing and circuit 6387 for damaged wiring.
  - Wrap removed, point of contact (1) and chafed wire.

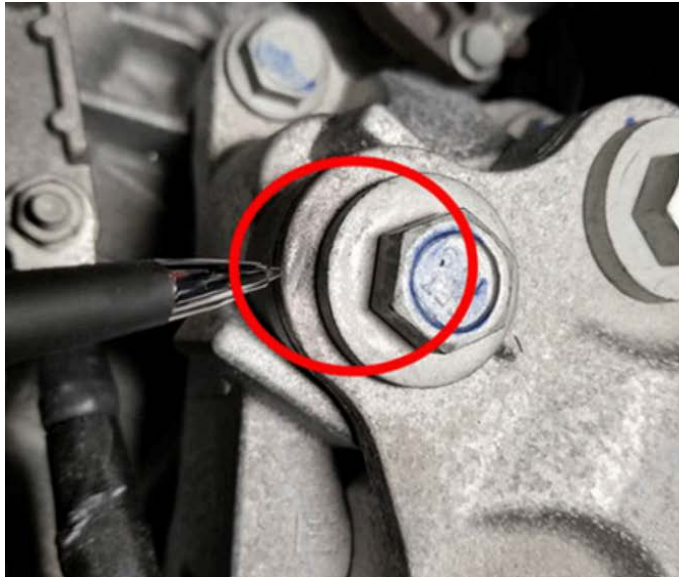
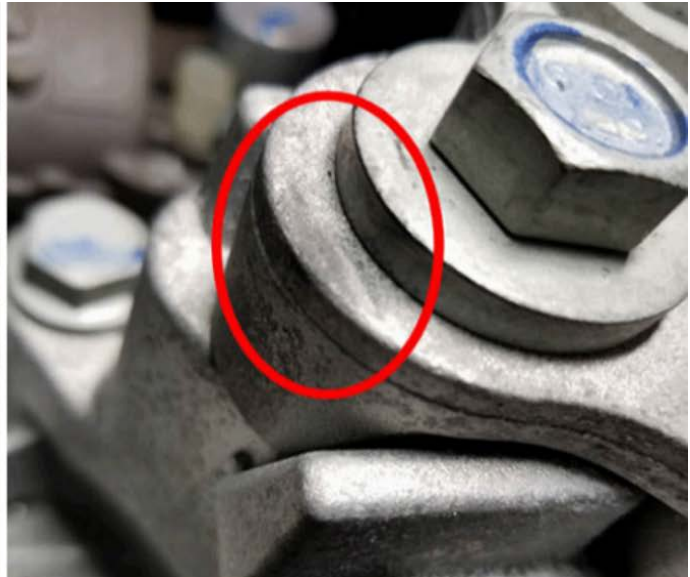
5394518

- Witness mark from point of harness contact.

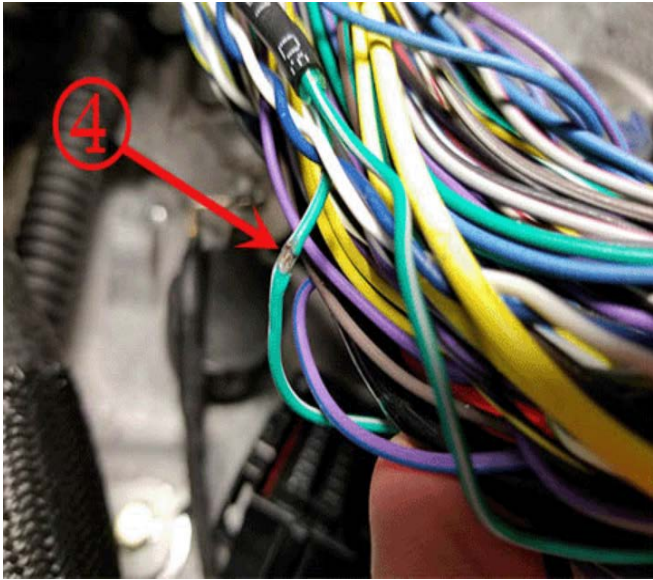
5023199

- Damaged wire (4) at circuit 6387 TCM high side driver.

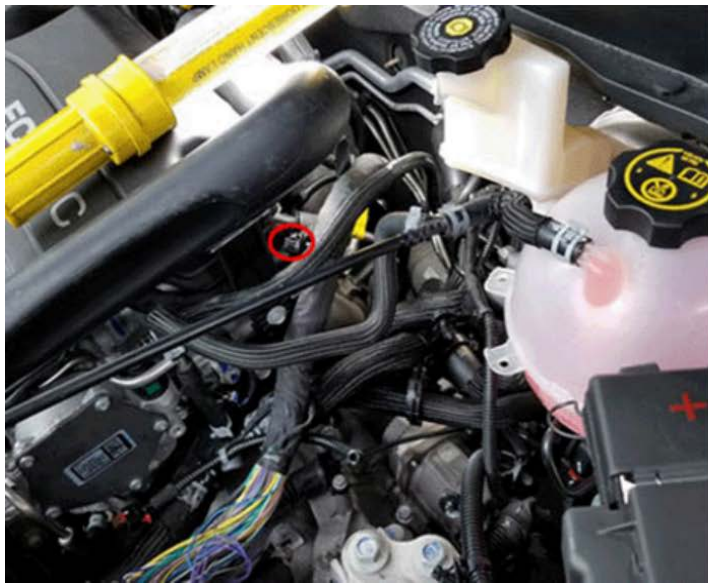
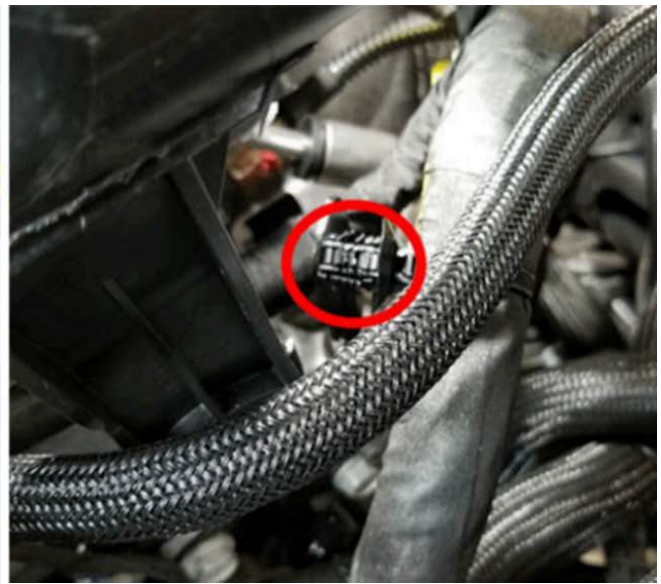
5394519

- Wire harness retainer not installed into bracket.

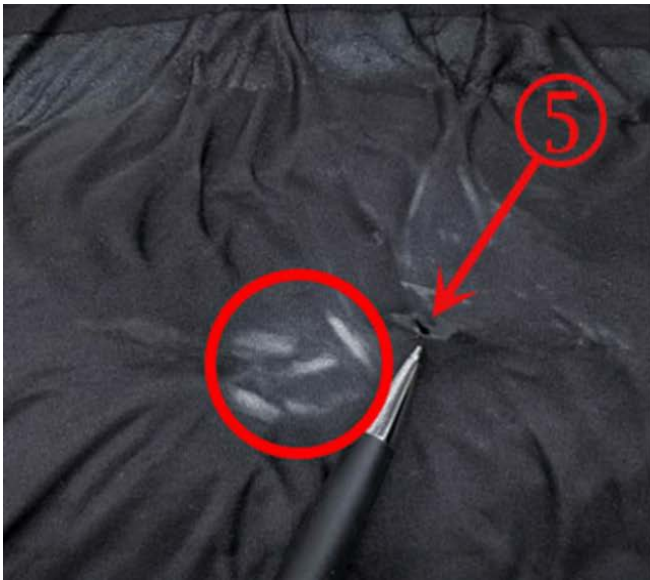
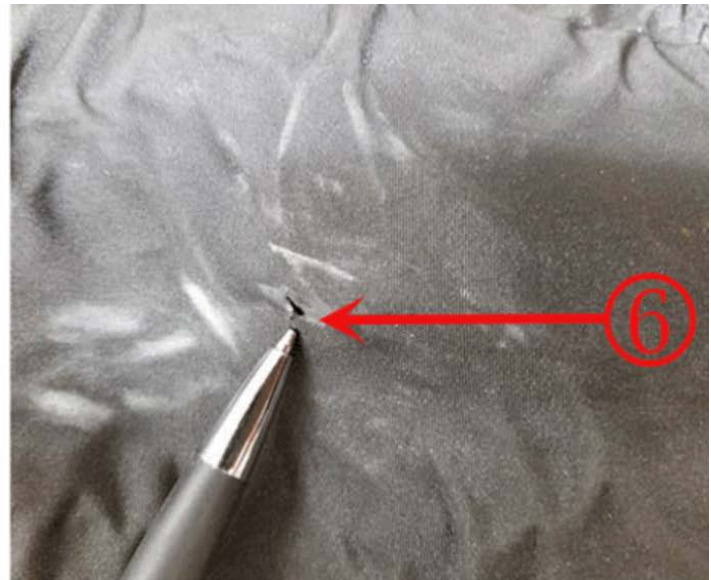
5394520

- Witness mark (hole) from removed wrap (5, 6).
2. Repair the wires per the *Wiring Repairs* procedure in SI.
  3. Using Woven Polyester Electrical Tape (PET), tape all the contact points of the engine harness ensuring that the tape is applied in a double layer extending along the harness past the splice sleeves.
  4. Verify all straps are secured and retainers are installed.

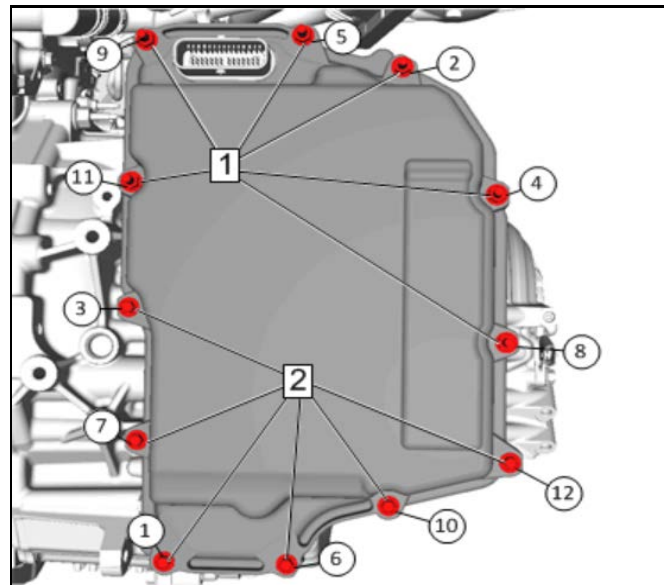
4489055

1. Inspect the engine wiring harness conduit and wires for chaffing around the #2, 5, and/or 9 stud of the transmission control valve body cover.

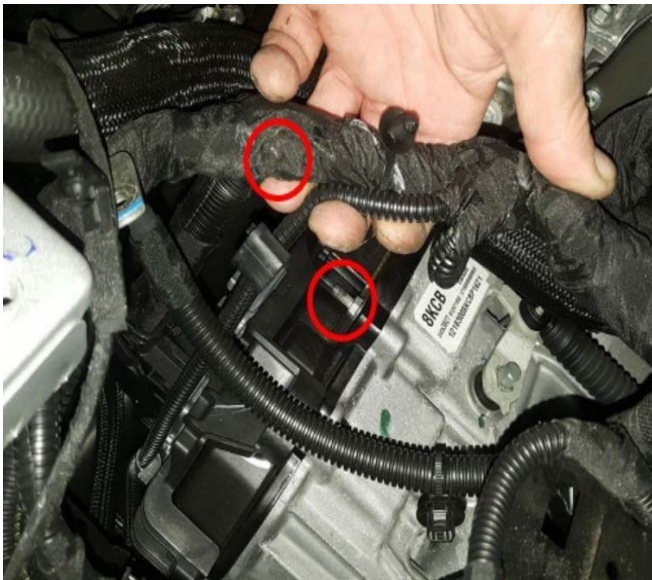
5387842

- Point of contact and chaffed wire.

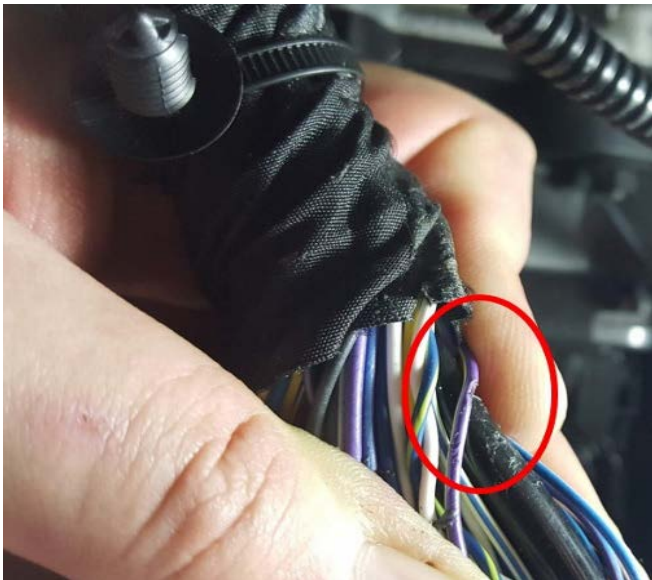
5387909

- Wrap removed, close-up picture.
2. Repair the wires per the *Wiring Repairs* procedure in SI.
  3. Using Woven Polyester Electrical Tape (PET), tape all the contact points of the engine harness ensuring that the tape is applied in a double layer extending along the harness past the splice sleeves.
  4. Verify all straps are secured and retainers are installed.
