# Service Bulletin

Bulletin No.: 21-NA-142

**Subject: Front Brake Grind/Groan Noise After Sitting Overnight**

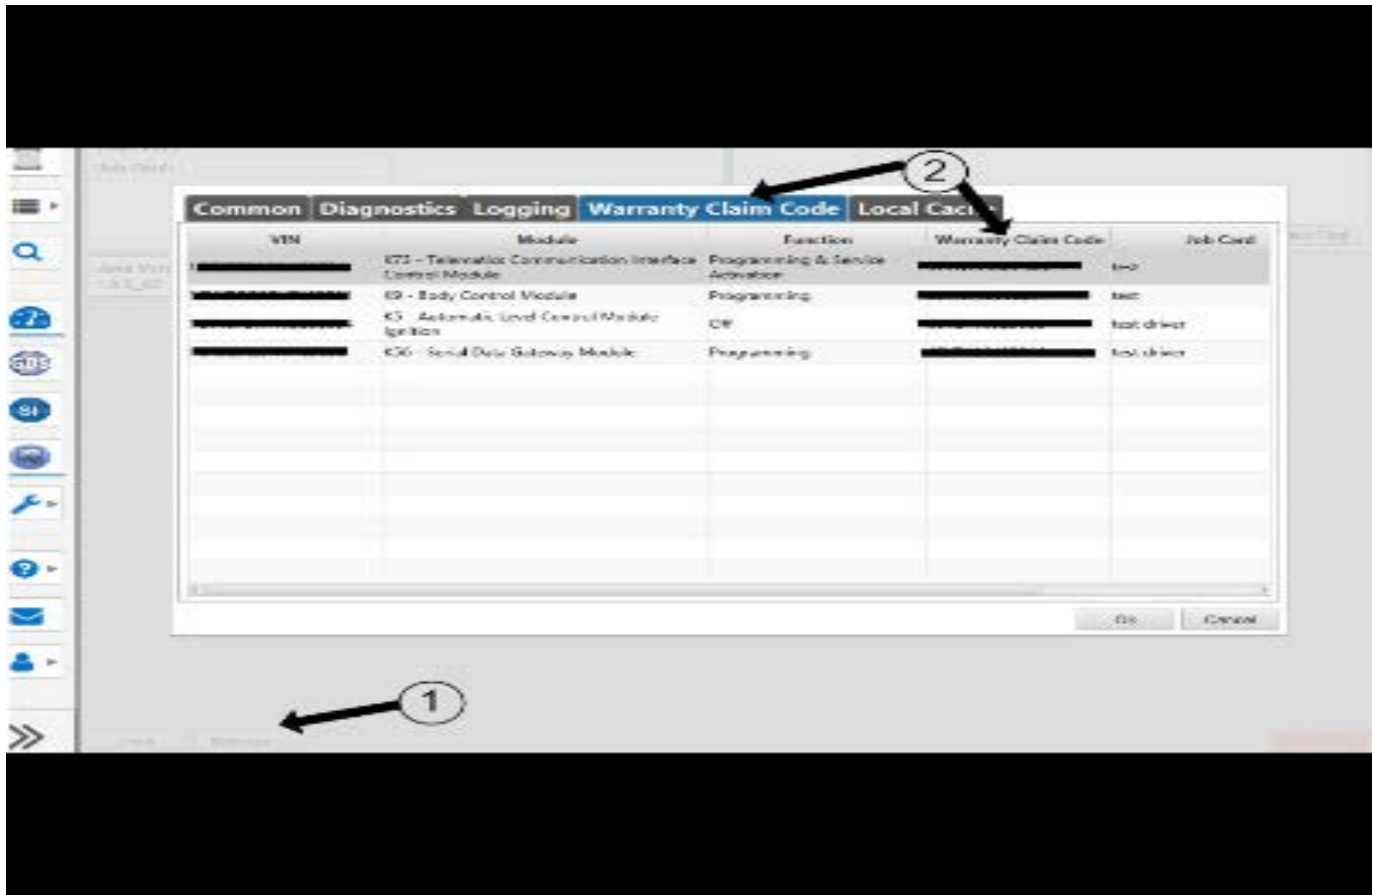
If the Warranty Claim Code was not recorded on the Job Card, the code can be retrieved in the SPS2 system as follows:

1. Open TLC on the computer used to program the vehicle.
2. Select and start SPS2.
3. Select Settings (1).
4. Select the Warranty Claim Code tab (2).
