# Service Bulletin

Bulletin No.: 23-NA-074

**Subject:** Service Engine Soon (SES), Reduced Power, Service Brake, Reduced Steering and/or Stabilitrak Message Illuminated on Driver Information Center (DIC), DTCs P0232, P023F, P0641, P0651, P06A3, P0697, P07BE, P1000, P1009, P2535, P129D, P12A6, P12A8, P2635, P3051, P3052, P3055, P3056, P305B, U0074, U0077, U0121, U0131, U0151, U0415, U0420, U0672, U111A, U18A2, U18C6, U18D2, U2502, U2616 Set

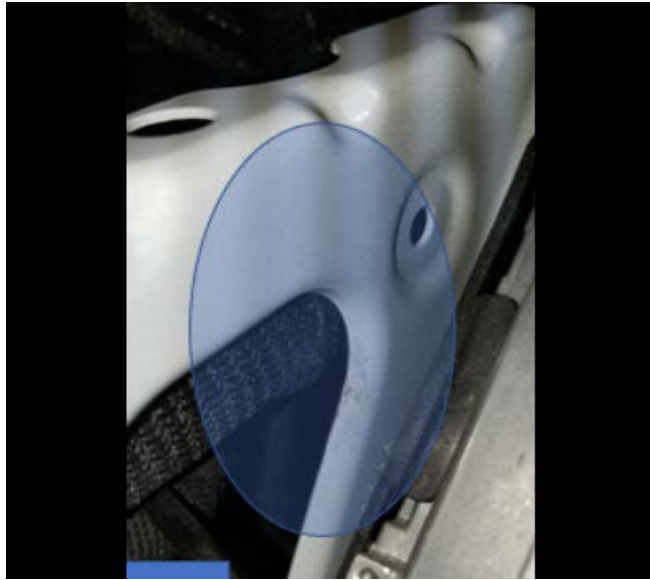
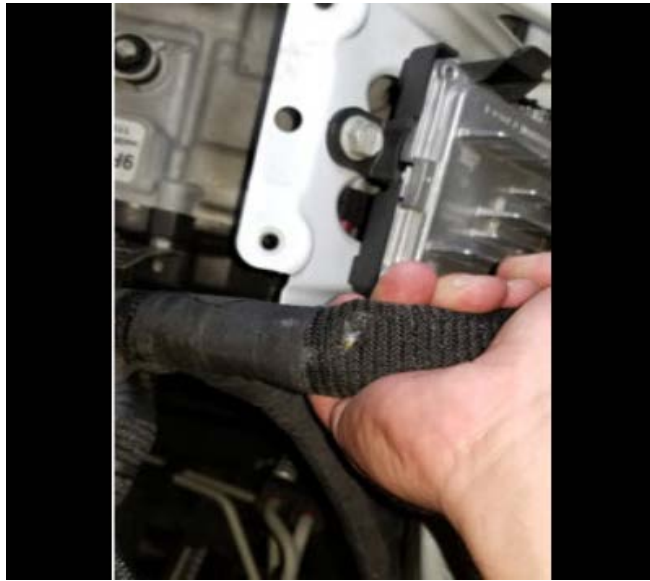
This condition may be caused by wire chafing on the battery tray support bracket.
