STAR ONLINE PUBLICATION

Case Number: S2323000083

Symptom/Vehicle Issue: Buzz Squeak Rattle (BSR) From Interior Near Rear Header D Pillar With Body Twist Or Over Bumps.

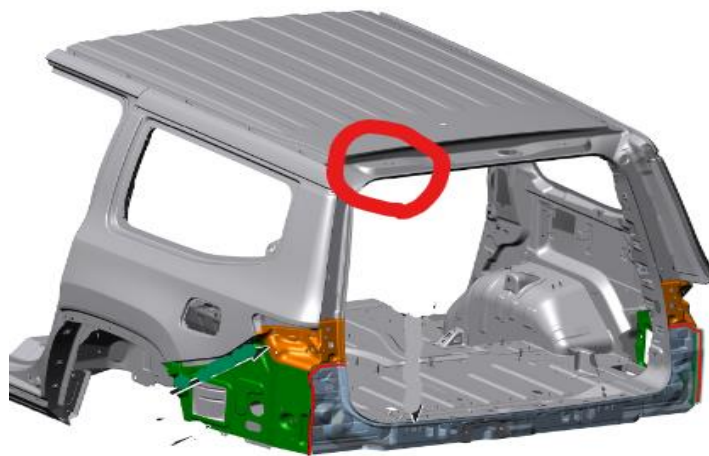
Fig 1

Discussion: With the aid of a helper, drive the vehicle in the manner the customer states the noise can be duplicated. If the noise is loudest heard at the rear roof area on the left-hand side (Fig 1), review and perform the below procedure.

1. If BSR noise heard is from the interior side of the red circled area in Fig 1, remove the headliner. Refer to Service Library 23 - Body / Interior / HEADLINER / Removal and Installation.
2. Lay a drop cloth on the interior at the lift gate opening to protect the interior carpet and trim from drips for the upcoming steps.
3. Obtain Loctite 290. Inspect the expiration date. **DO NOT USE EXPIRED MATERIAL.** Only use fresh 290.
4. Apply the Loctite 290 into the joint shown in Fig 2 below. Follow the application and cure instructions on the product. Because the application area is over head it may be of help to obtain an industrial material syringe also known as a hobby syringe (use internet web search to locate).
5. Once cured, assemble the interior in the reverse order of disassembly.
6. Perform a test drive to confirm condition is resolved.
