STAR ONLINE PUBLICATION

Case Number: S2323000083 Rev. A

Symptom/Vehicle Issue: Buzz Squeak Rattle (BSR) From Interior Near Rear Header D Pillar With Body Twist Or Over Bumps.

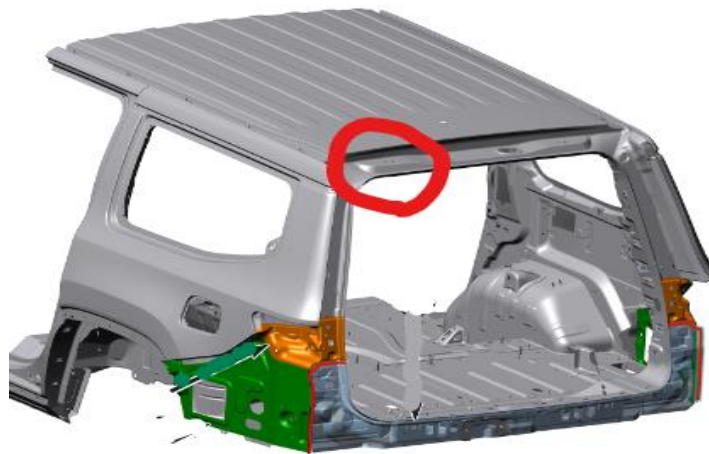
Fig 1

Discussion: With the aid of a helper, drive the vehicle in the manner the customer states the noise can be duplicated. If the noise is loudest heard at the rear roof area on the left-hand side (Fig 1), review and perform the below procedure.

1. If BSR noise heard is from the interior side of the red circled area in Fig 1, remove the headliner. Refer to Service Library 23 - Body / Interior / HEADLINER / Removal and Installation.
2. Lay a drop cloth on the interior at the lift gate opening to protect the interior carpet and trim from drips for the upcoming steps.
3. Obtain Loctite 290. Inspect the expiration date. **DO NOT USE EXPIRED MATERIAL.** Only use fresh 290.
4. Apply the Loctite 290 into the joint shown in Fig 2 below. Follow the application and cure instructions on the product. Because the application area is over head it may be of help to obtain an industrial material syringe also known as a hobby syringe (use internet web search to locate).
5. Once cured, assemble the interior in the reverse order of disassembly.
6. Perform a test drive to confirm condition is resolved.
