STAR ONLINE PUBLICATION

Case Number: S2308000148

Symptom/Vehicle Issue: Horn Sounding When Flashing a Body Control Module (BCM)

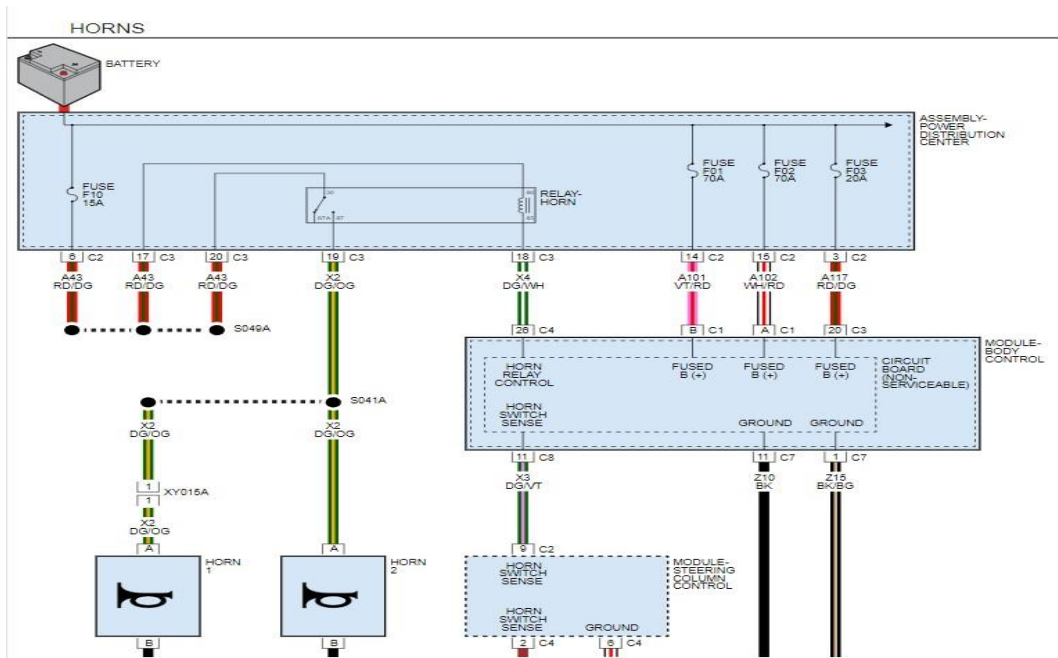
Technician Observation: On some occasions the horn may sound when flashing or servicing a BCM on a GG – Hornet or a GC – Tonale.

Discussion: To prevent the horn from sounding when servicing the BCM, remove the horn fuse or relay.

Remove Fuse F10 - Fuse cavity locations are printed on the inside of the power distribution center cover Fig 1 and 2.
