STAR ONLINE PUBLICATION

Case Number: S2323000085

Release Date: November 2023

Symptom/Vehicle Issue: Drone Noise From Bed Or Rear Of Truck While Driving At Speeds Between 20 And 45 MPH

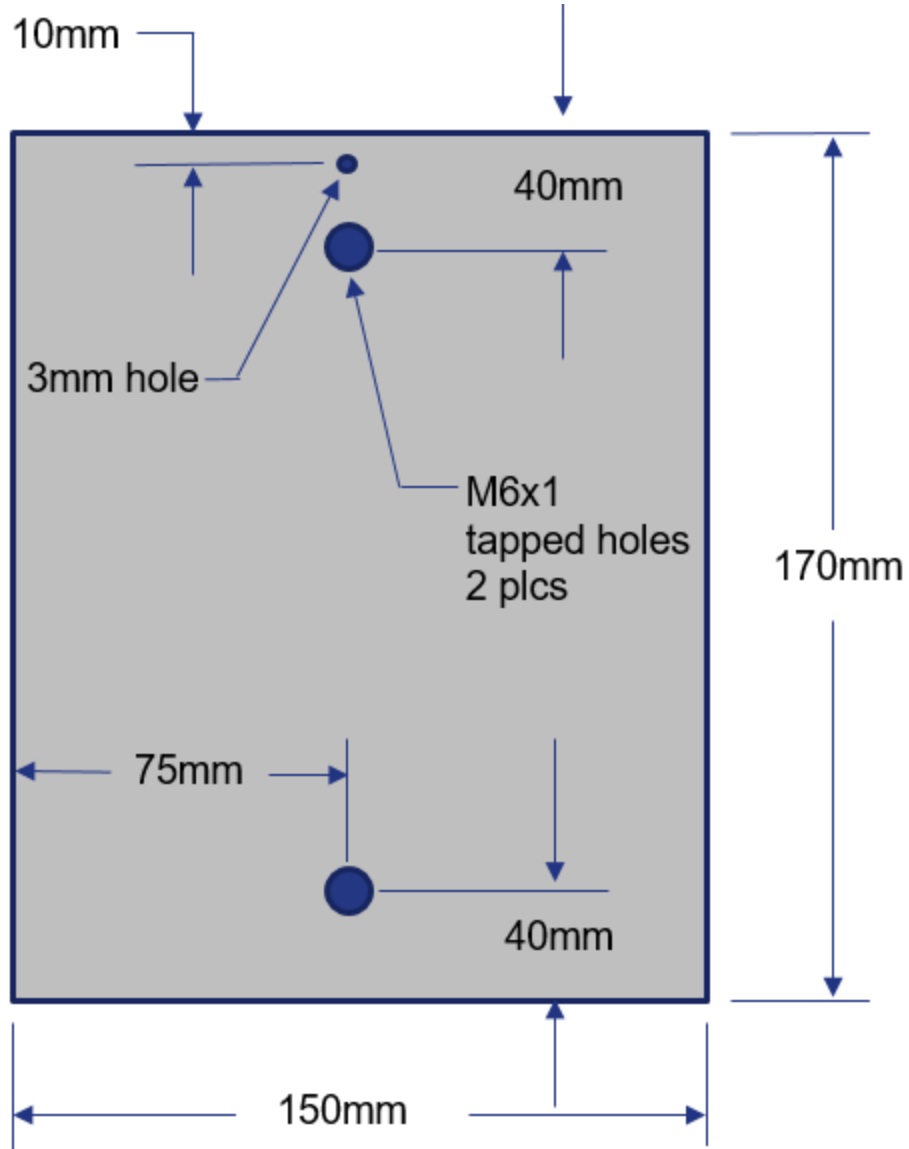
Fig 1
Fabricated Plate And Hole Locations.

Discussion: A noise vibration harshness (NVH) plate will need to be fabricated to reduce drone or noise from the vehicle. Obtain a piece of steel plate 6mm thick, 170mm x 150mm. Refer to Fig 1. Locate and drill the required holes based on the measurements in Fig 1. All 3 holes are centered on the 150mm side of the plate. It may be helpful to use a sharp scribe and a T-square to mark the center of the plate for the hole centers.

1. Using measurements from figure 1 mark, center punch, and drill the 3 hole centers. 3mm hole will be used to fish the plate into place. The 5mm holes once drilled will need to be tapped to M6x1. **Do not use the 6.6mm drill for these 2 holes in the plate.**
2. With all 3 holes drilled and tapped, prep the plate for corrosion coating. Remove any oils or grease with a grease and wax remover. Then apply zinc rich primer to the plate following application instructions. Once cured apply black spray enamel following the material's application instructions.

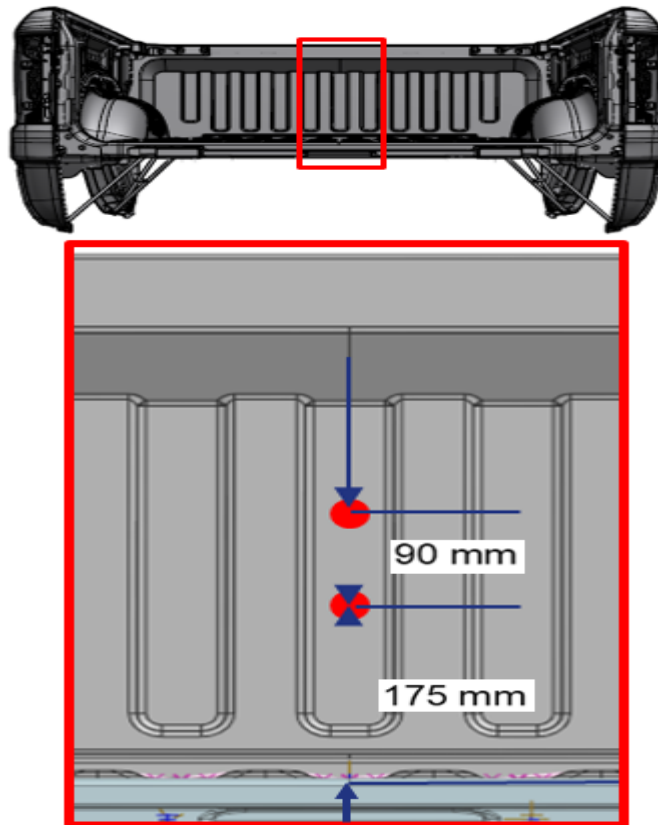
Fig 2.
Front Bed Bulkhead Hole Locations To Be Drilled With 6.6mm Drill.

3. Using a tape measure, locate the front bed bulkhead center inset rib. See Fig 2.
4. Measure up from the floor of the bed 175mm and place a paint mark or a scribe mark. Next, measure from the first hole upwards 90mm and mark a second hole. Center punch both hole locations and drill holes using a 6.6mm drill. NOTE- be very careful to not drill the truck cab when the drill passes completely through the bed bulkhead steel.
5. Use single step primer such as 3M 08682 (or equivalent) to corrosion protect the holes drilled in the bed. Follow product applications and cure times.

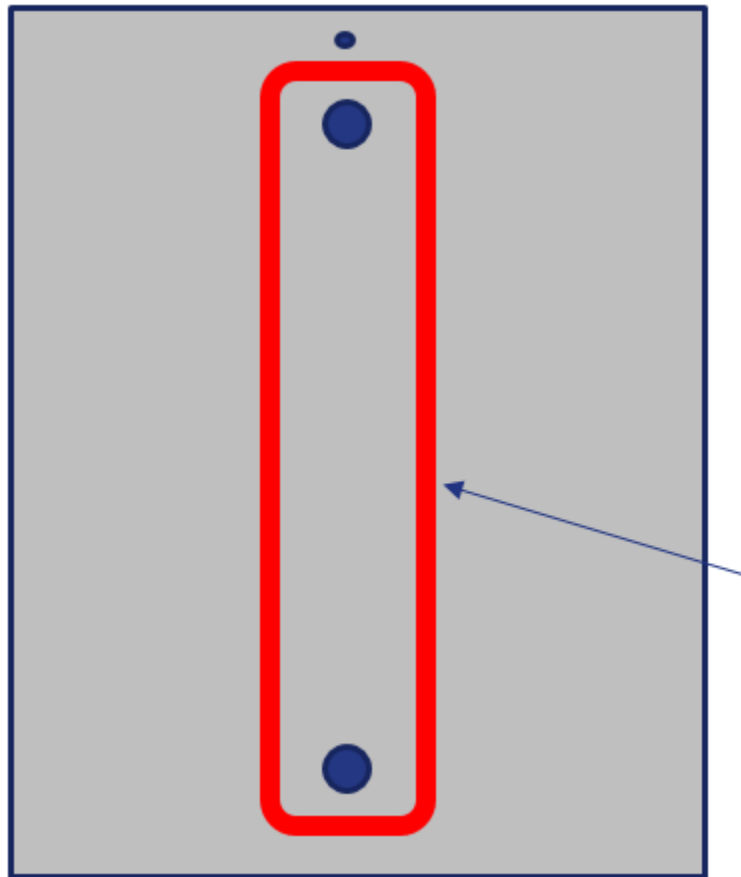
Pilogrip 7779 adhesive applied to the plate in the 3-5mm bead pattern shown.

6. Apply Pilogrip 7779 to the fabricated plate. Follow the pattern in Fig 3. The bead applied should be between 3-5mm diameter on the plate. Total width of both beads on the plate should not exceed 43mm wide (to cover the bulkhead rib width).
