## STAR ONLINE PUBLICATION

**Case Number:** S1525000009 REV. C

**Symptom/Vehicle Issue:** Updated Diagnostic Trouble Code (DTC) P2BA9 – Insufficient Reductant Quality, “Service Diesel Exhaust Fluid (DEF) System” Message Reset Procedure.

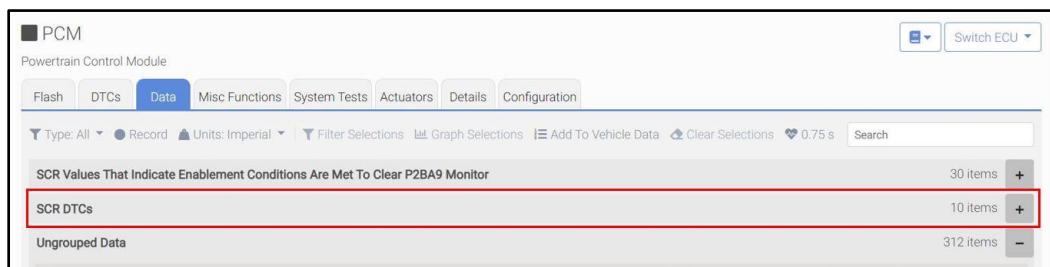
Figure 1.

3. Using wiTECH, navigate to the PCM DTCs tab and record the DTCs. If no DTCs are found, navigate to the PCM data tab. Expand the “SCR DTCs” group, and record the “SCR DTC” data parameters. Please see (Figures 1&2.). Is P2BA9 present in the PCM DTCs and/or 2BA9 present in the SCR DTC data parameters?
  - a. Yes>>> Proceed to (Step 4).
  - b. No>>> This document does not apply. Please follow normal published diagnostics for the other DTCs that are present.

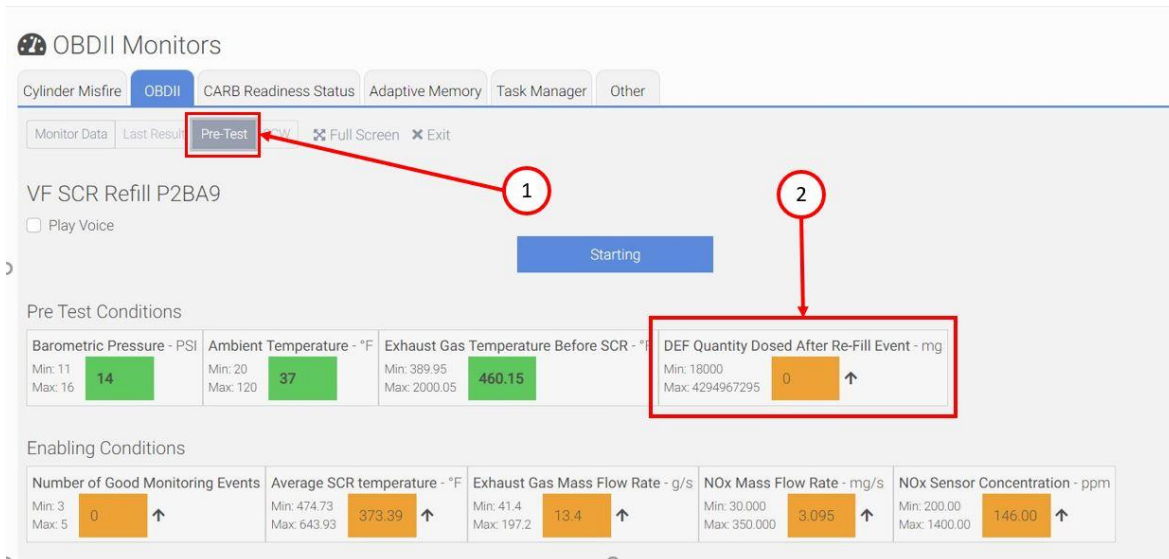
Figure 5.

1. Pre-Test tab
2. DEF Quantity Dosed After Re-Fill Event Data

13. Select Pre-Test and monitor the “DEF Quantity Dosed After Refill Event” while performing the next step. Please see (Figure 5).

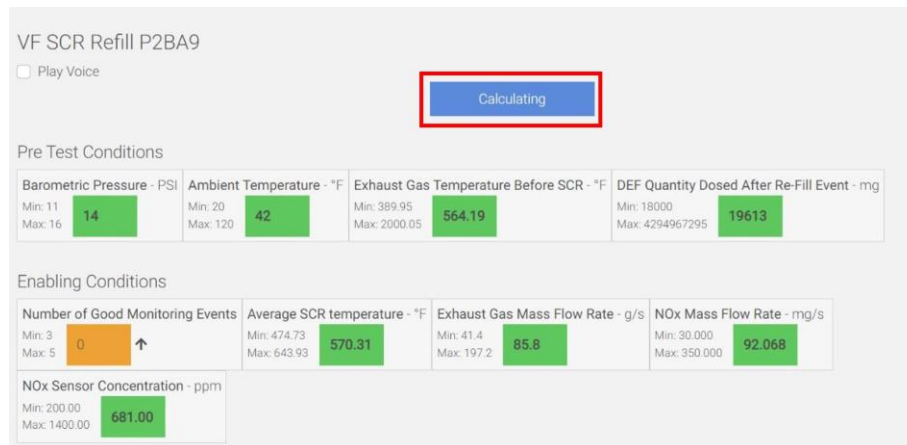
Figure 6.

15. Safely drive the vehicle in an environment that has routine stops (e.g., country road with routine stops or stop and go traffic along a boulevard). The monitor runs best during long, mild, steady accelerations from 0 to 55-60 mph (88-96 kph), using 20-40% throttle. While performing the accelerations, the system will start transitioning from “Starting” to “Calculating”. Please see (Figure 6). The longer the system indicates “Calculating”, during each acceleration, the better chance you

will have to clear the monitor. It may be necessary to slightly adjust the amount of throttle application during the accelerations, to keep the system in “Calculating” mode longer.

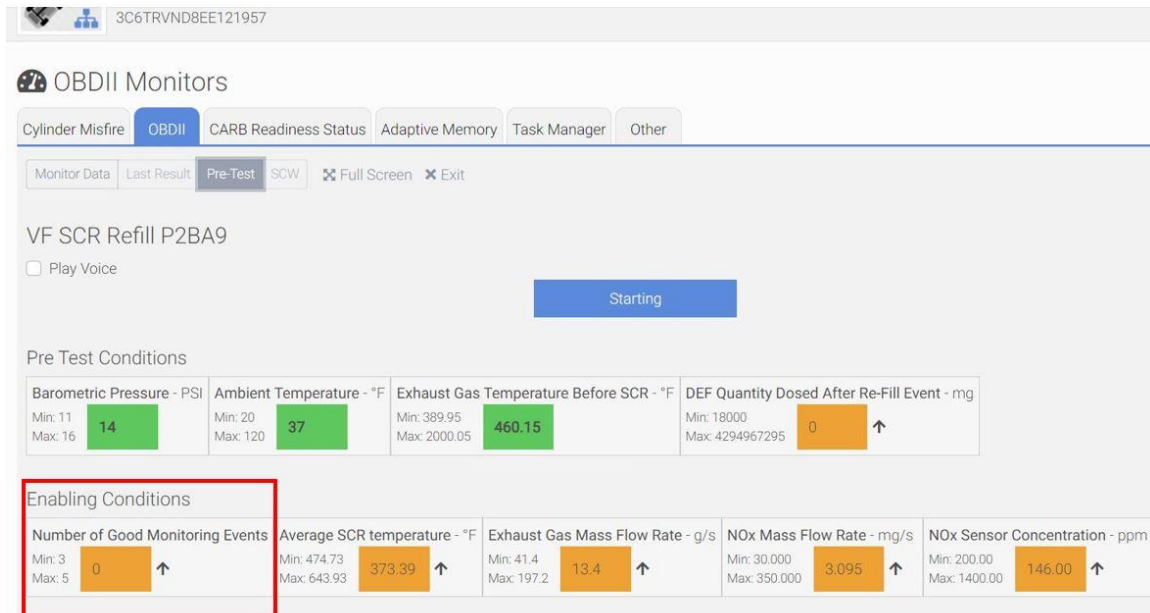
Figure 7.

16. As the system calculates, the “Number of Good Monitoring Events”, see (Figure 7), will begin to increase.

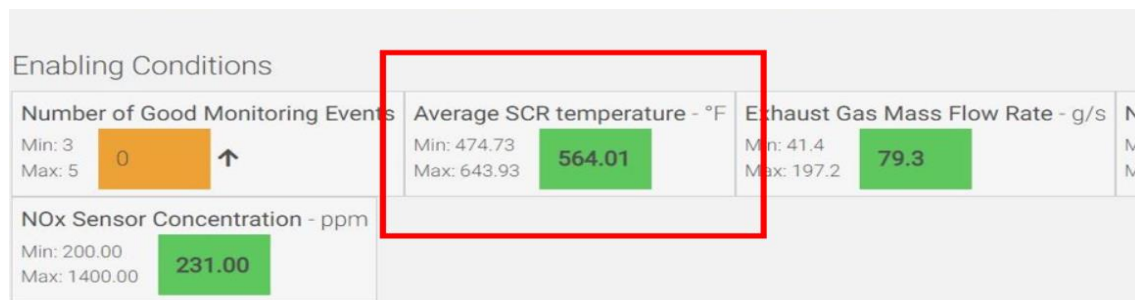
Figure 8.

**NOTE: While performing the above drive maneuver, the Average SCR temperature must remain between 475-644° F (246-340° C). Please see (Figure 8). Allowing the SCR temperature to fall outside these temps for too long will delay the monitor from running.**
