## STAR ONLINE PUBLICATION

**Case Number:** S2308000128 Rev. A

**Symptom/Vehicle Issue:** Day Night Mode Illumination on the Instrument Panel Cluster (IPC) and/or Radio Switches Frequently Under Low Lighting Conditions

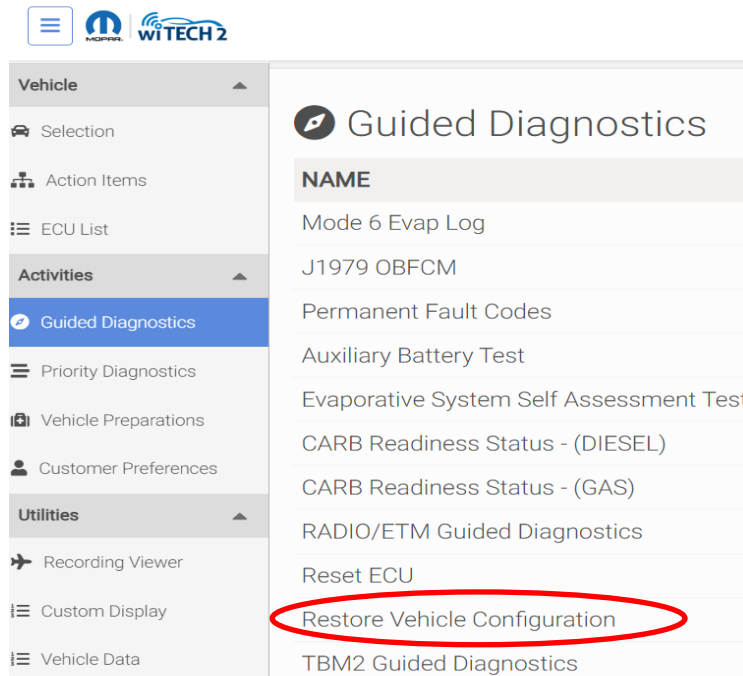
**Customer Complaint/Technician Observation:** The customer may complain after a recent service repair which included recall 88A that their instrument panel and/or radio backlighting has become more sensitive to light changes and may switch between night and day mode while driving.

**Discussion:** For vehicles which experience a day night mode light sensitivity condition, see the updated recall instructions for 88A and perform the wiTECH "Restore Vehicle Configuration" routine from the Guided Diagnostics tab and confirm the operation. The updates will sync any previous service configurations to resolve the concern. Do not replace any parts for this concern, parts are not required to resolve this condition.
