STAR ONLINE PUBLICATION

Case Number: S2308000151

Symptom/Vehicle Issue: Key Fob Battery Low Warning Message Displayed on The Instrument Panel Cluster (IPC)

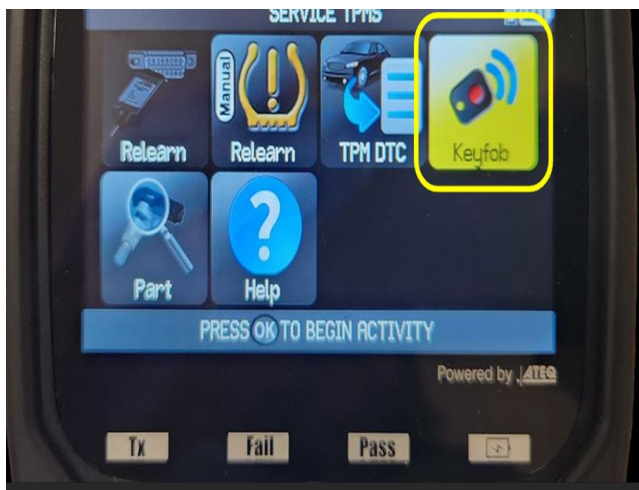
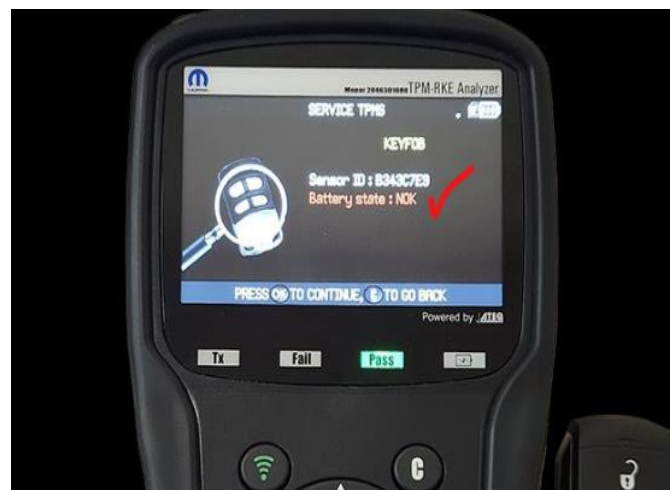
Discussion: If the customer complaint is a “Key Fob Battery Low” message on the cluster and the vehicle sets one of the above DTCs, it signals the key fob battery voltage is at a critical 2.3v or lower and may require a battery replacement. Use the TPM Analyzer tool 2046300080 to test the RKE performance/signal strength for the battery. For weak signals validate good internal FOB contacts for the battery before replacing a battery. Battery voltage can be tested with a voltmeter as needed once removed.

If the concern is present and the FOB battery is ok, inspect for aftermarket equipment (cell phone chargers, cell phones, LED lamps and any other aftermarket installed equipment that can be creating signal interference. If needed confirm all system antennas are secure with no damage.
