<b>REFERENCE:</b>	<b>TSB:</b> 08-237-23 <b>GROUP:</b> 08 - Electrical	<b>Date:</b>	November 2, 2023	<b>REVISION:</b>	–
<b>VEHICLES AFFECTED:</b>	<b>2023 (DS) RAM 1500 Pickup</b> This bulletin applies to vehicles built on or after June 16, 2023 (MDH 0616XX) and on or before June 24, 2023 (MDH 0624XX).			<b>MARKET APPLICABILITY:</b>	
				<input checked="" type="checkbox"/> NA	<input type="checkbox"/> MEA
				<input type="checkbox"/> SA	<input type="checkbox"/> IAP
				<input type="checkbox"/> EE	<input type="checkbox"/> CH
<b>CUSTOMER SYMPTOM:</b>	<p><b>Customers may experience a Malfunction Indicator Lamp (MIL) illumination. Upon further investigation the technician may find that one or more of the following Diagnostic Trouble Codes (DTCs) have been set:</b></p> <ul style="list-style-type: none"> <li>• U0418-00 - Implausible Data Received From Brake System Control Module.</li> <li>• C1444-98 - T-Case Motor Overuse-Component or System Over Temperature.</li> <li>• C00A8-13 - 4WD/AWD Transfer Case Unit Actuator Position Sensor B-Circuit Open.</li> <li>• C00A7-13 - 4WD/AWD Transfer Case Unit Actuator Position Sensor A-Circuit Open.</li> <li>• C149E-64 - Transfer Case Motor Position Sens

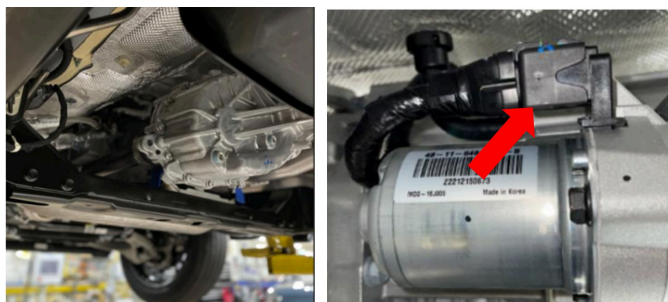
**Fig. 1****Transfer Case Shift Motor Wire Harness Connector**

<b>CAUSE:</b>	<b>Connector not fully seated.</b>

1. Raise and support the vehicle. Refer to the detailed service procedures available in DealerCONNECT/Service Library under: Service Info>04 - Vehicle Quick Reference / Hoisting / Standard Procedure.
2. Remove the transfer case skid plate, **if equipped**. Refer to the detailed service procedures available in DealerCONNECT/Service Library under: Service Info>13 - Frame and Bumpers / Under Body Protection / Plate, Skid / Removal.
3. Perform a push-pull-push test on the transfer case shift motor wire harness connector [Fig. 1](#) to verify the connector is fully seated.
