Technical Service Bulletin (TSB)

Air Conditioning Not Blowing Cold or is Inoperative

REFERENCE:	TSB: 24-013-23 GROUP: 24 - Heating and Air Conditioning	Date:	November 15, 2023	REVISION:	-
VEHICLES AFFECTED:	2023 - 2024 (H1) Jeep Commander 2023 - 2024 (M1) Jeep Compass 2023 - 2024 (B1) Jeep Renegade This bulletin applies to vehicles built on or after May 02, 2023 (MDH 0502XX) and on or before September 19, 2023 (MDH 0919XX).			MARKET APPLICABILITY:	
				<input checked="" type="checkbox"/> NA	<input type="checkbox"/> CH
				<input type="checkbox"/> EE	<input type="checkbox"/> IAP
				<input checked="" type="checkbox"/> SA	<input type="checkbox"/> MEA
CUSTOMER SYMPTOM:	Customers may comment on one or more of the following: <ul style="list-style-type: none"> • A/C will not function. • A/C is not blowing cold. 				
CAUSE:	Leaking Evaporator.

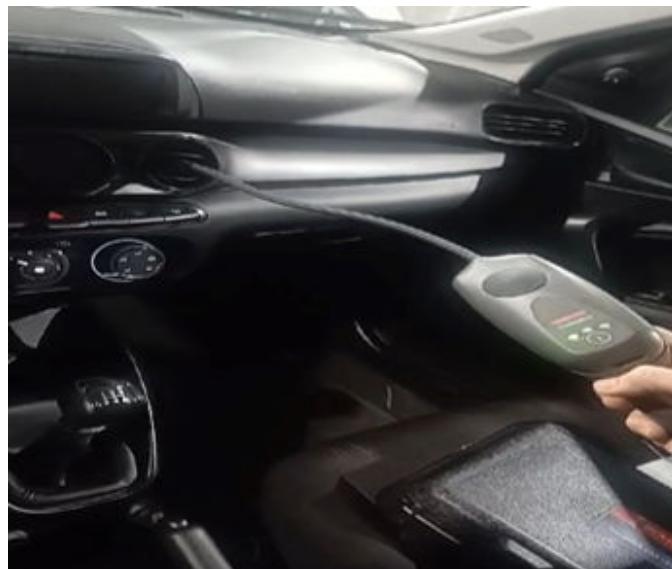
Fig. 1
Leak Detector Position

1. Turn on the A/C system.
2. Set the blower fan to speed 1.
3. Set the recirculation closed.
4. Keep all of the windows and doors closed.
5. Position the A/C vent to the panel position and open the diffusers.
6. Set the A/C system in the Max A/C operating mode.
7. Using the leak detector (EQ-10353143), inspect for a freon gas leak inside the cabin by placing the probe in the central diffuser [Fig. 1](#).

8. Is there a leak in the evaporator detected?
 - YES>>> Proceed to [Step 9](#).
 - NO>>> This bulletin has been completed. Use Inspection LOP (24-65-02-90) to close the active RSU.
9. Replace the evaporator. Refer to the detailed service procedures available in DealerCONNECT/Service Library under: Service Info> 24 - Heating and Air Conditioning / Plumbing / Evaporator, A/C / Removal and Installation.
