STELL PARTS & S			I Service Bulleti Blade Icing Serv	` ,	
REFERENCE:	TSB : 09-023-23 GROUP : 09 - Engine	Date:	November 28, 2023	REVISION:	_
VEHICLES AFFECTED:	2013 - 2023 (DS) RAM 1500 Pickup This bulletin applies to vehicles equipped with a 3.6L V6 24V VVT Engine (Sales Code ERB).		MARKET AP NA SA EE	PLICABILITY: MEA IAP CH	
CUSTOMER SYMPTOM:	Customers may experience a Malfunction Indicator Lamp (MIL) illumination. Upon further investigation the technician may find that one or more of the following Diagnostic Trouble Codes (DTCs) have been set: • P2072 - Electronic Throttle Control System - Ice Blockage. • P2110 - Electronic Throttle Control - Forced Limited RPM. • P2118 - Electronic Throttle Control Motor Current Performance - Bank 1. The customer may also comment on the following: • The vehicle may not start (below freezing conditions - typically -7 °C (-20 °F))				
CAUSE:	Throttle body blade icing up.

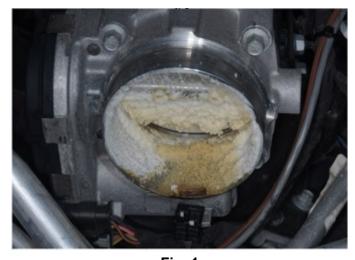
Fig. 1
Iced Throttle Body

3. Clean out and dry, any water or ice from the throttle body Fig. 1.
