**Technical Service Bulletin (TSB)**  
**Engine Misfire From Intake Manifold Crack**

<b>REFERENCE:</b>	<b>TSB:</b> 09-024-23 <b>GROUP:</b> 09 - Engine	<b>Date:</b>	November 29, 2023	<b>REVISION:</b>	-
<b>VEHICLES AFFECTED:</b>	<b>2022 - 2023 (WD) Dodge Durango</b> This bulletin applies to vehicles built on or after November 27, 2022 (MDH 1127XX) and on or before June 10, 2023 (MDH 0610XX) equipped with a 5.7L V8 Hemi MDS VVT Engine (Sales Code EZH).	<b>MARKET APPLICABILITY:</b>			
		<input checked="" type="checkbox"/> NA <input type="checkbox"/> MEA <input type="checkbox"/> SA <input type="checkbox"/> IAP <input checked="" type="checkbox"/> EE <input type="checkbox"/> CH			
<b>CUSTOMER SYMPTOM:</b>	<p>Customers may experience a Malfunction Indicator Lamp (MIL) illumination. Upon further investigation the technician may find the following Diagnostic Trouble Code (DTC) has been set:</p> <ul style="list-style-type: none"> <li>• P0301 - Cylinder 1 Misfire.</li> </ul> <p>Customers may also experience one or more of the following:</p> <ul style="list-style-type: none"> <li>• Rough engine idle.</li> <li>• Shakes while driving.</li> </ul>

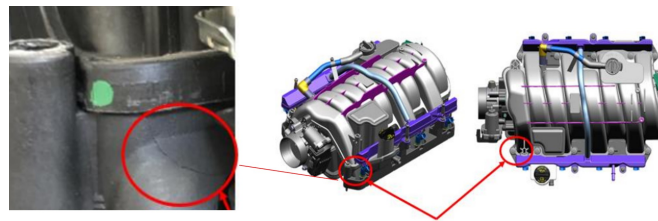
**Fig. 1**

<b>CAUSE:</b>	Fracture crack at left front of intake manifold <a href="#">Fig. 1</a> .

Area Where Crack Occurs

This bulletin involves inspecting and if needed replacing the intake manifold for a crack.

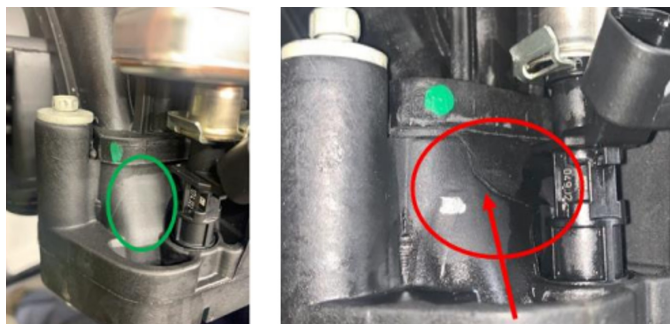
**Fig. 2**  
Crack Shown Up Close

4. Is the DTC present, or were any intake manifold cracks found in the left front corner [Fig. 2](#)?
  - YES>>> Proceed to [Step 5](#).
  - NO>>> This bulletin does not apply. Install the oil cap and engine cover. Use Inspect LOP (09-50-01-98) to close this active RSU. Normal diagnosis should be performed.
5. Replace the intake manifold. Refer to the detailed service procedures available in DealerCONNECT/ Service Library under: 09 - Engine, 5.7L / Manifolds / Manifold, Intake / Removal and Installation.
6. Install the engine cover.
7. Install the oil cap.
8. Clear all DTCs that may have been set in any module due to reprogramming. The wiTECH application will automatically present all DTCs after the flash and allow them to be cleared.
