**Technical Service Bulletin (TSB)**  
**Radio Over the air update to R255.45.06**

| REFERENCE: | TSB: 08-190-23<br>REV. A<br>GROUP: 08 -<br>Electrical | Date: | November 30, 2023 | REVISION: | 08-190-23 |

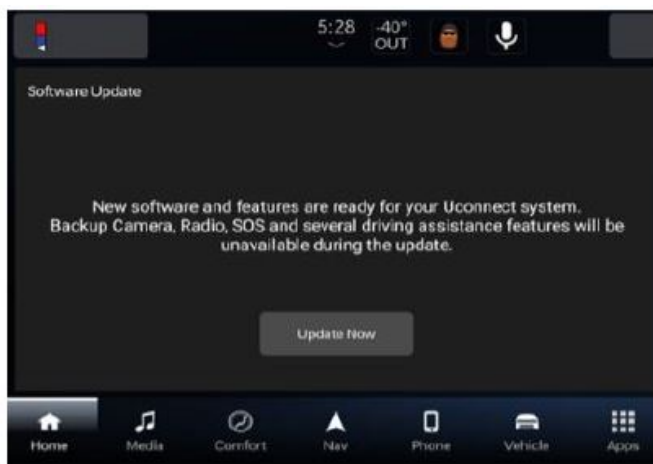
**Fig. 1**

## Software Acceptance Screen

1. The vehicle needs to be in 'Park'. The ignition needs to be in the off position.
2. If the customer selects "Update Now" [Fig. 1](#) they can shut off the vehicle and leave. The update will be completed automatically.

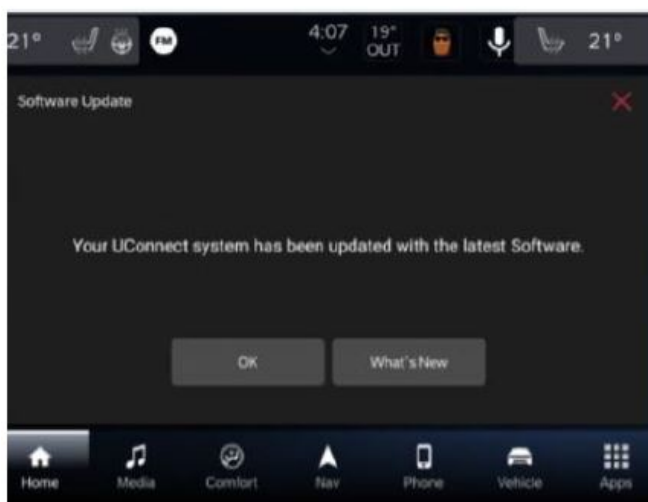
**Fig. 2**

3. Upon completion of update, the radio will display a confirmation message [Fig. 2](#).

## Software Update Confirmation Screen
