Technical Service Bulletin (TSB)
Engine Misfire From Intake Manifold Crack

REFERENCE:	TSB: 09-025-23 GROUP: 09 - Engine	Date:	November 30, 2023	REVISION:	-
VEHICLES AFFECTED:	2022 - 2023 (LD) Dodge Charger This bulletin applies to vehicles built on or after December 09, 2022 (MDH 1209XX) and on or before January 20, 2023 (MDH 0120XX) equipped with a 5.7L V8 Hemi MDS VVT Engine (Sales Code EZH).	MARKET APPLICABILITY:			
		<input checked="" type="checkbox"/> NA <input type="checkbox"/> MEA <input type="checkbox"/> SA <input type="checkbox"/> IAP <input type="checkbox"/> EE <input type="checkbox"/> CH			
CUSTOMER SYMPTOM:	<p>Customers may experience a Malfunction Indicator Lamp (MIL) illumination. Upon further investigation the technician may find the following DTC has been set:</p> <ul style="list-style-type: none"> • P0301 - Cylinder 1 Misfire. <p>Customers may experience the following:</p> <ul style="list-style-type: none"> • Rough idle and shakes while driving.

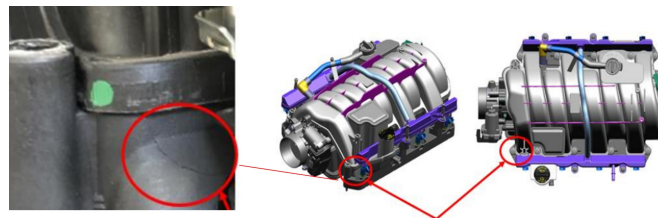
CAUSE:	Fracture crack at left front of intake manifold Fig. 1 .

Area Where Crack Occurs

This bulletin involves inspecting and if needed replacing the intake manifold for a crack.

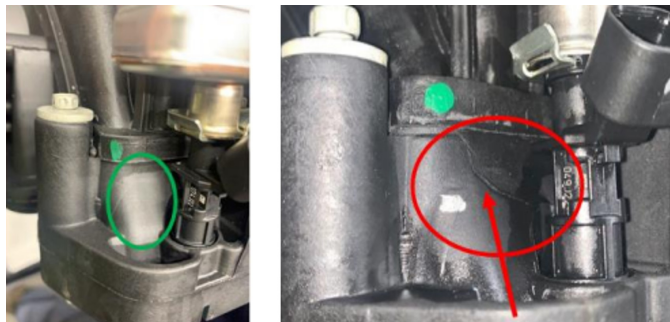
**Fig. 2**

1. Remove the oil cap.
2. Lift upward and remove the engine cover.
3. Verify the above DTC as being stored, active or pending and inspect the left front corner of the intake manifold for any signs of cracks.

Crack Shown Up Close

4. Is the DTC present or were any intake manifold cracks found in the left front corner [Fig. 2](#)?
 - YES>>> Proceed to [Step 5](#).
 - NO>>> This bulletin does not apply. Install the oil cap and engine cover. Use Inspect LOP (09-50-01-91) to close this active RSU. Normal diagnosis should be performed.
5. Replace the intake manifold. Refer to the detailed service procedures available in DealerCONNECT/ Service Library under: 09 - Engine, 5.7L / Manifolds / Manifold, Intake / Removal and Installation.
6. Clear all DTCs that may have been set in any module due to reprogramming. The wiTECH application will automatically present all DTCs after the flash and allow them to be cleared.
