| <b>REFERENCE:</b> | <b>TSB:</b> 08-255-23<br><b>GROUP:</b> 08 - Electrical | <b>Date:</b> | November 28, 2023 | <b>REVISION:</b> | - |
| <b>VEHICLES AFFECTED:</b> | <b>2022 - 2023 (B1) Jeep Renegade</b><br><b>2022 - 2023 (H1) Jeep Commander</b><br><b>2022 - 2023 (M1) Jeep Compass</b><br><b>This bulletin applies to vehicles built on or after August 04, 2022 (MDH 0804XX) and on or before June 20, 2023 (MDH 0620XX).</b> | | | <b>MARKET APPLICABILITY:</b> | |

This bulletin involves tightening the G002 ground cable bolt.

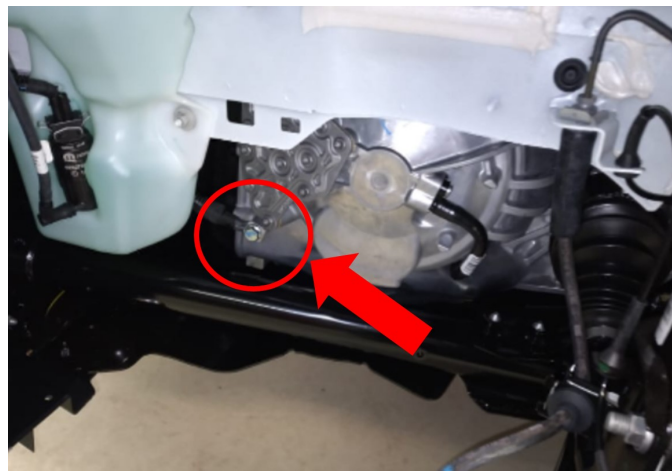
**Fig. 1**

| <b>CAUSE:</b> | <b>Loose ground cable.</b> | | | | |

Ground Cable G002

1. Disconnect and isolate the negative battery cable(s). **If equipped with an Intelligent Battery Sensor (IBS), disconnect the IBS connector first before disconnecting the negative battery cable.**
2. Raise and support the vehicle. Refer to the detailed service procedures available in DealerCONNECT/ Service Library under: Service Info>04 - Vehicle Quick Reference / Hoisting / Standard Procedure.
3. Remove the left front fender. Refer to the detailed service procedures available in DealerCONNECT/ Service Library under: Service Info>23 - Body / Exterior / Fender, Front / Removal.
4. Locate the ground cable G002 on the vehicle, which connects the ground cable from the battery to the transmission, located near the front left fender [Fig. 1](#).

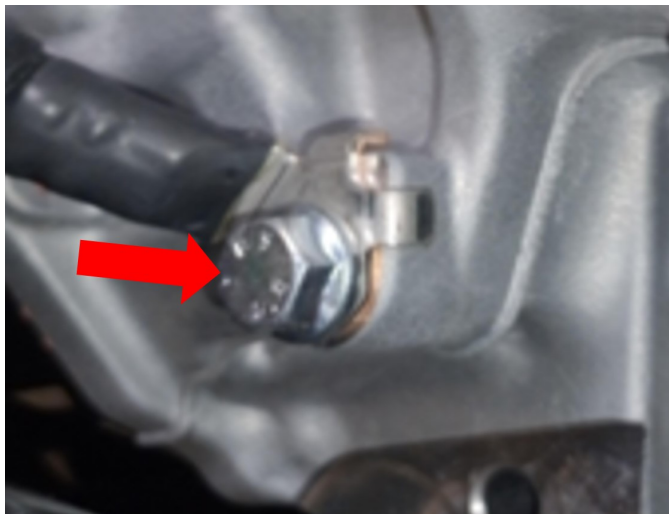
**Fig. 2**

G002 Ground Cable Bolt

5. Tighten the G002 ground cable bolt [Fig. 2](#) to 22 N·m (16 ft. lbs.).
