# Rapid Update 678

## Grecale – Intercooler pipe replacement

DATE: DECEMBER 5 2023

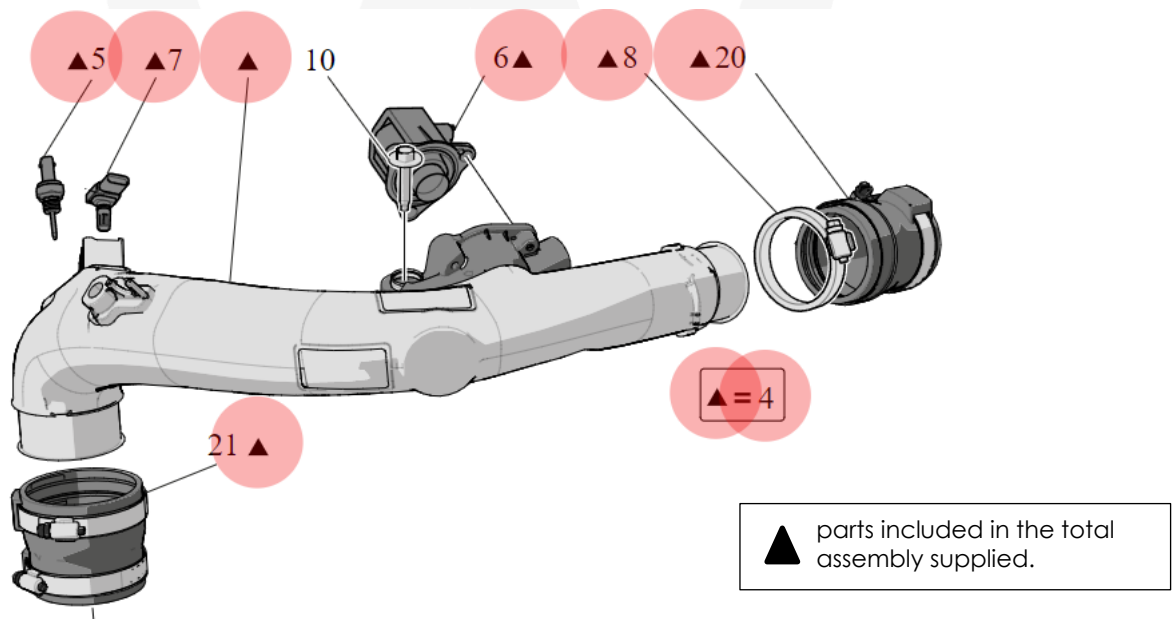
A limited batch of vehicles may potentially have been fitted with piping that has a plastic burr in the connection area. Over time, it can detach and cause noise and disruptions in the component's operation. The expectation of this anomaly occurring is very low and is usually detected early by triggering a MIL and setting a P2261 DTC. The procedure consists of replacing the non-compliant component.

6. At this point, you can reach the outlet pipe of the turbocharger. replace the pipe following the workshop manual instructions. **Section 01.32 - 1**

**01.40.062 AIR OUTLET PIPE FROM TURBOCHARGER TO MANIFOLD THROTTLE BODY - Removal-Refitting or Replacement**

**Important!** Parts highlighted in red are included with the new pipe. There is no need to transfer these parts from the old one.
