MAS003863 RU 23-69

# Rapid Update 681

## Granturismo – Front Wiring Repositioning

DATE: DECEMBER 5 2023

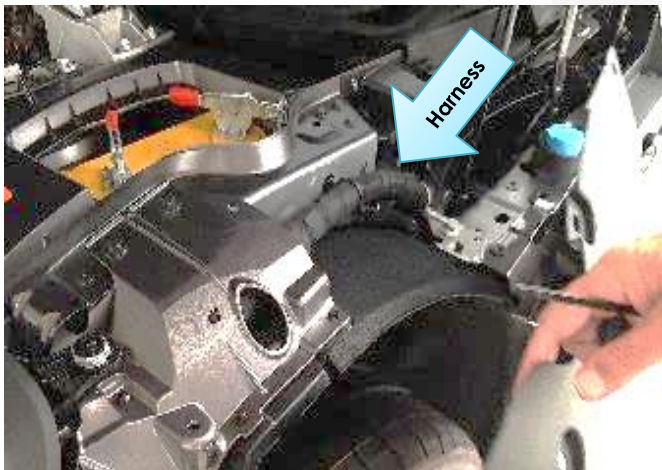
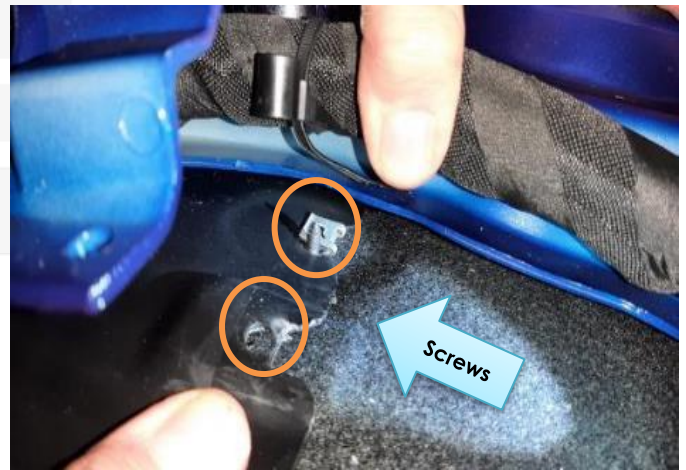
This action is necessary because there may be possible interference between the front fender well screws and a wiring harness that is positioned above the wheel arch. Although the integrity of the wiring is guaranteed by a double layer of anti-cut sheath which protects the harness in the event of interference with one or both screws, it is still necessary to proceed with the rework to ensure harness integrity.

4. Locate the wiring harness underneath the front fender cover and inspect the entire circumference of the wiring harness for damage or abrasions, especially the area where the harness is routed between two screw fasteners.

- **OK** ▶ No damage or abrasions to the harness is found. Continue with the cable tie install **Step 7**.
- **NOT OK** ▶ Wire wrap shows signs of damage, unwrap the electrical tape of the suspected area and inspect for signs of damage to the individual wires.
