MAS003864 RU 23-70

# Rapid Update 682 Granturismo – Branch Service Cable Check

DATE: DECEMBER 14 2023

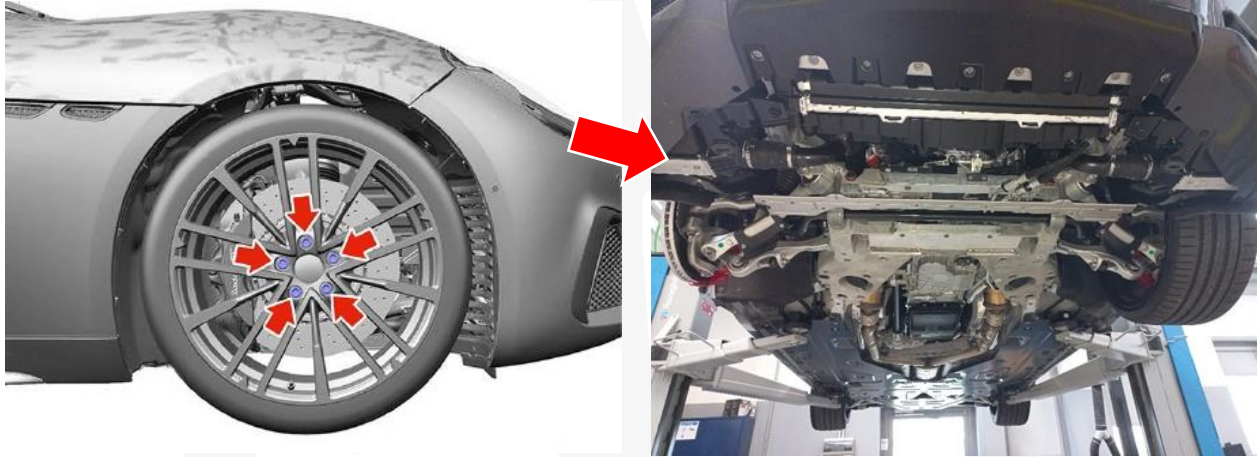
1. Always check ModisCS+ to see if the vehicle is involved in this action and if it has not been previously performed.
2. Disconnect the battery according to the instructions in the workshop manual:  
**08.20.001 - BATTERY - Connecting/disconnecting the electrical power supply**
3. Carefully lift the vehicle on a lift and dismantle the front right wheel assembly.  
**06.00.001 - RIGHT FRONT WHEEL RIM - Removal-Refitting or Replacement**

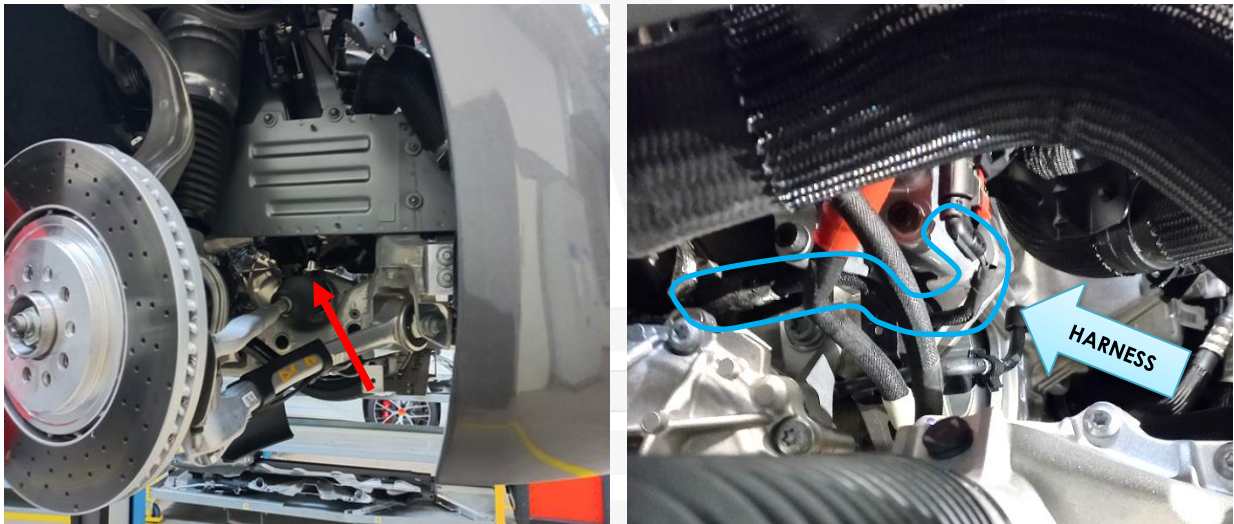
4. Inspect the wiring harness, from the right side of the vehicle towards the inside of the engine.

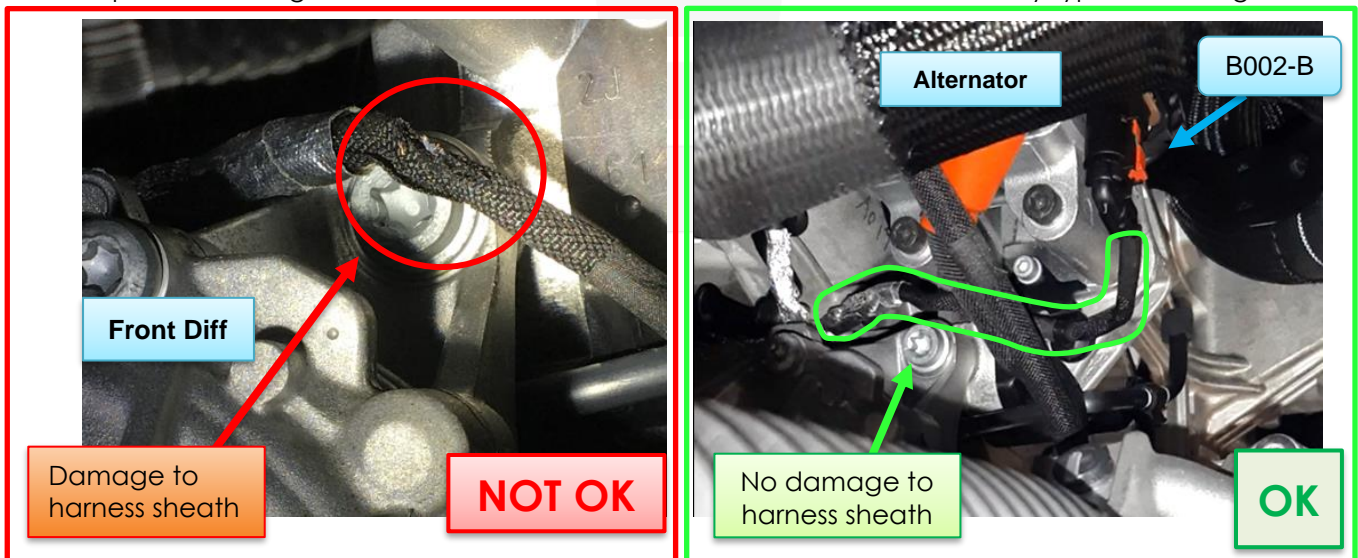
5. Inspect the wiring and check that it is free to move and does not show any type of damage.

- **OK ▶** No damage or abrasions to the harness is found. No further action needed. Re-install all components removed in reverse order and release the vehicle.
- **NOT OK ▶** Harness sheath shows signs of damage. Open a BOL as "Support Request", attach pictures of the damage and **wait for further instructions**.

**Recommendations in case wire repair is needed.** It is advisable not to entirely remove the harness sheath; instead, cut it open to facilitate the repair. This allows for easy rewiring using "wire harness tape" (e.g., Tesa 51036, COROPLAST 8310SE, SCAPA TAPES 003\_BK). Use only solder seal shrink tubing as referenced in bulletin **MAS000766**.
